60th Street District

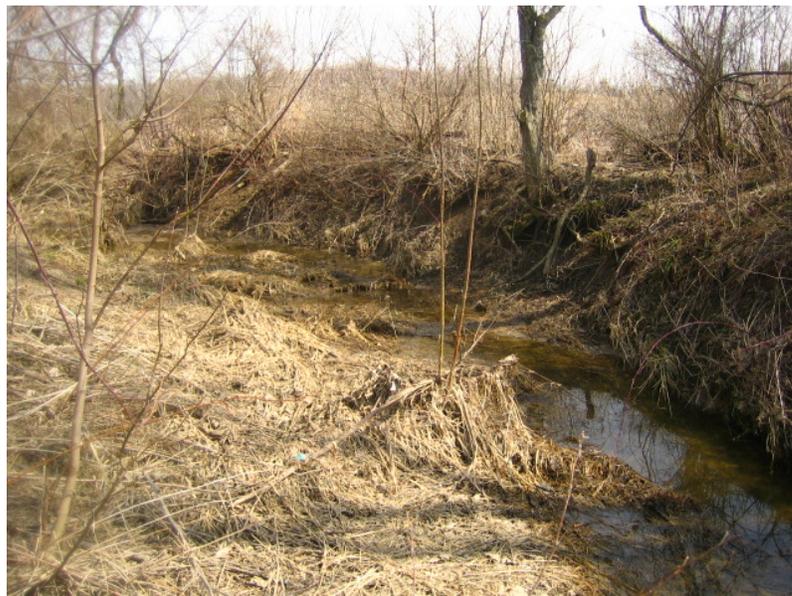
Photograph TH2 (see flag A, Figure TH1)

The 60th Street District is shown in Figure TH1. The primary stream that drains the district has its headwaters south of Cascade Charter Township in Caledonia Charter Township. It discharges through Caledonia Charter Township and on into Gaines Charter Township. The stream is designated as a Kent County Drain (named the Wenger and Nulty). Upstream of Broadmoor Avenue, the stream is a channelized agricultural drain. The stream appears to be protected from direct runoff from the farm fields with a brush/forest buffer zone along its banks. It shows minor streambank erosion (Photograph TH2) and contains a significant amount of woody debris.

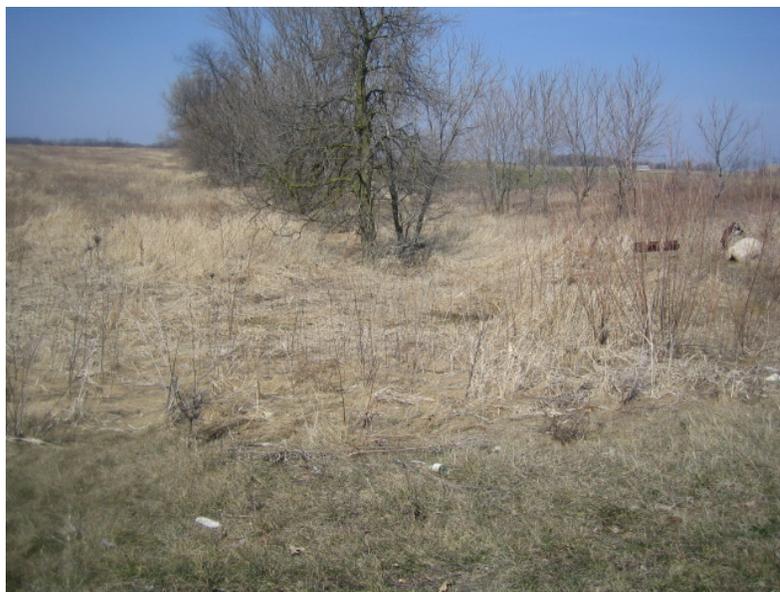
Photograph NE2 (see flag A, Figure NE1)

The Gerald R. Ford International Airport (GRFIA) Northeast District is shown in Figure NE1. The stream that drains this district has its headwaters between Thornapple River Drive and M-6. The stream is very minor downstream of 48th Street (Photograph NE2) as it parallels Burger Drive, crosses Burger Drive, and continues onto the western half of the Thornapple Pointe Golf Club property. There are no buffer zones along the stream through the golf course property (Photograph NE-3). After passing under M-6 and the eastern half of the golf course, the stream discharges into the Thornapple River.

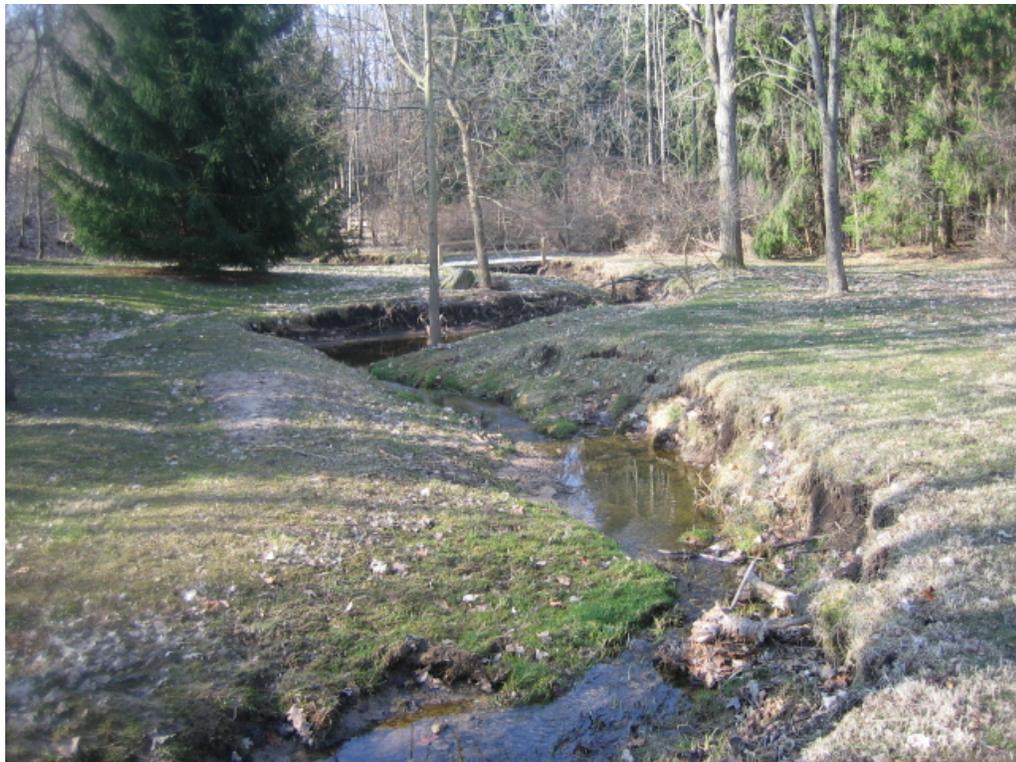
Photograph CD3 (see flag B, Figure CD1)

Downstream of the easternmost Cascade Road crossing severe streambank erosion and failed stabilization efforts are evident (photograph CD3). Lawns parallel the banks before the stream enters a forest. Through the forest, moderate erosion on the outside of meanders is evident. An old farm crossing has collapsed and fallen into the stream approximately halfway between Cascade Road and Cherry Lane. The forest opens to farm land, where the stream narrows and deepens. It then travels through brush until it reaches the Cherry Lane crossing. Downstream of Cherry Lane, both banks of the stream are covered with small brush and slight sedimentation is noticeable. Just upstream of Cascade Road (western crossing for southern branch) the stream is in a mature forest with moderate streambank erosion and sedimentation (photograph CD4). The upstream end of the Cascade Road culvert is clogged with debris causing some flooding to occur (photograph CD5).

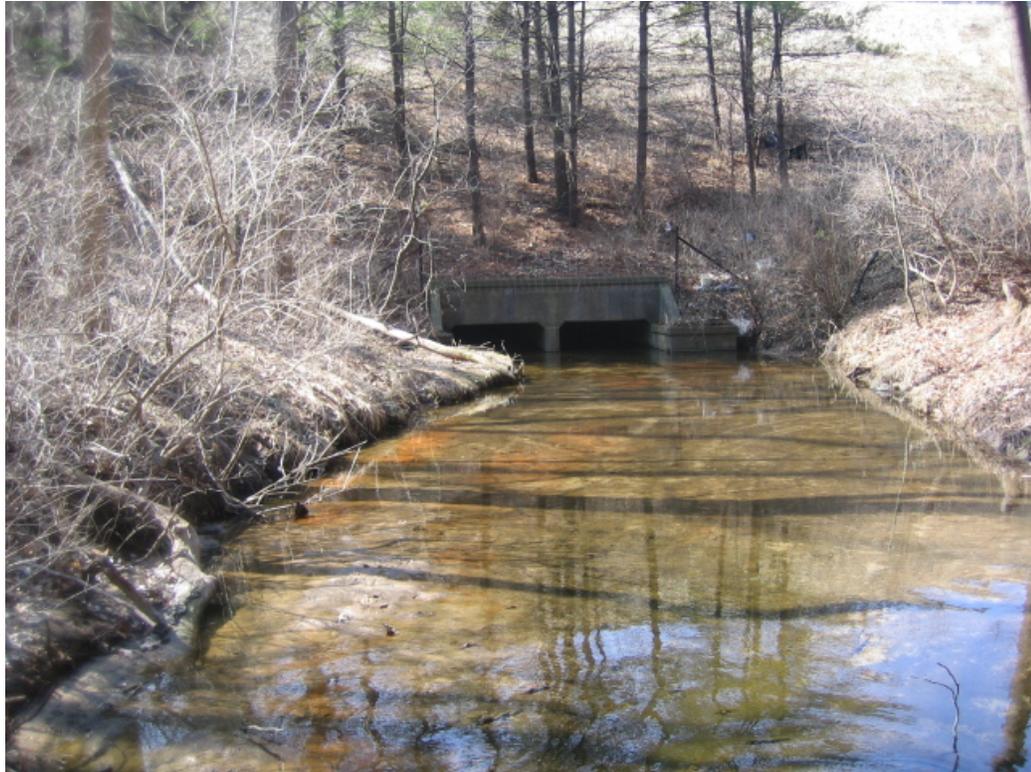
Photograph CD7 (see flag F, Figure CD1)

The confluence of the northern and southern branches occurs between the two eastern Cascade Road crossings. The easternmost Cascade road crossing carries flows from both branches. Sedimentation is evident from this crossing all the way to the discharge point at the Thornapple River. Downstream of Whitneyville Avenue streambank erosion is moderate (photograph CD6). Just upstream of I-96, sedimentation is severe resulting in a culvert over half clogged with sediment (photograph CD7).

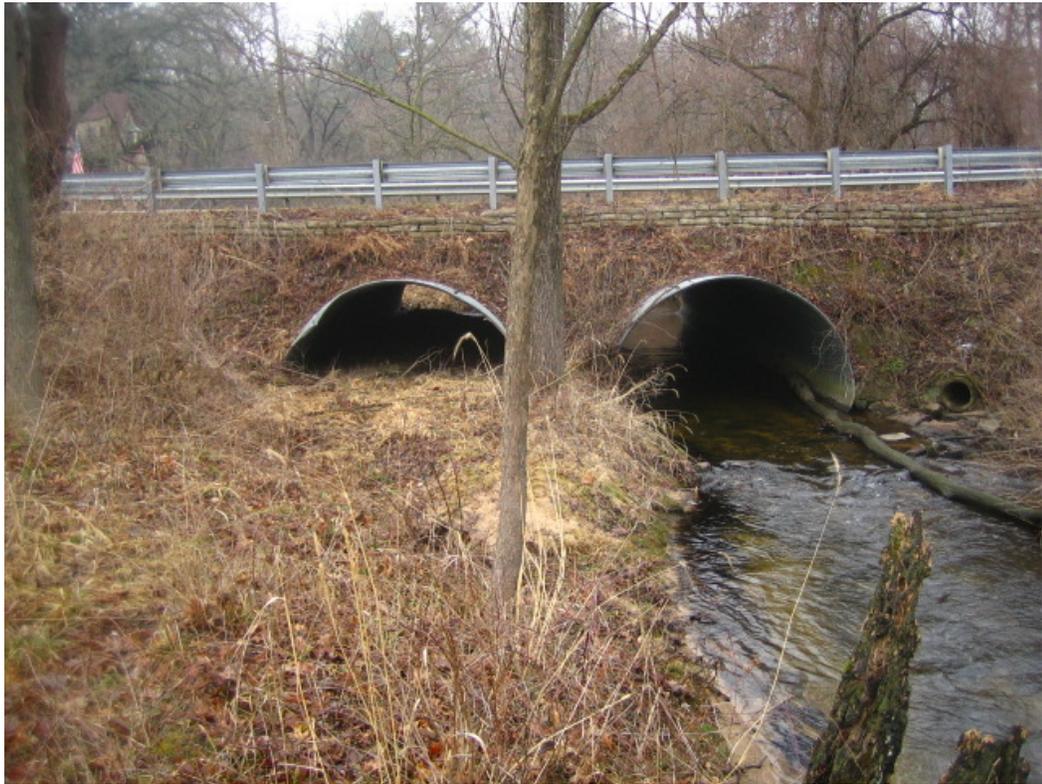
PhotoCS4 (flag B, Figure CS1)

The Cascade Southeast District is shown in Figure CS1. The stream that drains this district has its headwaters in both Lowell Charter Township to the east and Caledonia Charter Township to the south. A bayou is located near the confluence of the stream and the Thornapple River. The bayou has many homes built along its banks. Upstream of the Thornapple Bayou Drive bridge moderate streambank erosion is evident on the outside of the meanders and in some places major sloughing (separation and sliding of bank materials due to erosion at the toe of a steep streambank) of the larger banks was observed. Most natural streams contain riffle, run, and pool sequences. A riffle is a section of the stream with shallow depths, high velocities, and coarse channel bottom materials. Riffles tend to dissipate much of the energy as water flows downstream. The section of stream upstream of Thornapple Bayou Drive contains both natural and manmade riffles (photographs CS2 and CS3). The Buttrick Avenue crossing consists of two corrugated metal pipe culverts with one partially filled with sediment (photograph CS4). This culvert is probably in use only during high flow events.

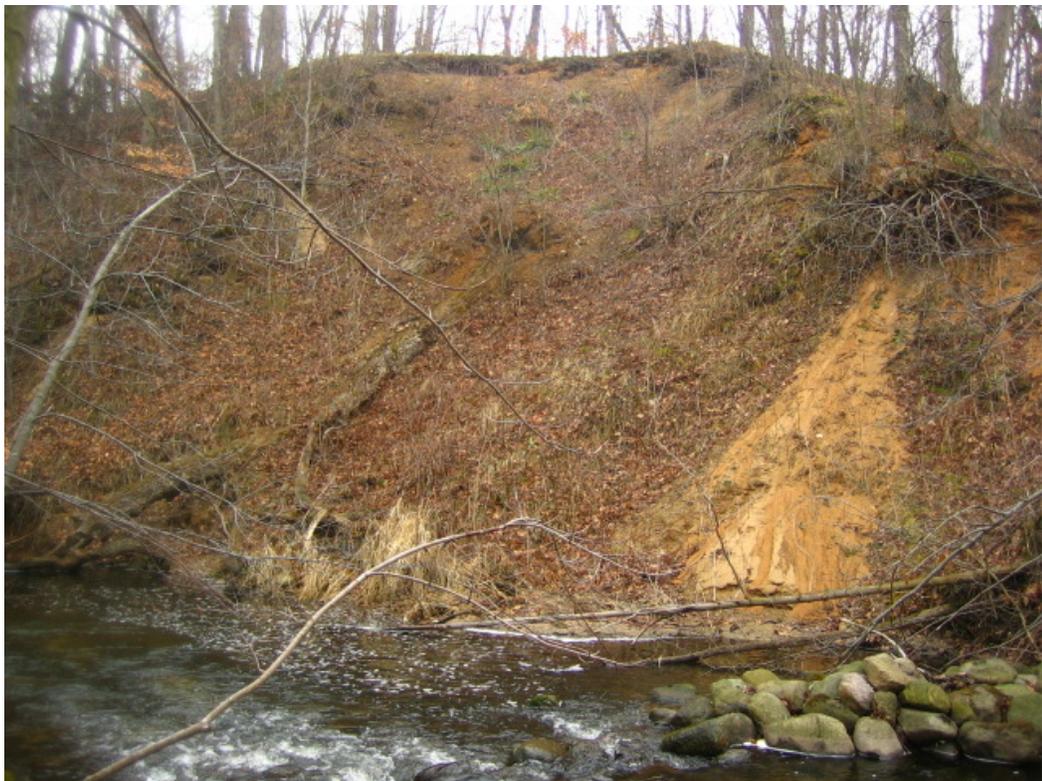
Photograph CS5 (flag D, Figure CS1)

Upstream of Buttrick Avenue the stream continues meandering with erosion visible on the banks and major sloughing on the highest banks. In one location a 50-foot-high slough was noted (photograph CS5). The stream has many riffles and is fast moving. The confluence with the north branch occurs midway between Buttrick Avenue and 52nd Street. The south channel passes under both 52nd Street and Whitneyville Avenue.

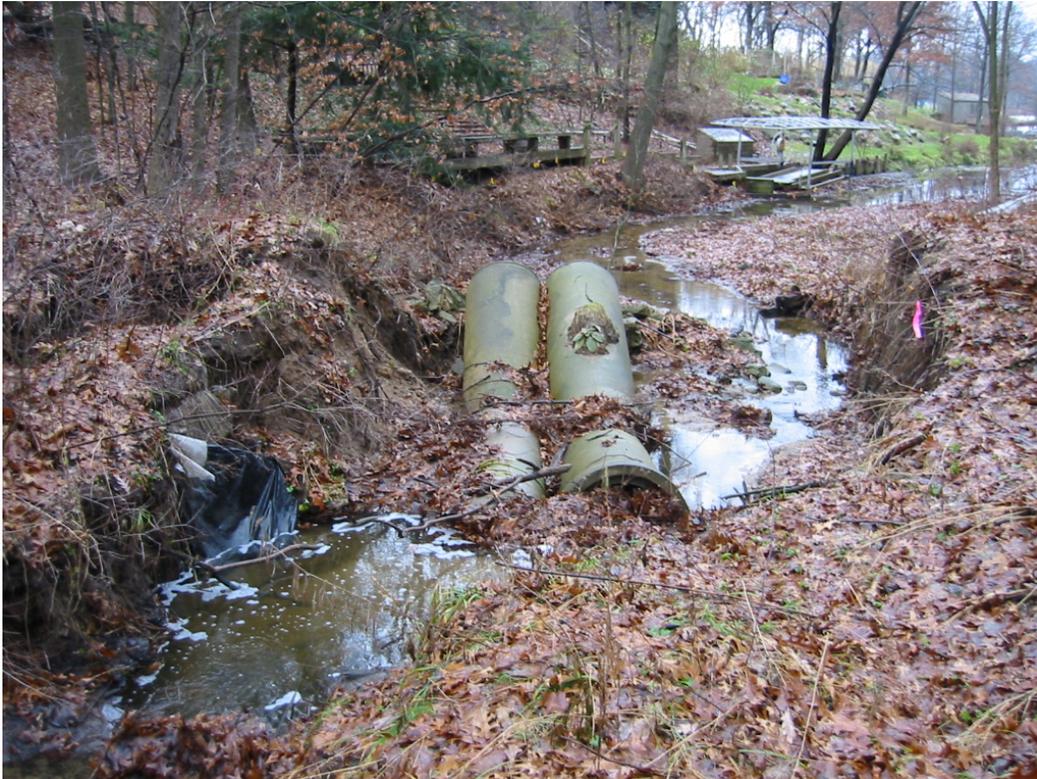
Photo

The Forest Creek District is shown in Figure FC1. The stream that drains this district has its headwaters south of Cascade Township Park. Flooding occurs in Cascade Township Park with floodwaters from the Forest Creek district flowing over to the GRFIA Northeast 1 district. There is also a failed, former farm crossing, failed sheet pile weir, and erosion. The stream that drains the Forest Creek district has its headwaters south of Thornapple River Drive. After passing under I-96, the stream flows through Cascade Township Park. In the park the stream passes through three culverts. Two of these culverts (shown in Figure FC1) pass under the park walking path. They were both recently replaced because of flooding issues. During frequent rainfall events this stream would flood and floodwater would pass through the park parking lot over to the Burger 1 district (photograph FC2). Downstream of the Township Park, there is an old farm crossing where the culverts are completely plugged and ineffective (photograph FC3). There is a failed sheet pile weir (photos FC4 and FC5). Some streambank erosion is noted in the lower reaches before the stream discharges into the Thornapple River (photograph FC6).

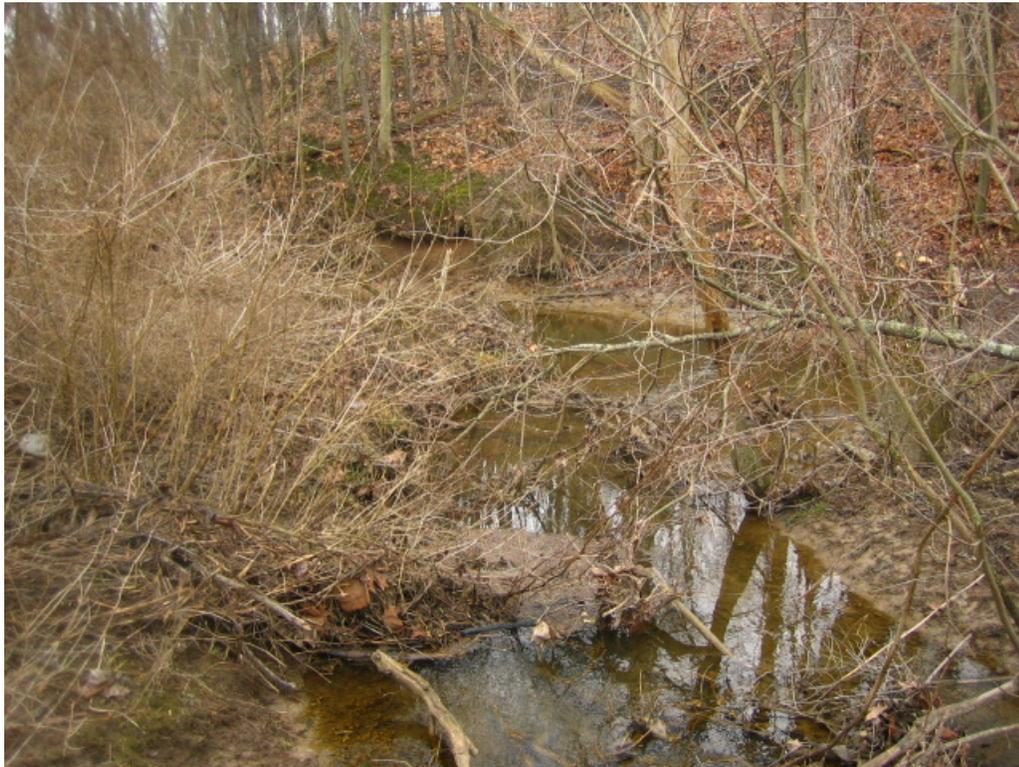
Photograph SE2 (flag A, Figure SE1)

The Gerald R. Ford International Airport (GRFIA) Southeast District is shown in Figure SE1. The northern branches of the stream that drains this district have its headwaters on Gerald R. Ford International Airport property. The southern branch originates in Caledonia Charter Township. Because of limited access rights on the airport property, the investigation considered only the section downstream of M-6. Between M-6 and Thornapple River Drive the stream is very muddy and slow moving (photograph SE2). Accumulated debris gives evidence that the stream overtops its banks on a regular basis.

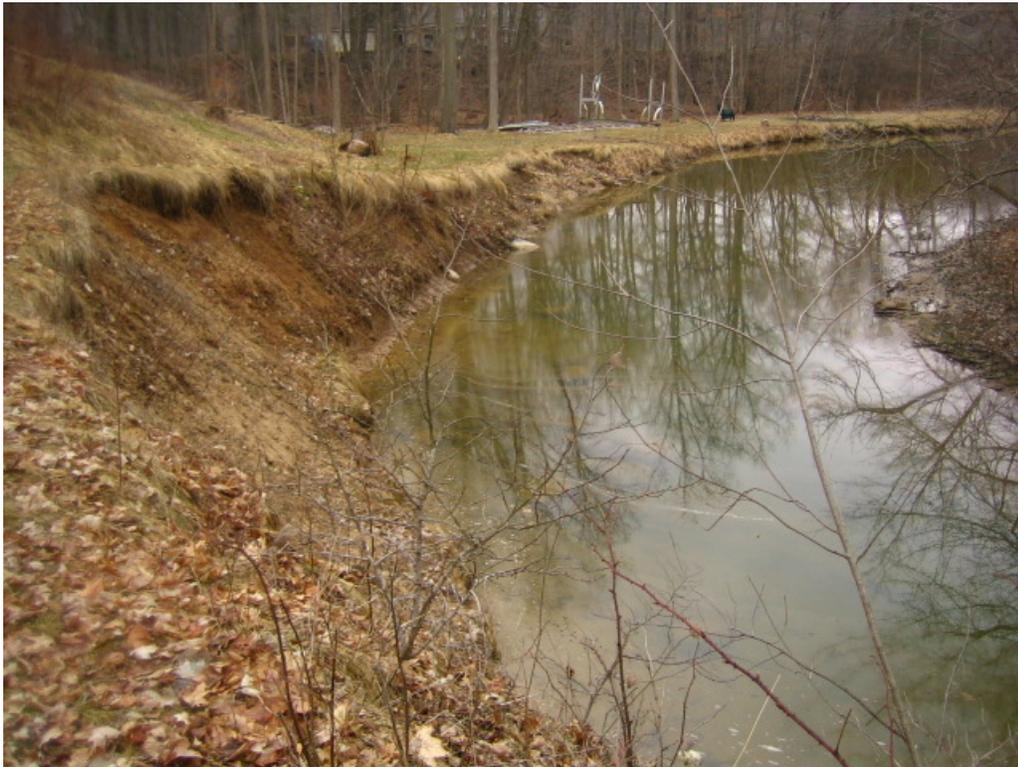
Figure SE4 (flag C, Figure SE1)

Downstream of Thornapple River Drive the banks of the stream are covered with small brush and the stream itself is practically stagnant. The brush gives way to a dense forest where the stream picks up in velocity. Streambank erosion is evident on the outside of meanders and some sloughing of adjacent streambanks is present (photograph SE3). Small riffles are noted in the stream. The stream discharges to the Thornapple River through a bayou. Banks of the bayou are sloughing, possibly due to manicured lawns eliminating buffer zones (photograph SE4).

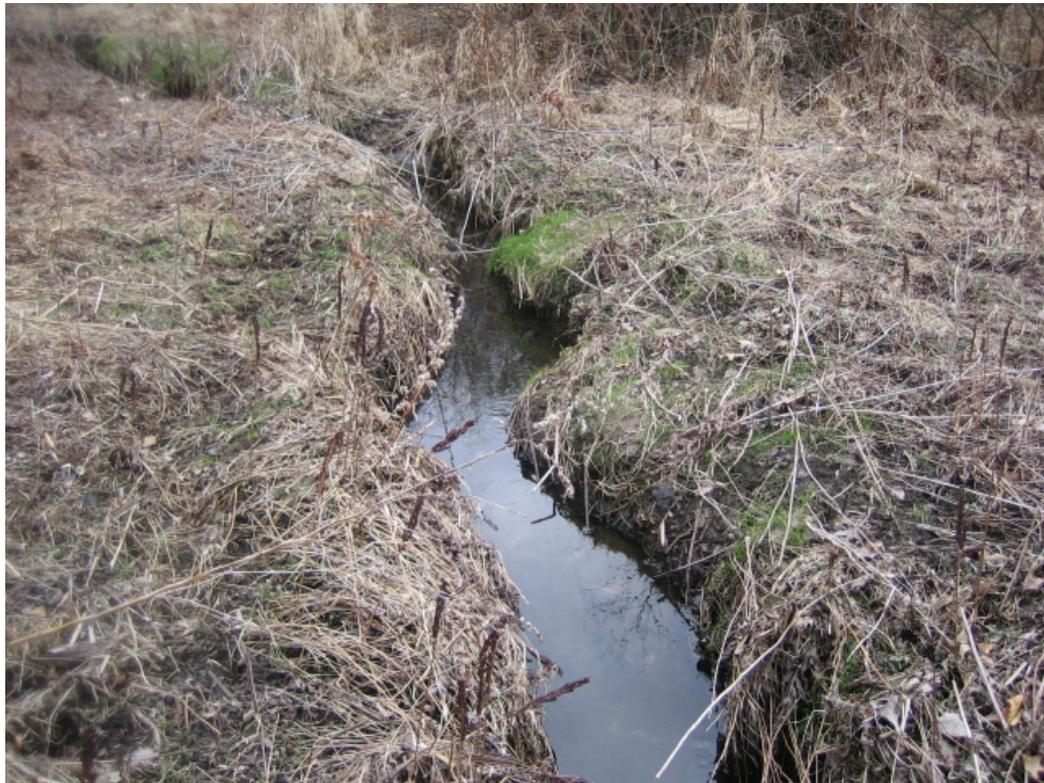
Photograph HG3 (flag B, Figure HG1)

The Highgrove District is shown in Figure HG1. The stream that drains this district has its headwaters along Buttrick Avenue. Upstream of Grand River Drive the stream passes through a low density residential development. Along this reach the forest adjacent to the stream is still standing providing streambank buffer. The stream experiences moderated erosion through the development (see flag A in Figure HG1 and photograph in Figure HG2). Upstream of the development, the stream narrows, deepens, and the surrounding ground becomes boggy (see flag B in Figure HG1 and photograph in Figure HG3). Downstream of Bolt Drive the stream is undefined as it passes through a wetland.

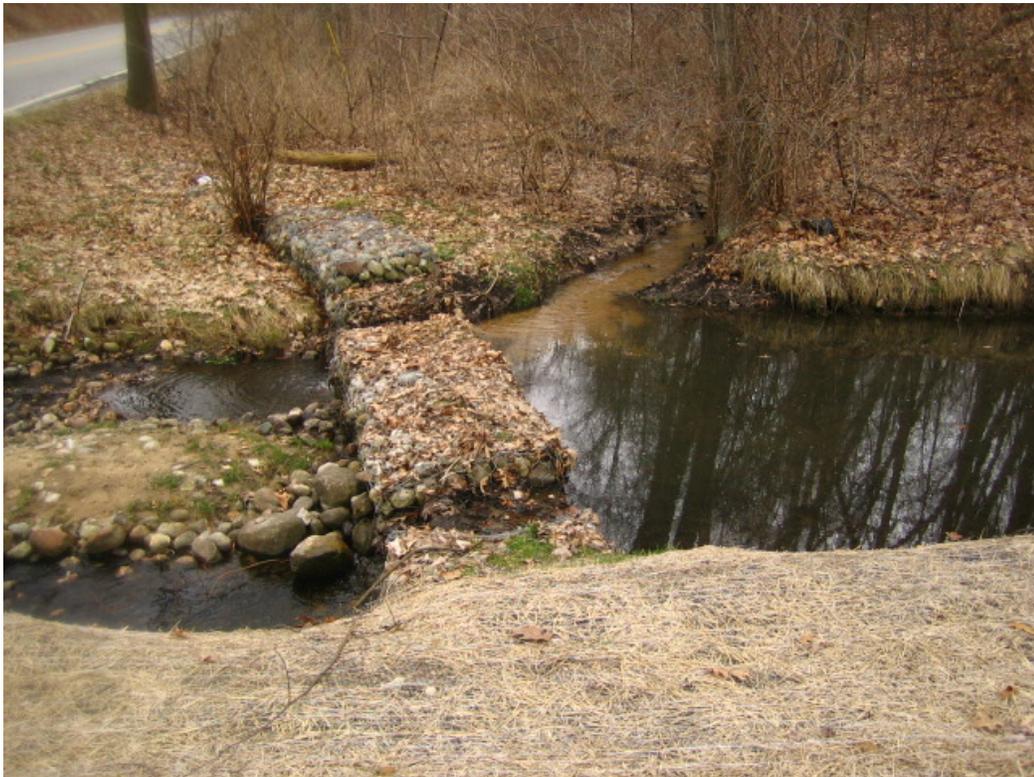
**Figure SP3 Gabion check dam upstream of Thornapple River Drive
(flag B, Figure SP1)**

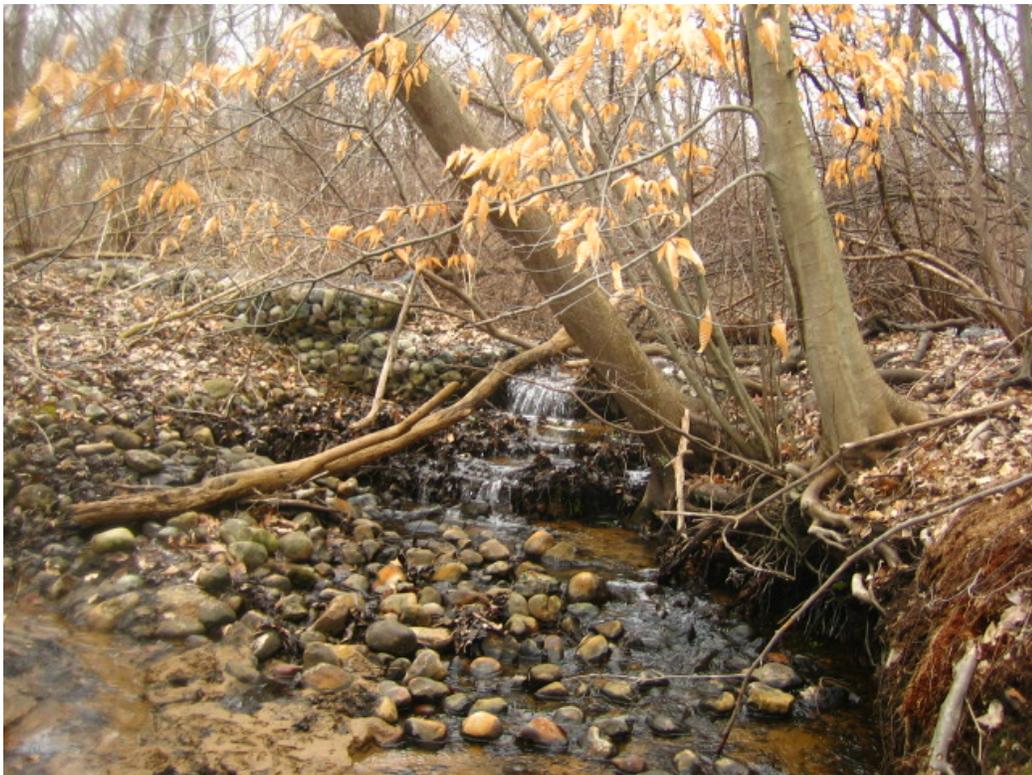
Photograph SP5 (flag D, Figure SP1)

The south branch has a lower discharge than the north. Between Thornapple River Drive and Thornhills Avenue the banks are lower and the surrounding land is very mucky. Gabion check dams are used in this reach as well (photograph SP5). Downstream of the Thornhills Avenue crossing a wetland area makes it difficult to locate the stream. The stream is undefined and dry upstream of Thornhills Avenue.

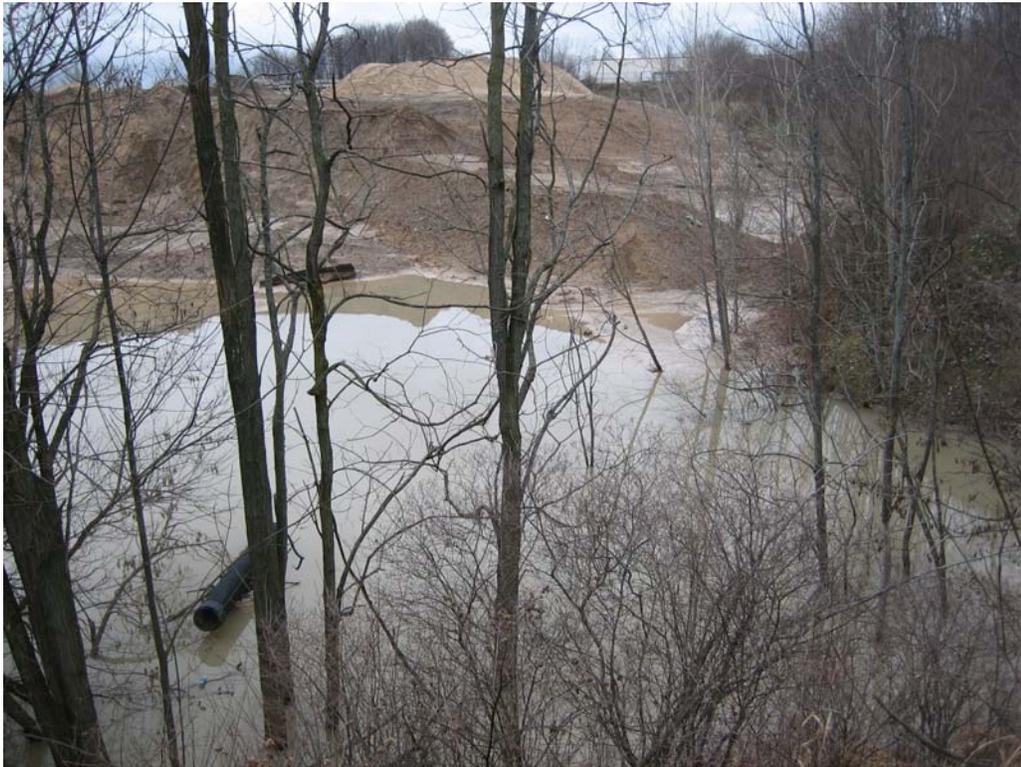
Photograph 2 (see flag A, Figure B2-1)

A construction site with poor soil erosion and sedimentation control is located just upstream of the Kraft Avenue crossing (photograph 2). This site in addition to the new 36th Street extension and interchange could have contributed to the large amount of sediment discovered in the stream. The stream exhibits moderate streambank erosion as it flows through a mature forest upstream of I-96 (photograph 4). Downstream of I-96, the stream flows through a golf course before entering a brushy forest. Downstream of Thornapple River Drive, the surrounding area is mature forest where sedimentation (photograph 3) and streambank erosion are evident. This is consistent up to the bayou at the stream's confluence with the Thornapple River.
