# Thornapple River Sedimentation Control and Mitigation Planning

Prepared for  
**Cascade Charter Township**

June 2026

# Thornapple River Sediment Deposition Areas

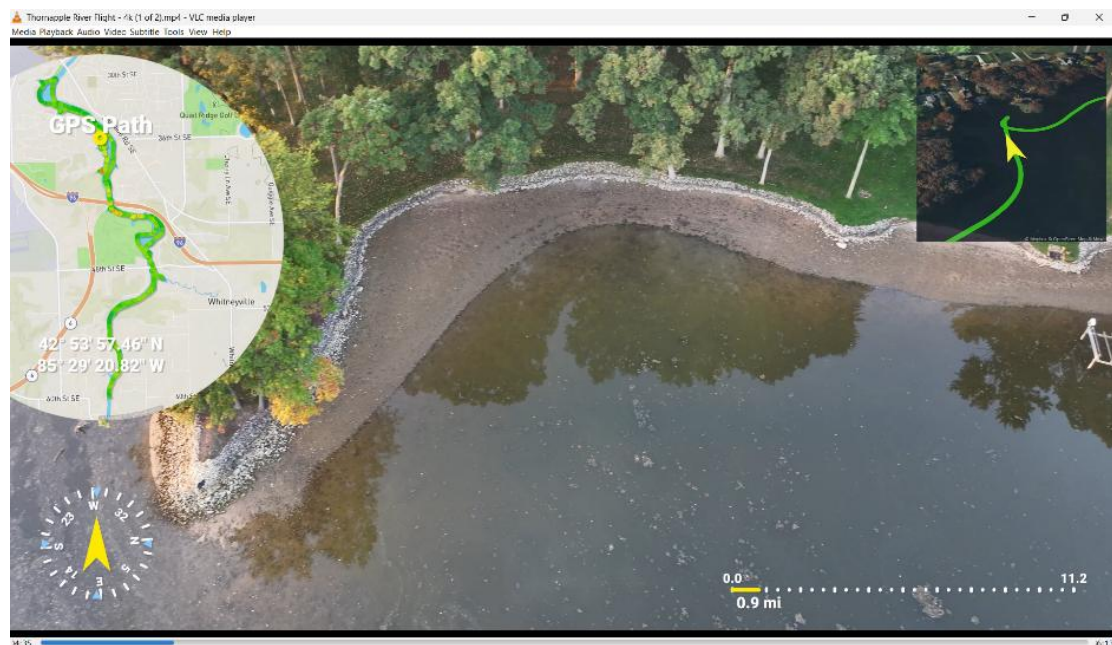
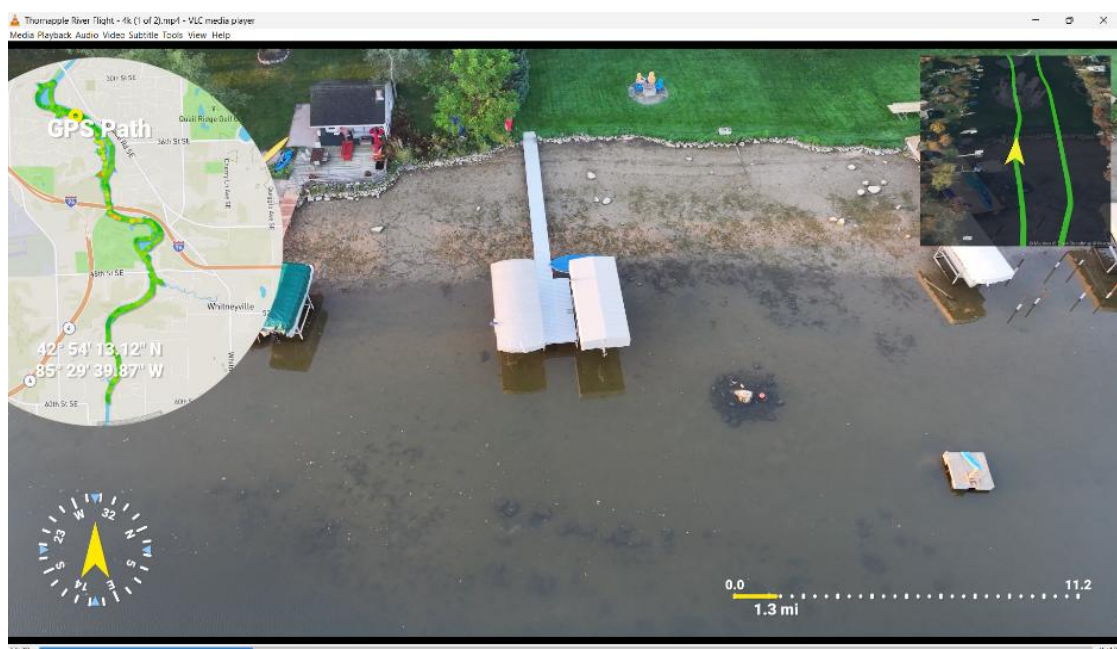
The following are examples from the photo log of fine grained sediment deposition areas.

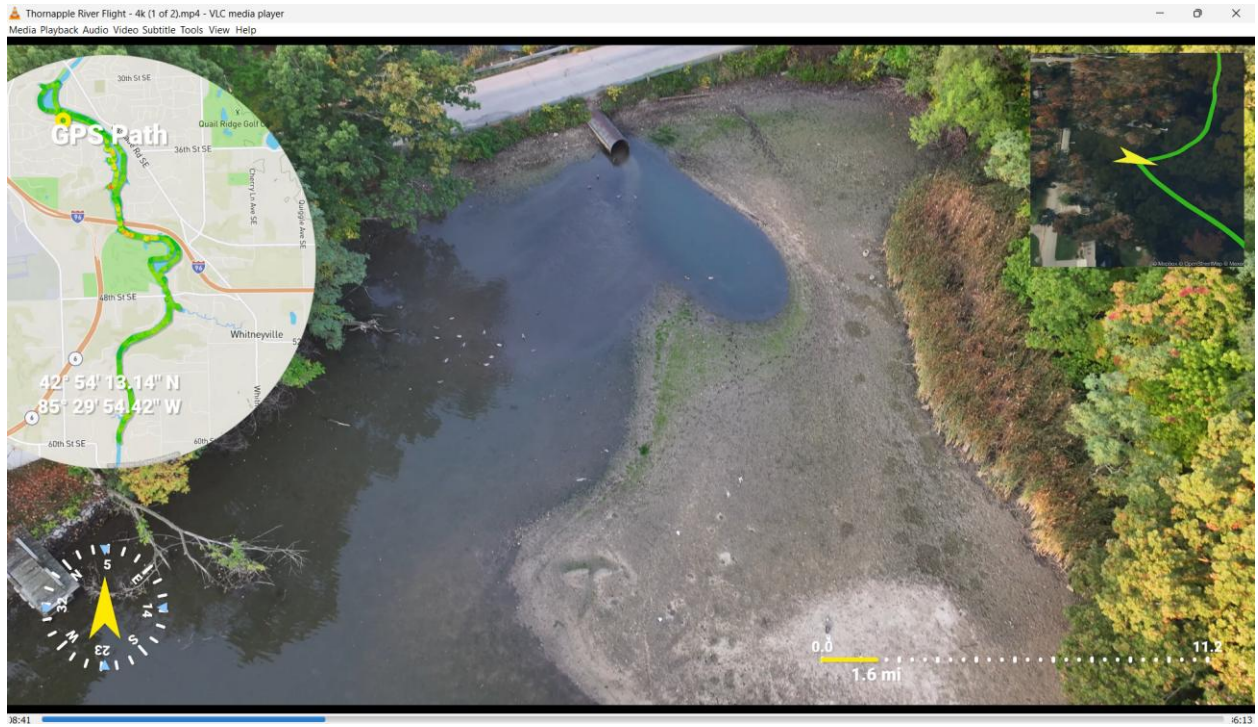
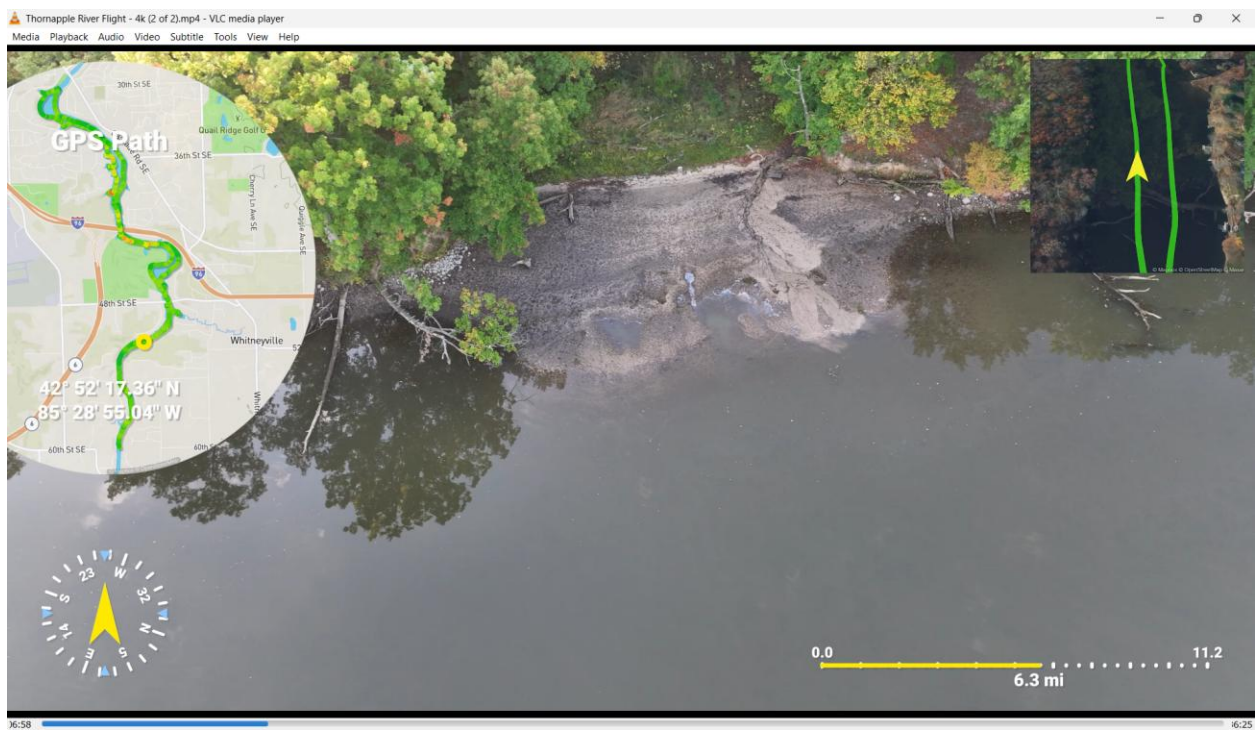
The following are examples from the photo log of coarse grained sediment deposition areas

Coarse grained sediment deposition in the river can be removed by periodic dredging or by one-time removal paired with additional management that captures the mobilized sediment upstream of the waterway discharge into the river. Sediment capture is usually achieved with a dam structure of sheeting or rock gabion baskets. The structure is placed across the waterway creating an upstream pool that traps coarse grained sediments which then need to be mechanically removed on a regular basis. The frequency and volume of removal depends on the severity of the upstream erosion and the size of the waterway watershed. There is currently a small gabion basket sediment trap on the Thornapple Hills Drain just upstream of Thornapple River Drive.

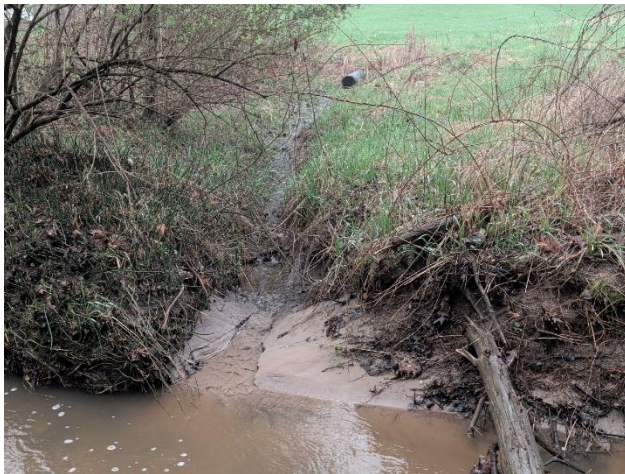
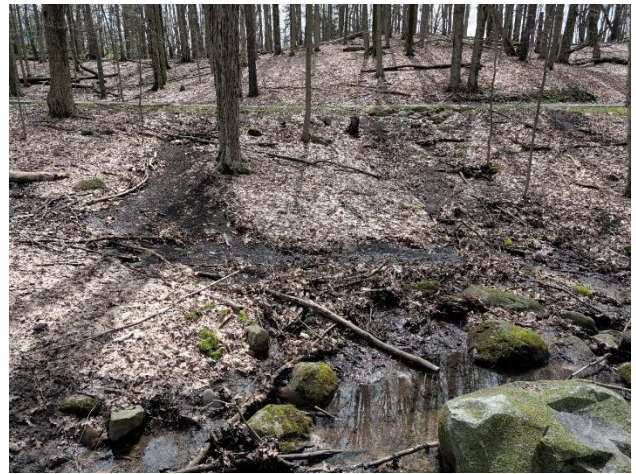
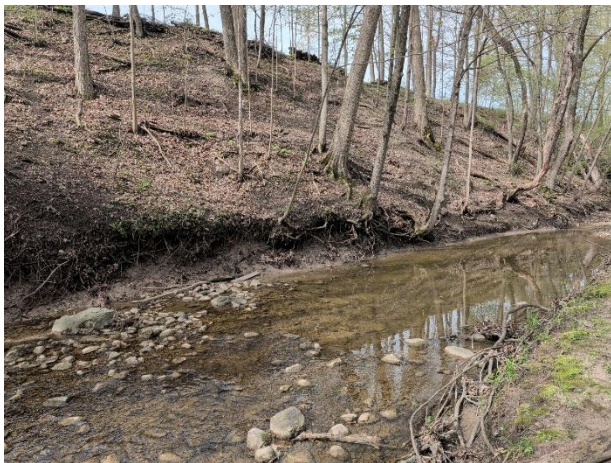
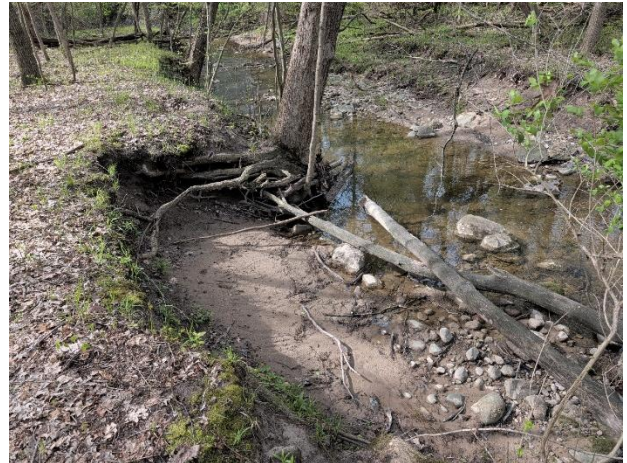
Noted are some examples of both human induced and natural erosion

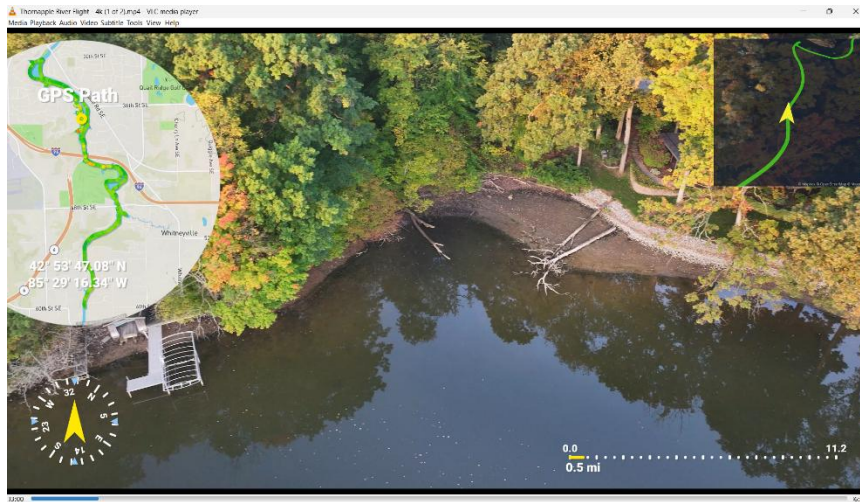
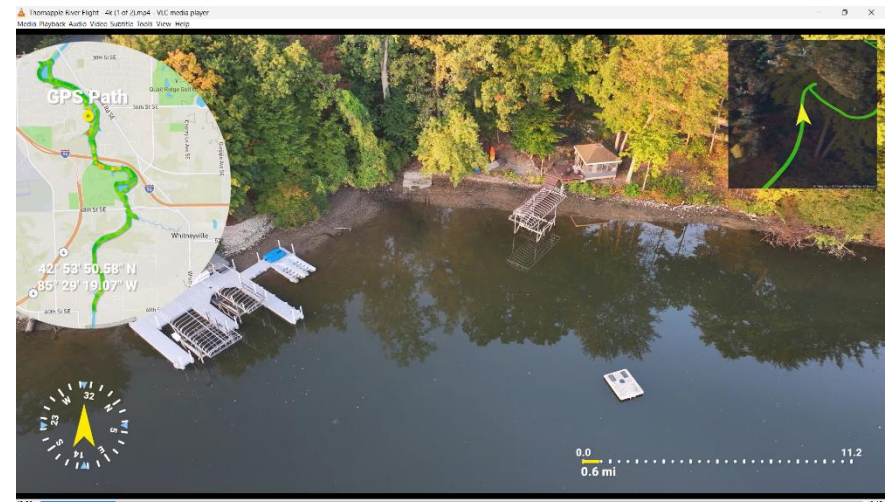
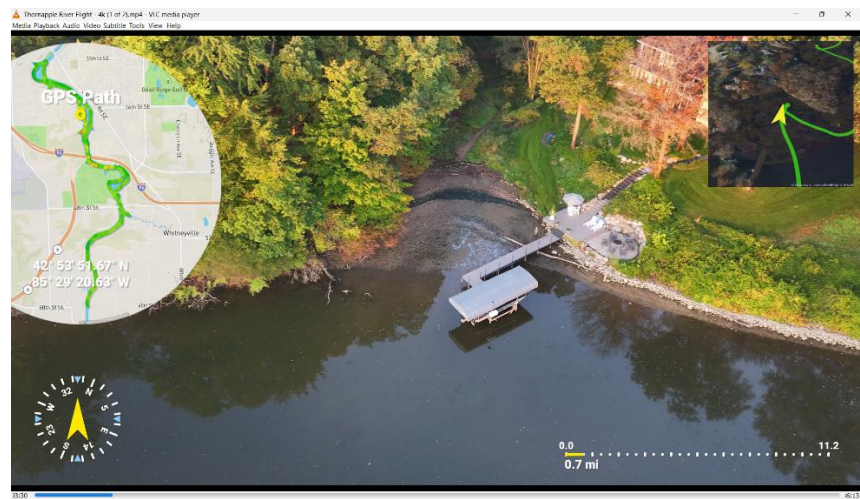
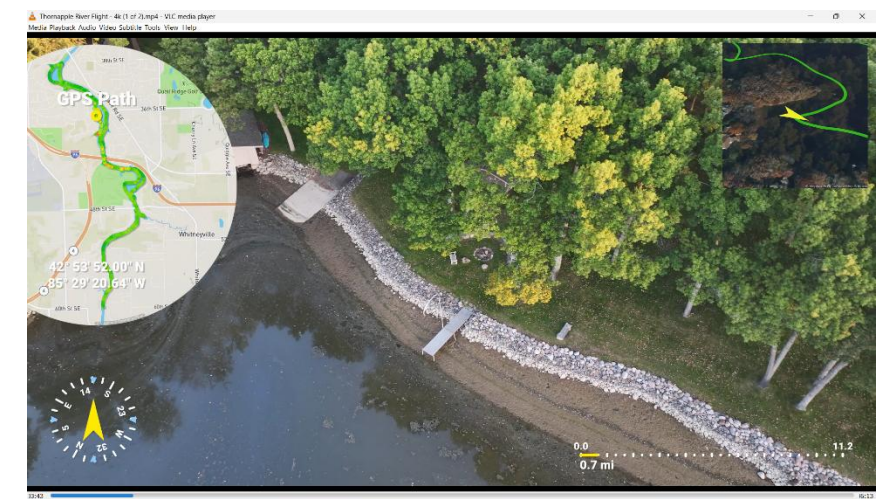
AREA 1: Some sediment deposition but limited to Forest Valley Creek mouth.

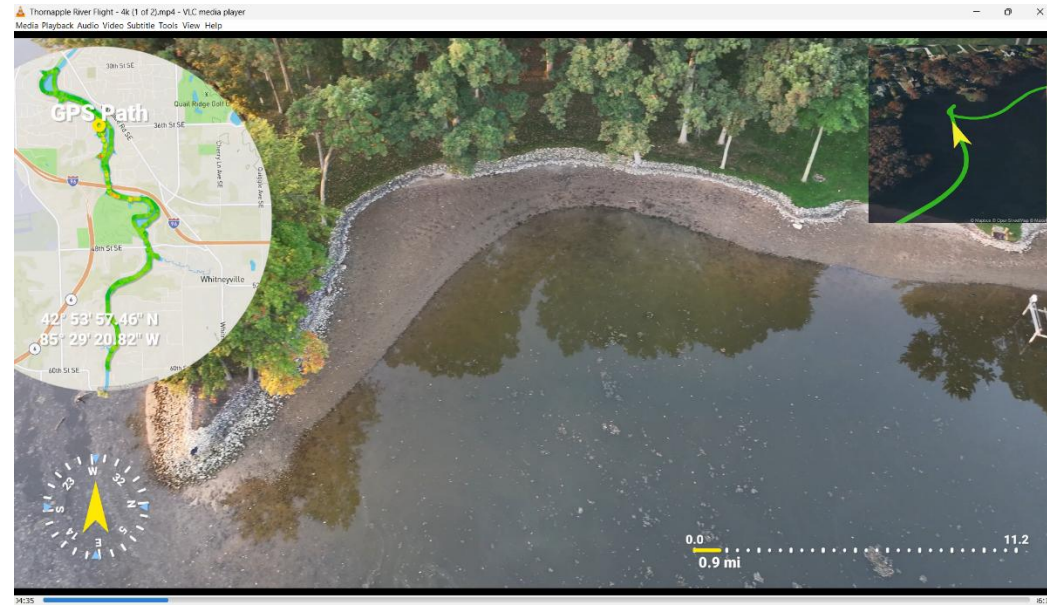
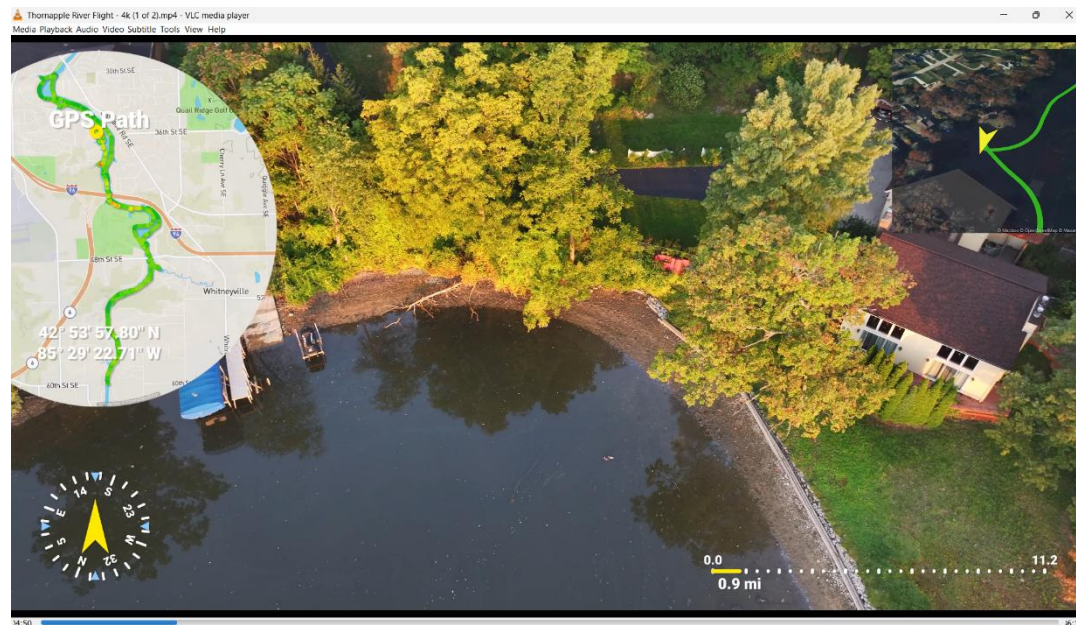
AREA 2: Sedimentation just upstream of Goodwood neighborhood boat ramp on inside of river bend point. Related to slower water area on inside of bend, not related to waterway erosion.

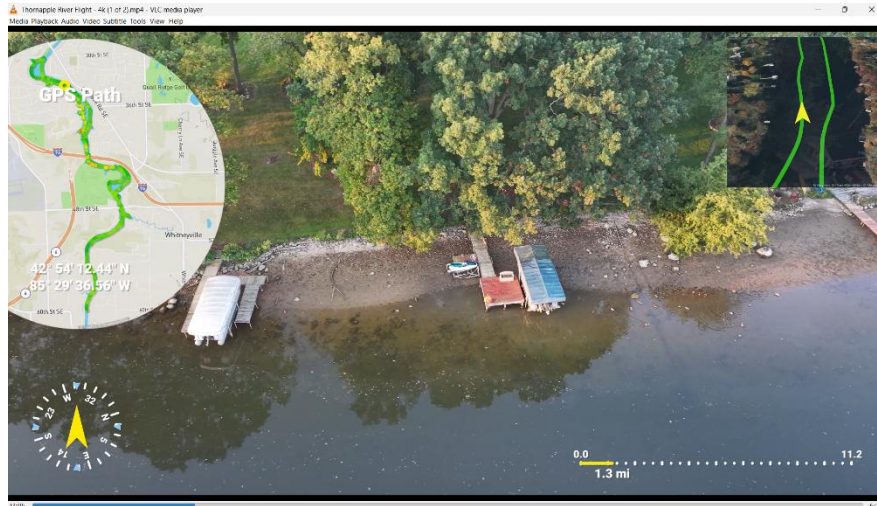
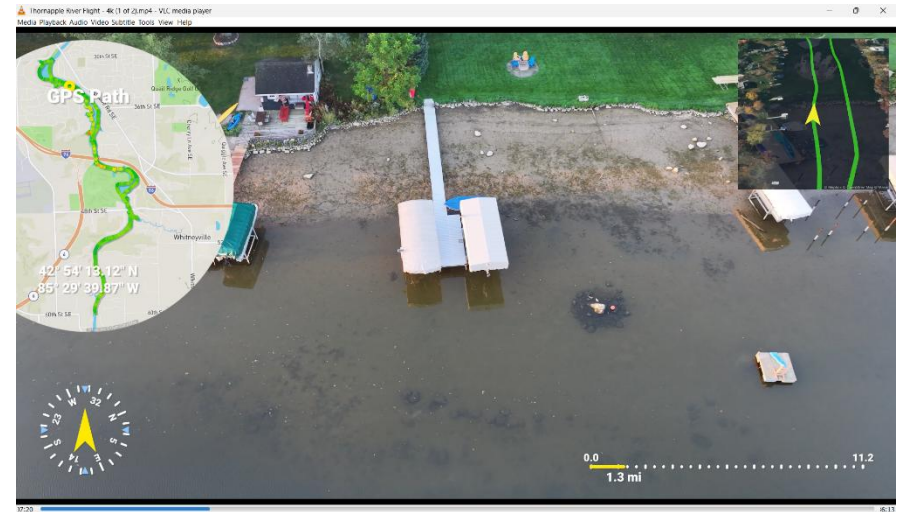
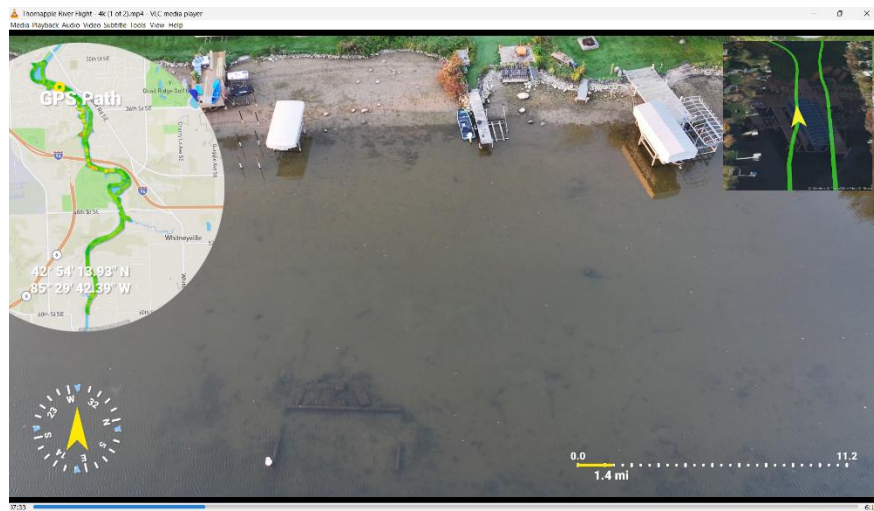
AREA 3: Sedimentation on inside of river bend near 6995 Burger. Related to slower water area on inside of bend, not related to waterway erosion.

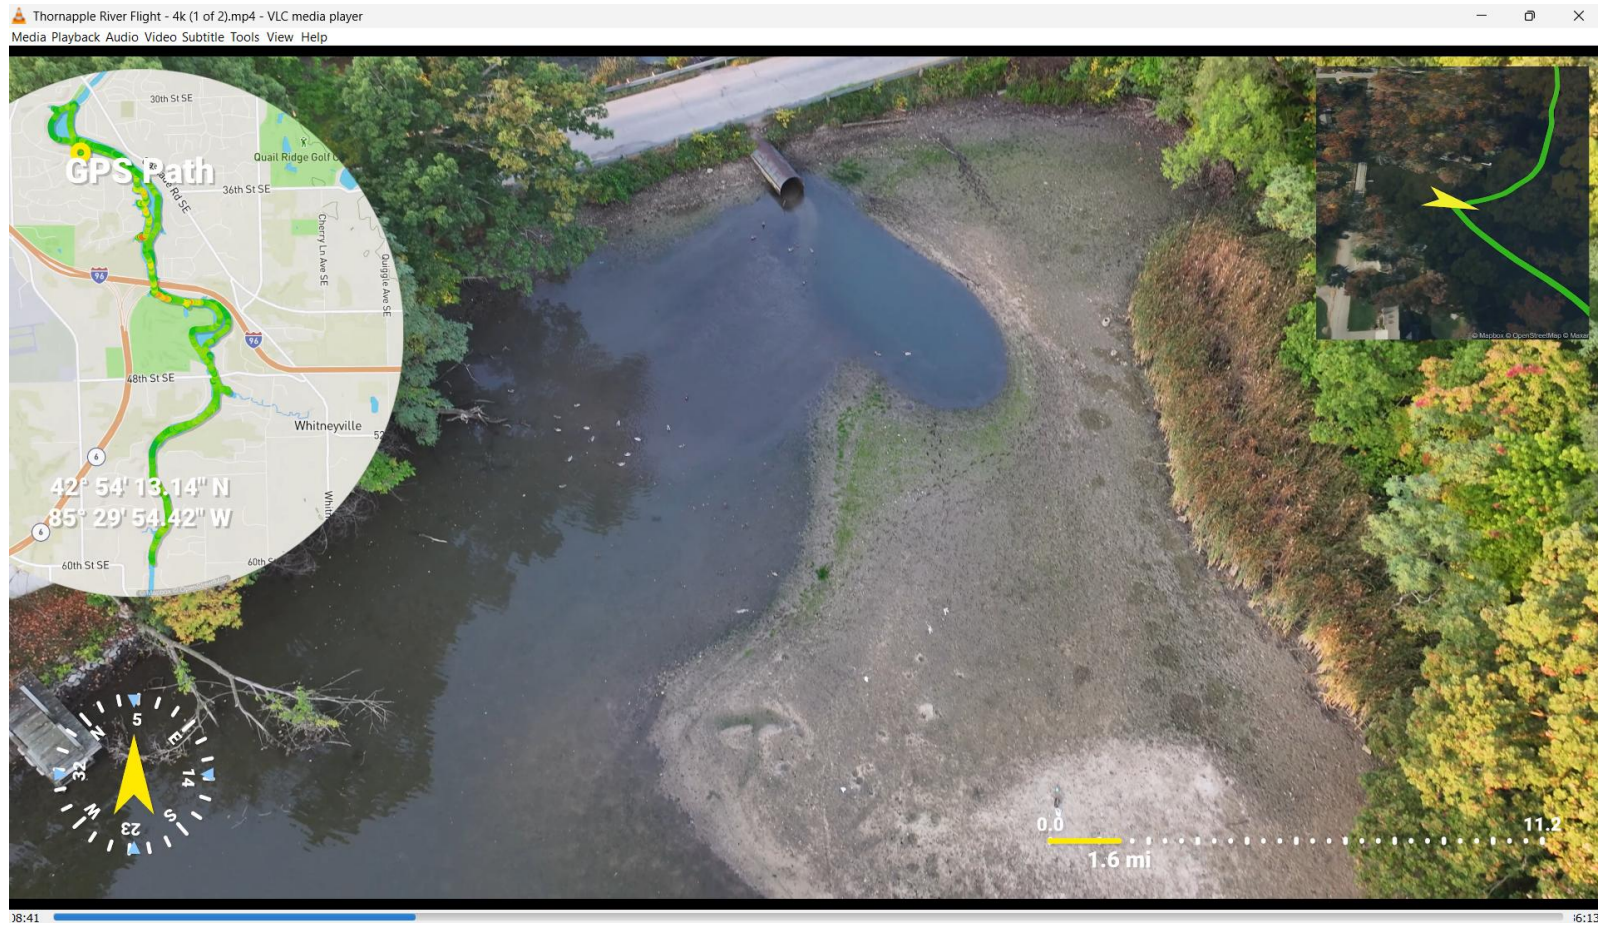
AREA 4: Significant sediment deposition at mouth of Tanglewood Creek due to upstream erosion.

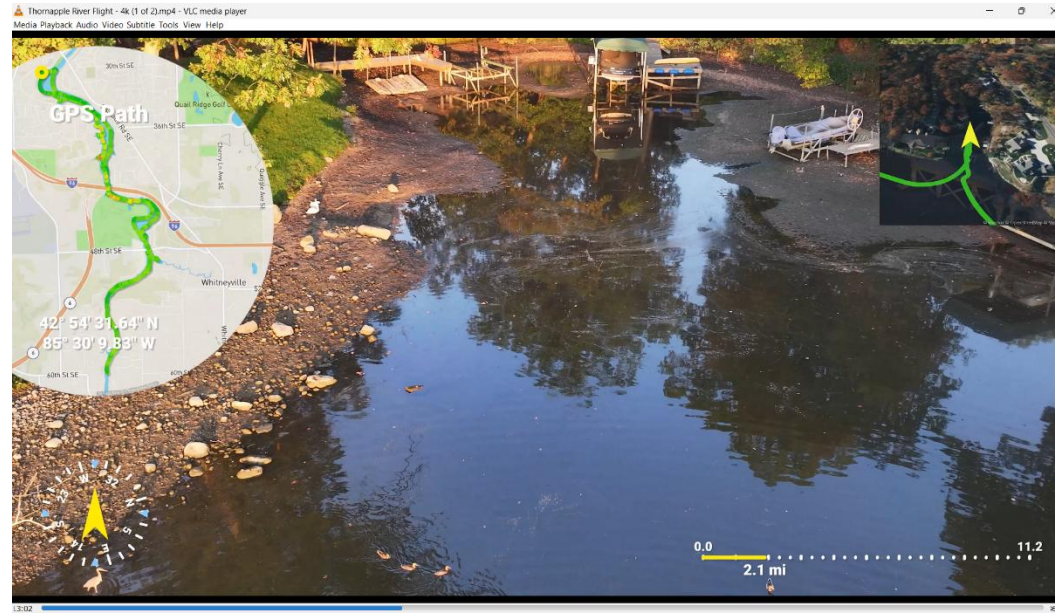
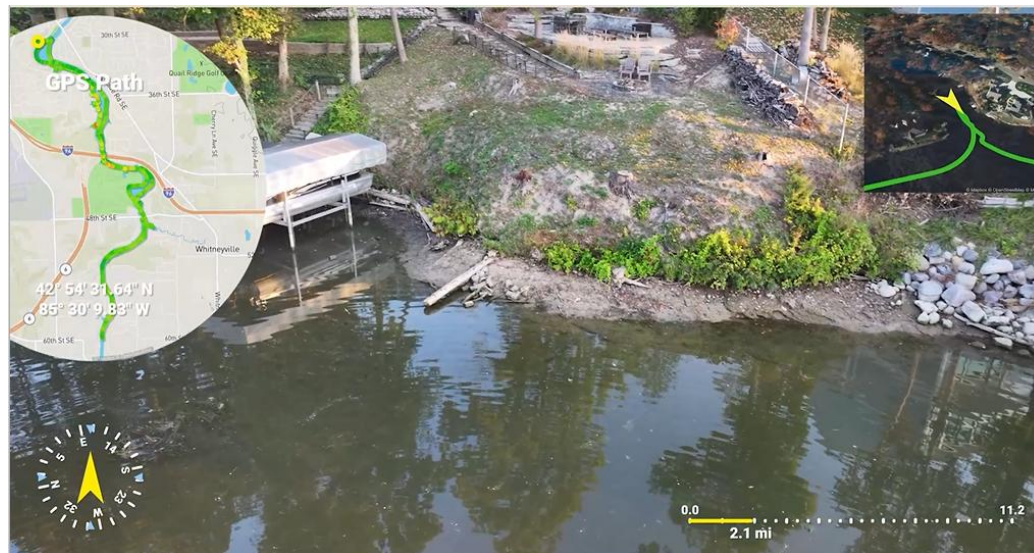
AREA 5: Significant sediment deposition at mouth of Thornapple Hills Drain due to upstream erosion. Also some bank erosion on private property at 3024 Thornapple River Drive.

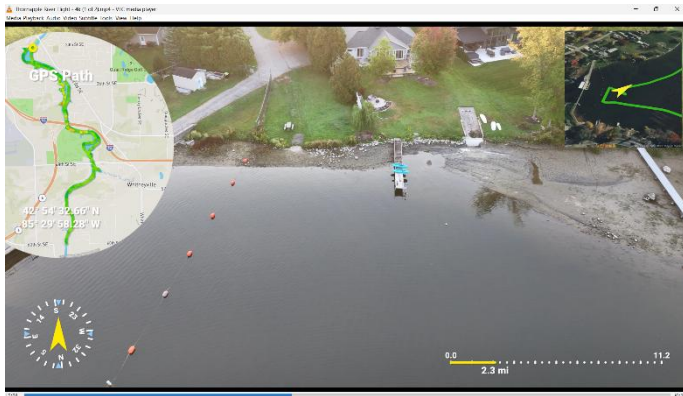
AREA 6: Sedimentation on inside of river bend, east side of river, upstream of the Cascade dam. Related to slow water area on inside of bend but not related to waterway erosion.

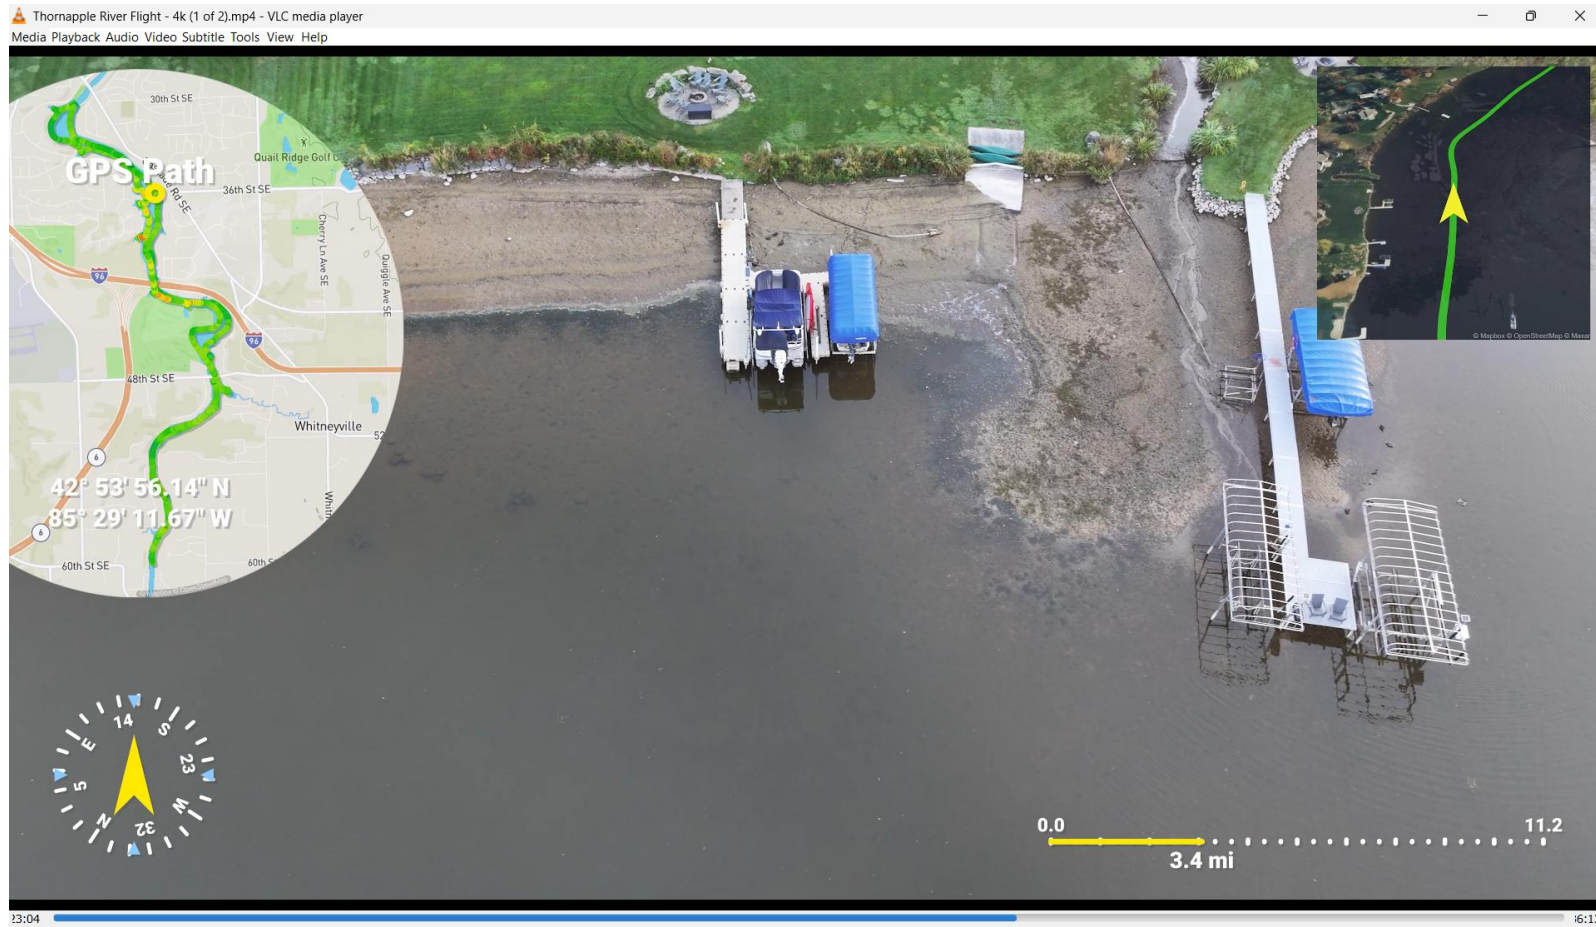
AREA 7: Some sediment deposition but limited to Hidden Hills Drain mouth.

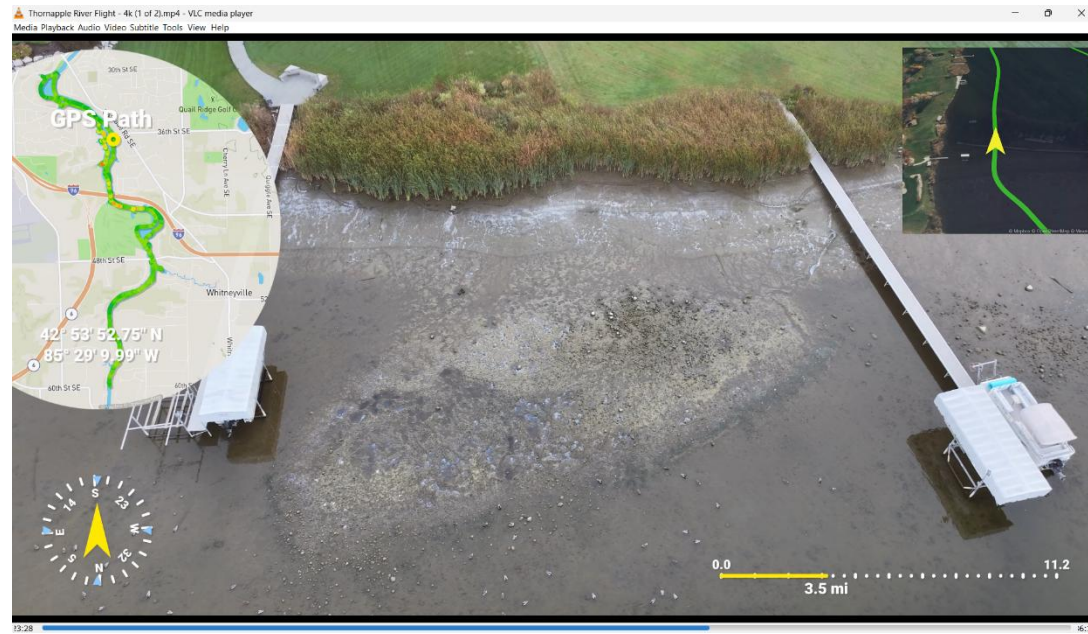
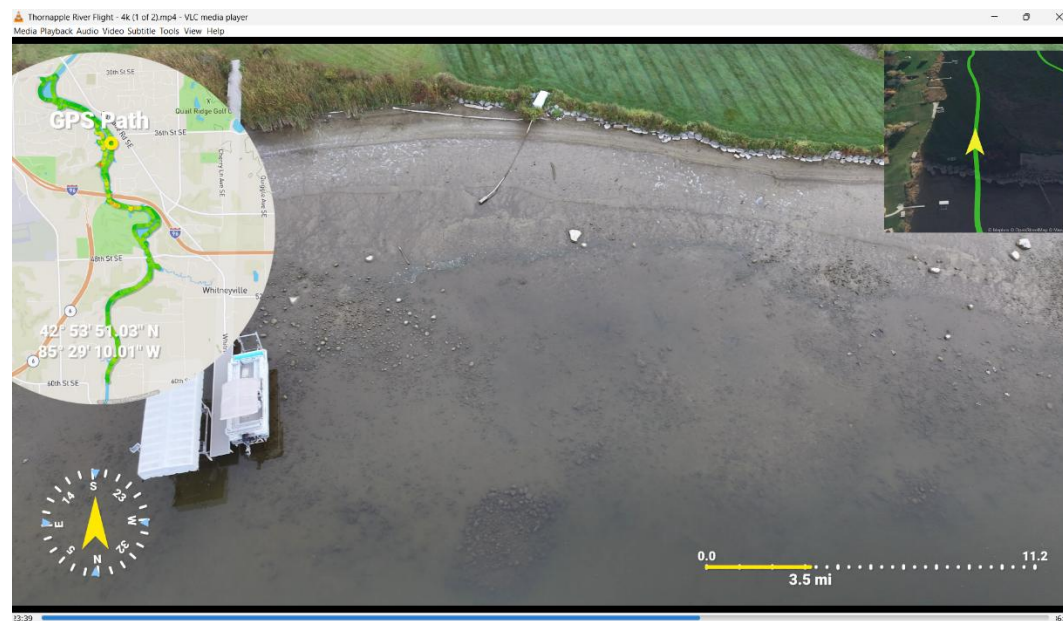
AREA 8: Sediment deposition on east bank between 7476 Cascade Road and 7370 Whispering Ridge. Deposition due to slow water area.

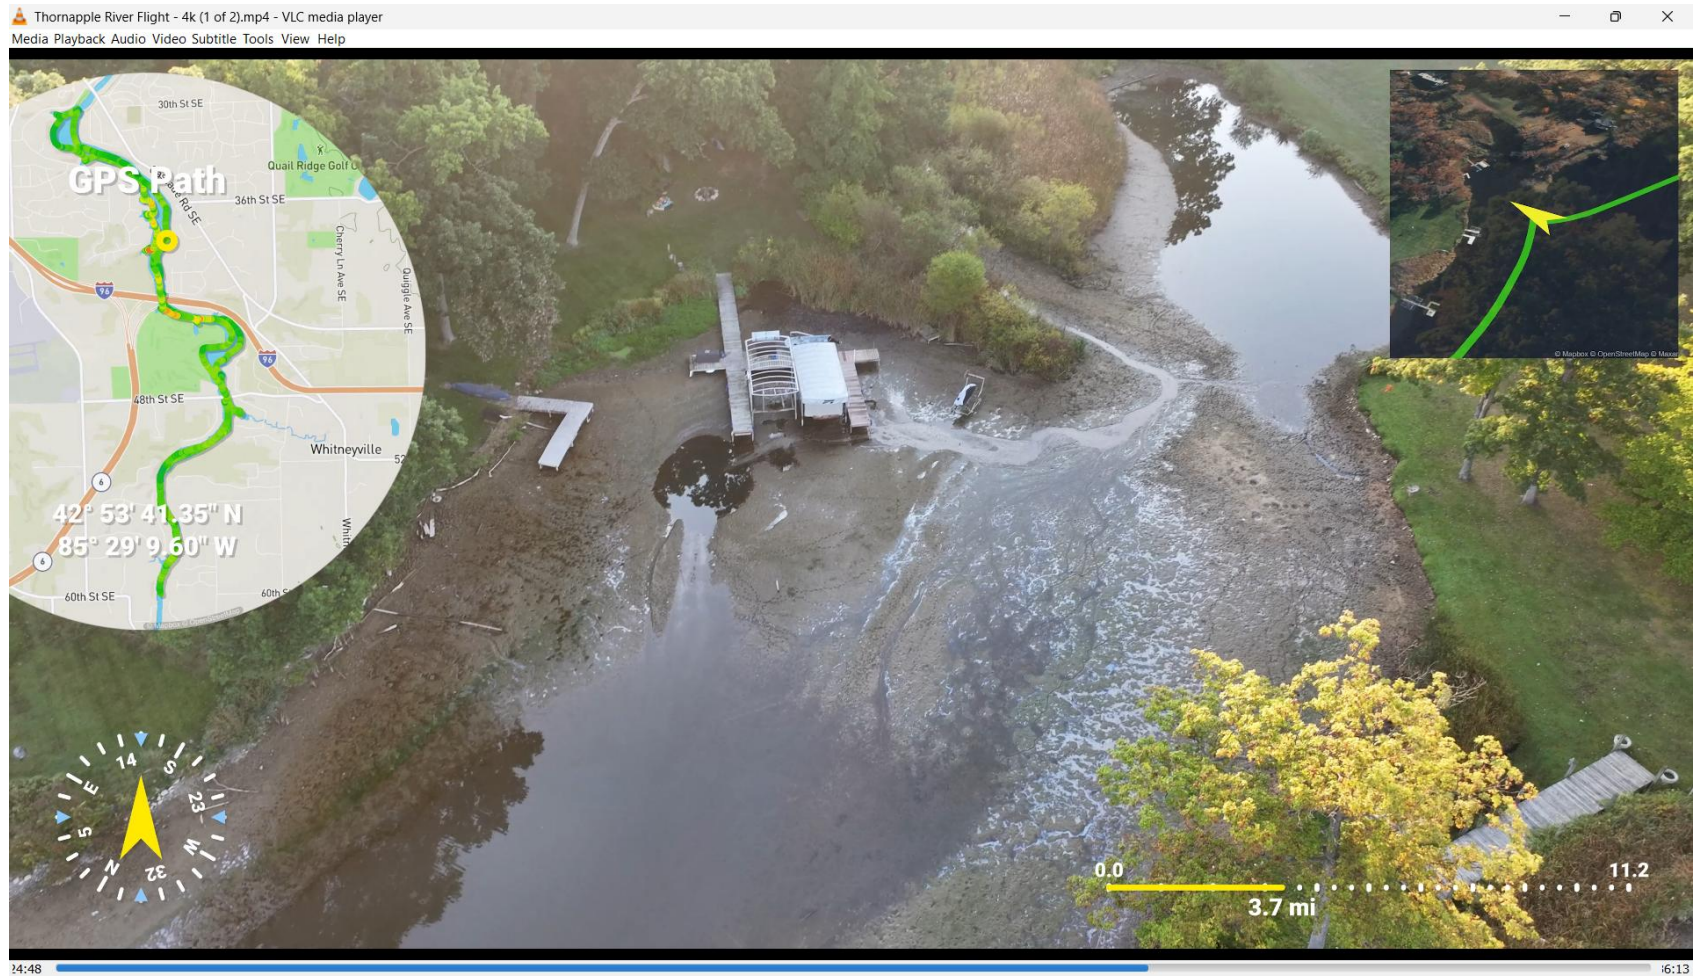
AREA 9: Significant sediment deposition at mouth of Quiggle Lake Creek due to upstream erosion.

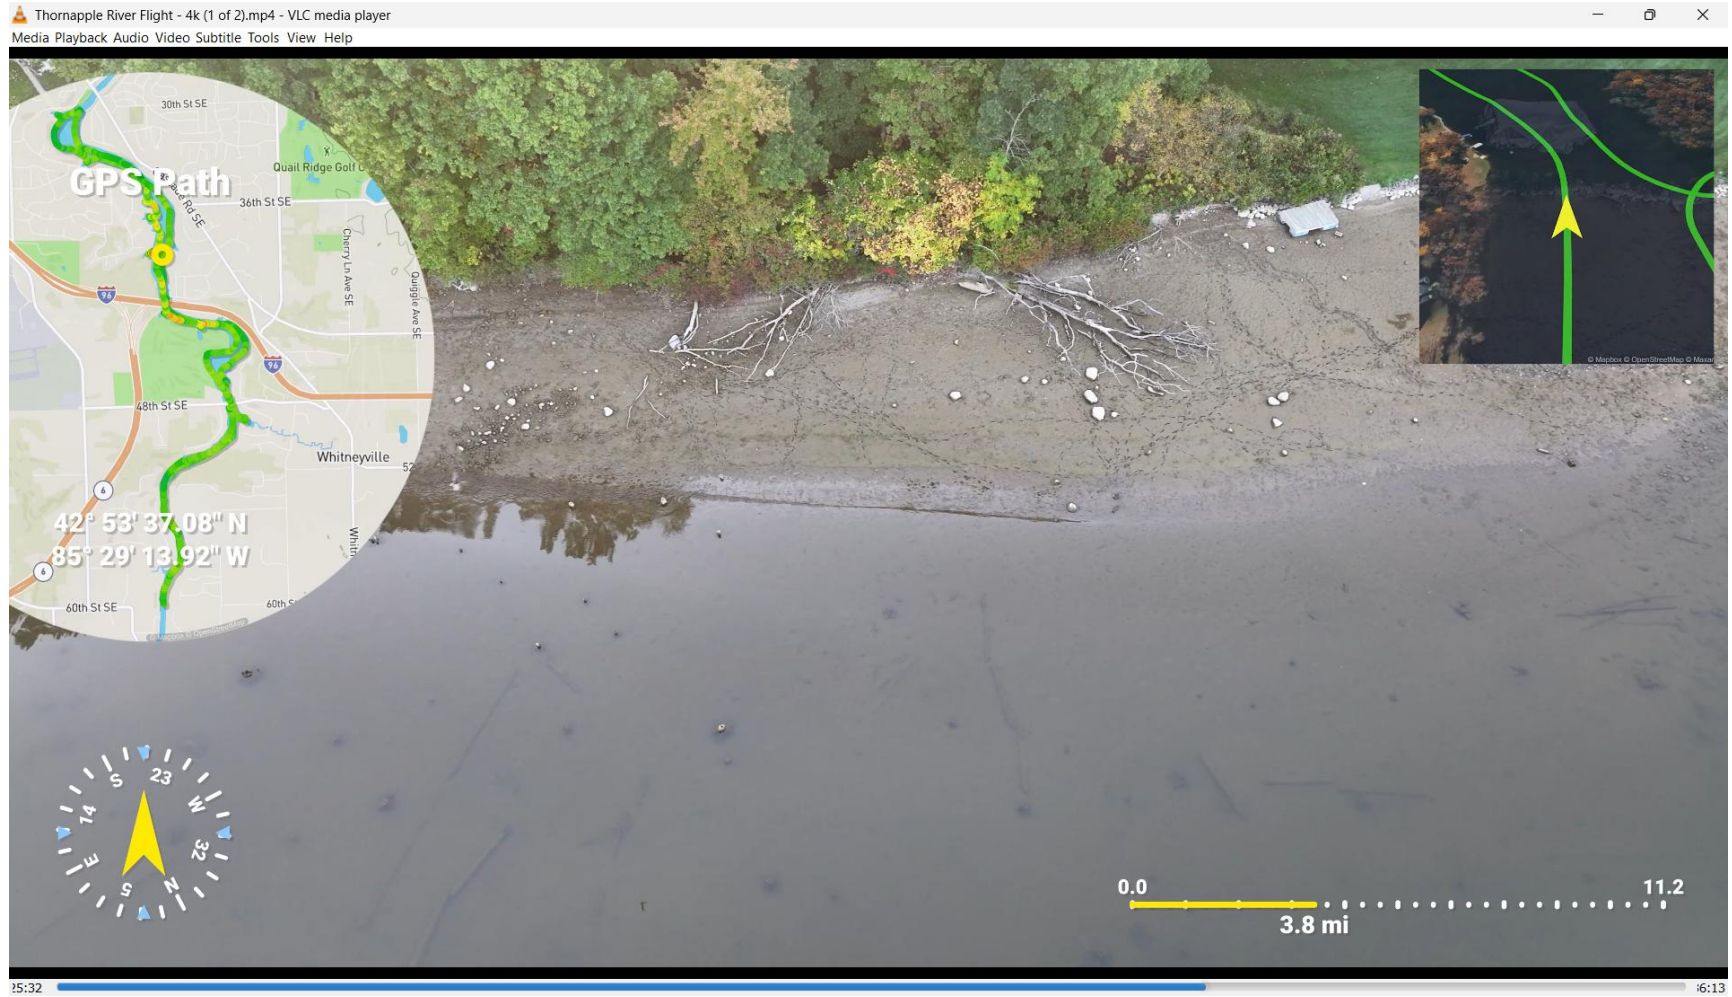
AREA 10: Local deposition at 7447 Kenrob Drive related to slower water area on inside of bend, not related to waterway erosion.

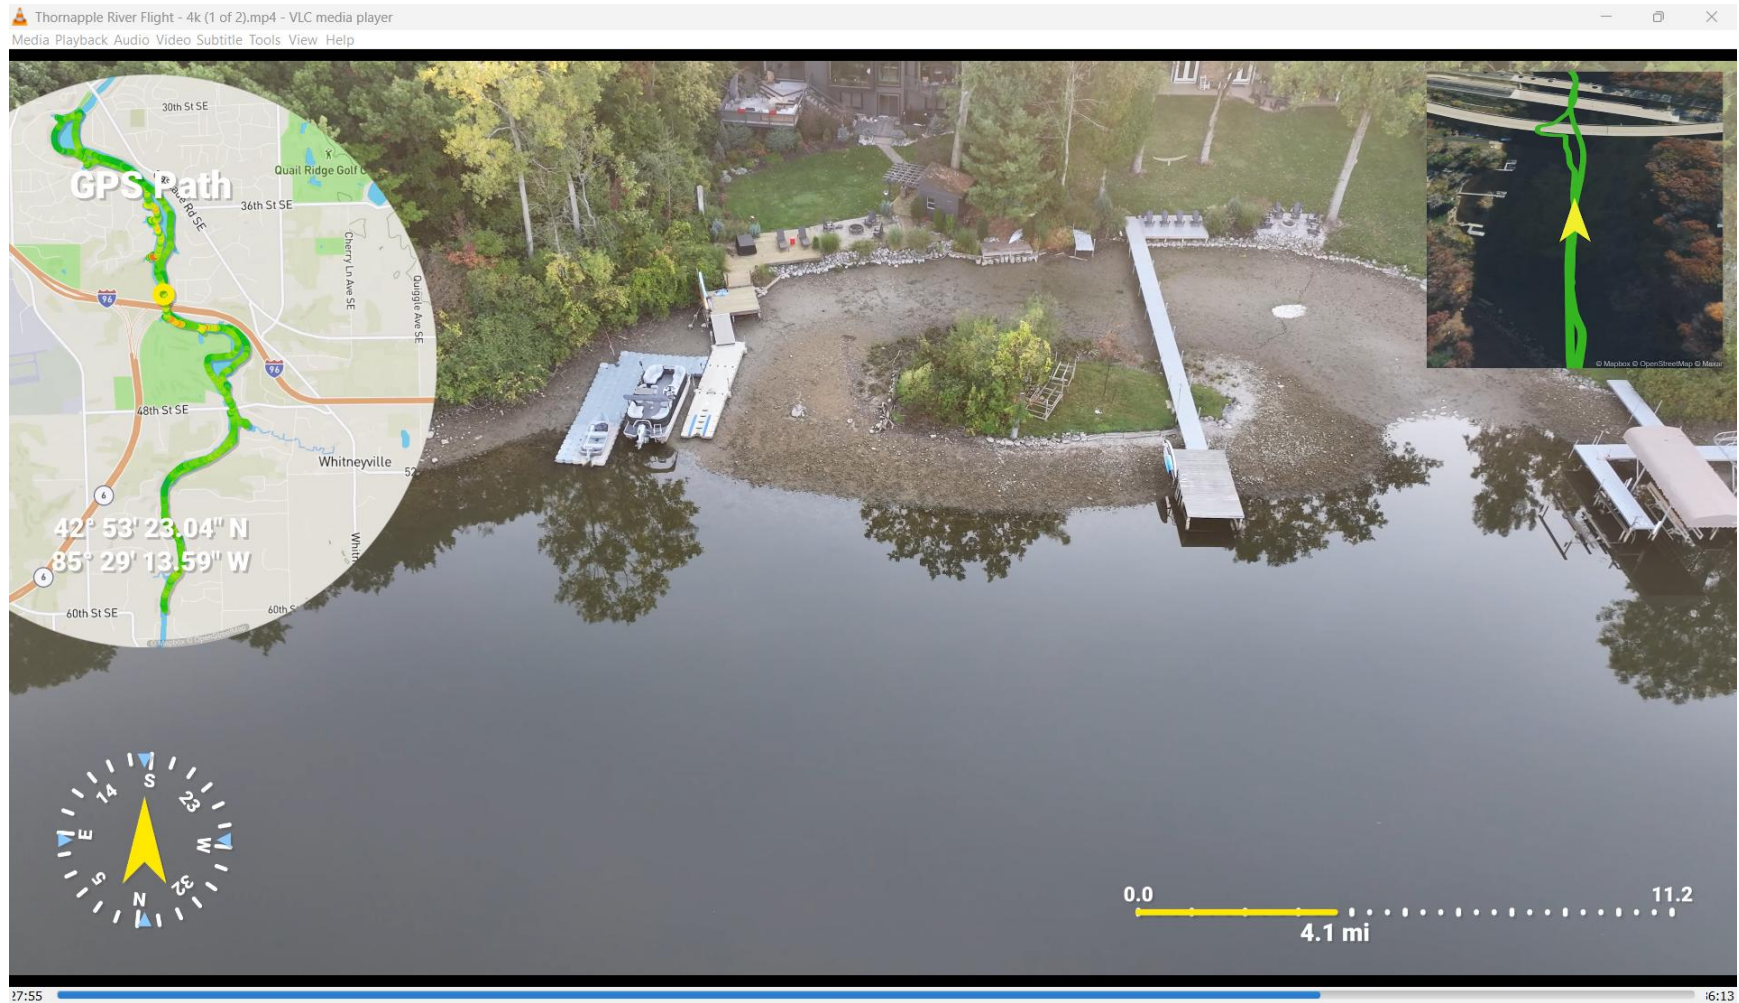
AREA 11: Local deposition at 4105 and 4121 Maricao Shores Drive related to slower water area on inside of bend, not related to waterway erosion.

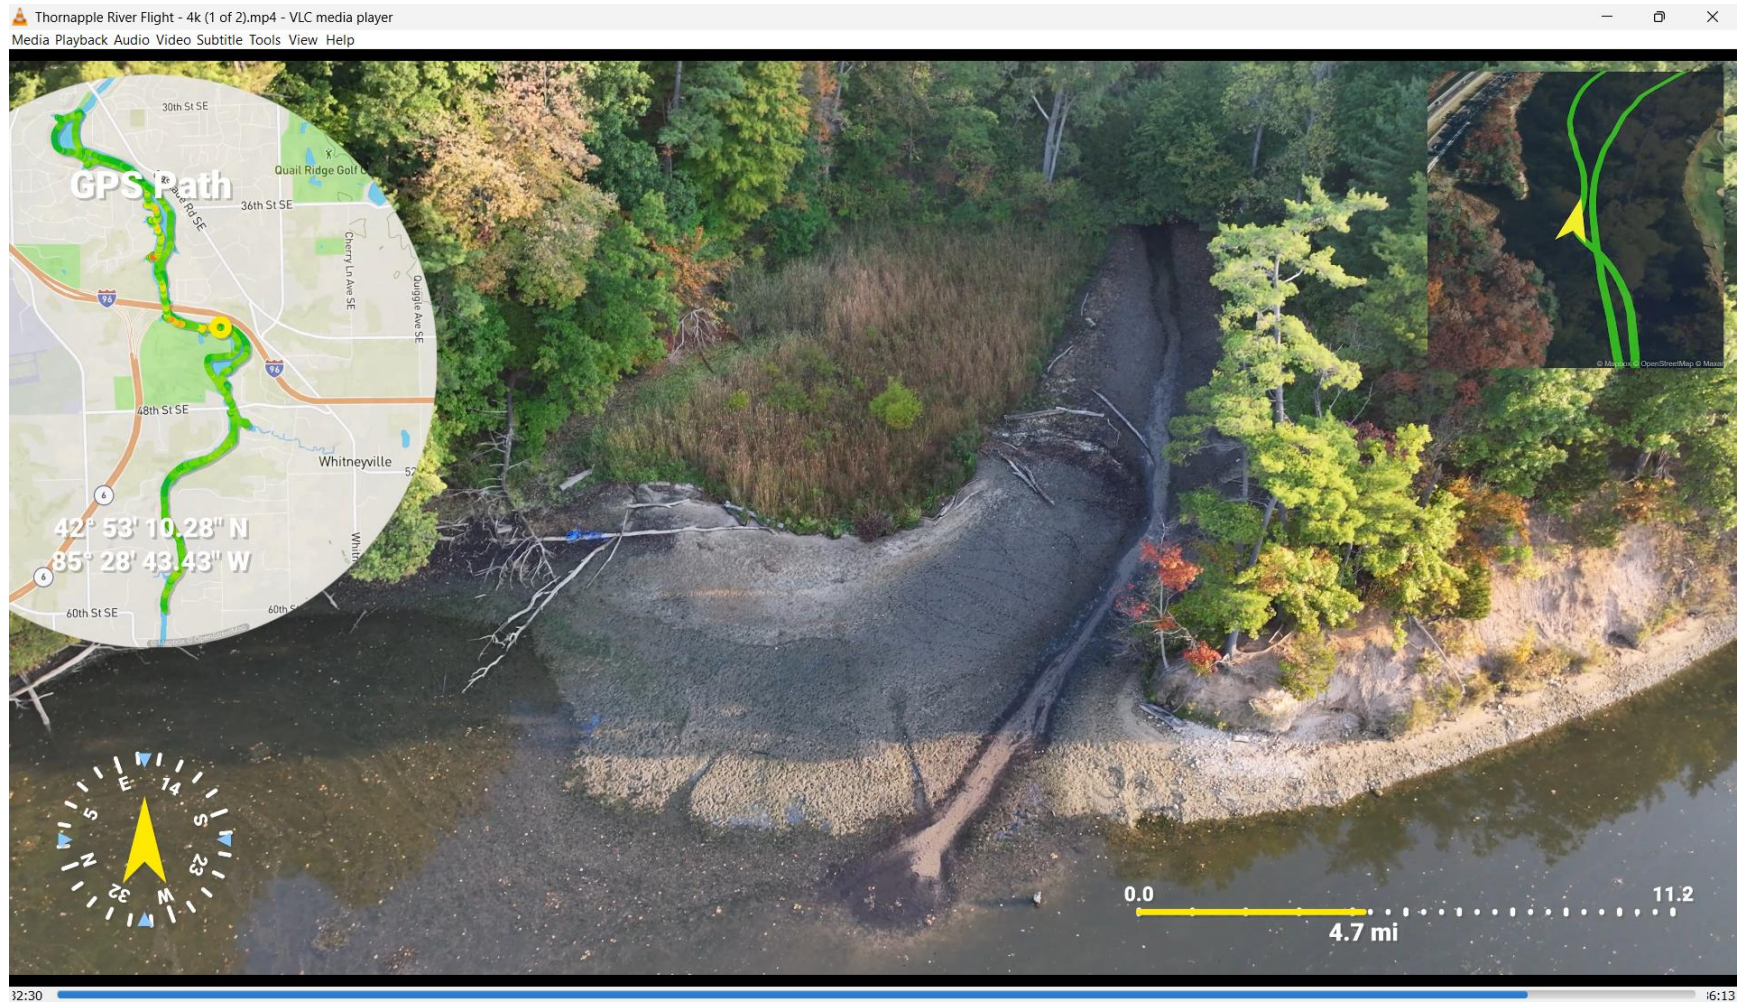
AREA 12: Significant sediment deposition at mouth of Cascade Creek due to upstream erosion.
