# Thornapple River Sedimentation Control and Mitigation Planning

Prepared for  
**Cascade Charter Township**

June 2026

# Thornapple River Sediment Deposition Areas

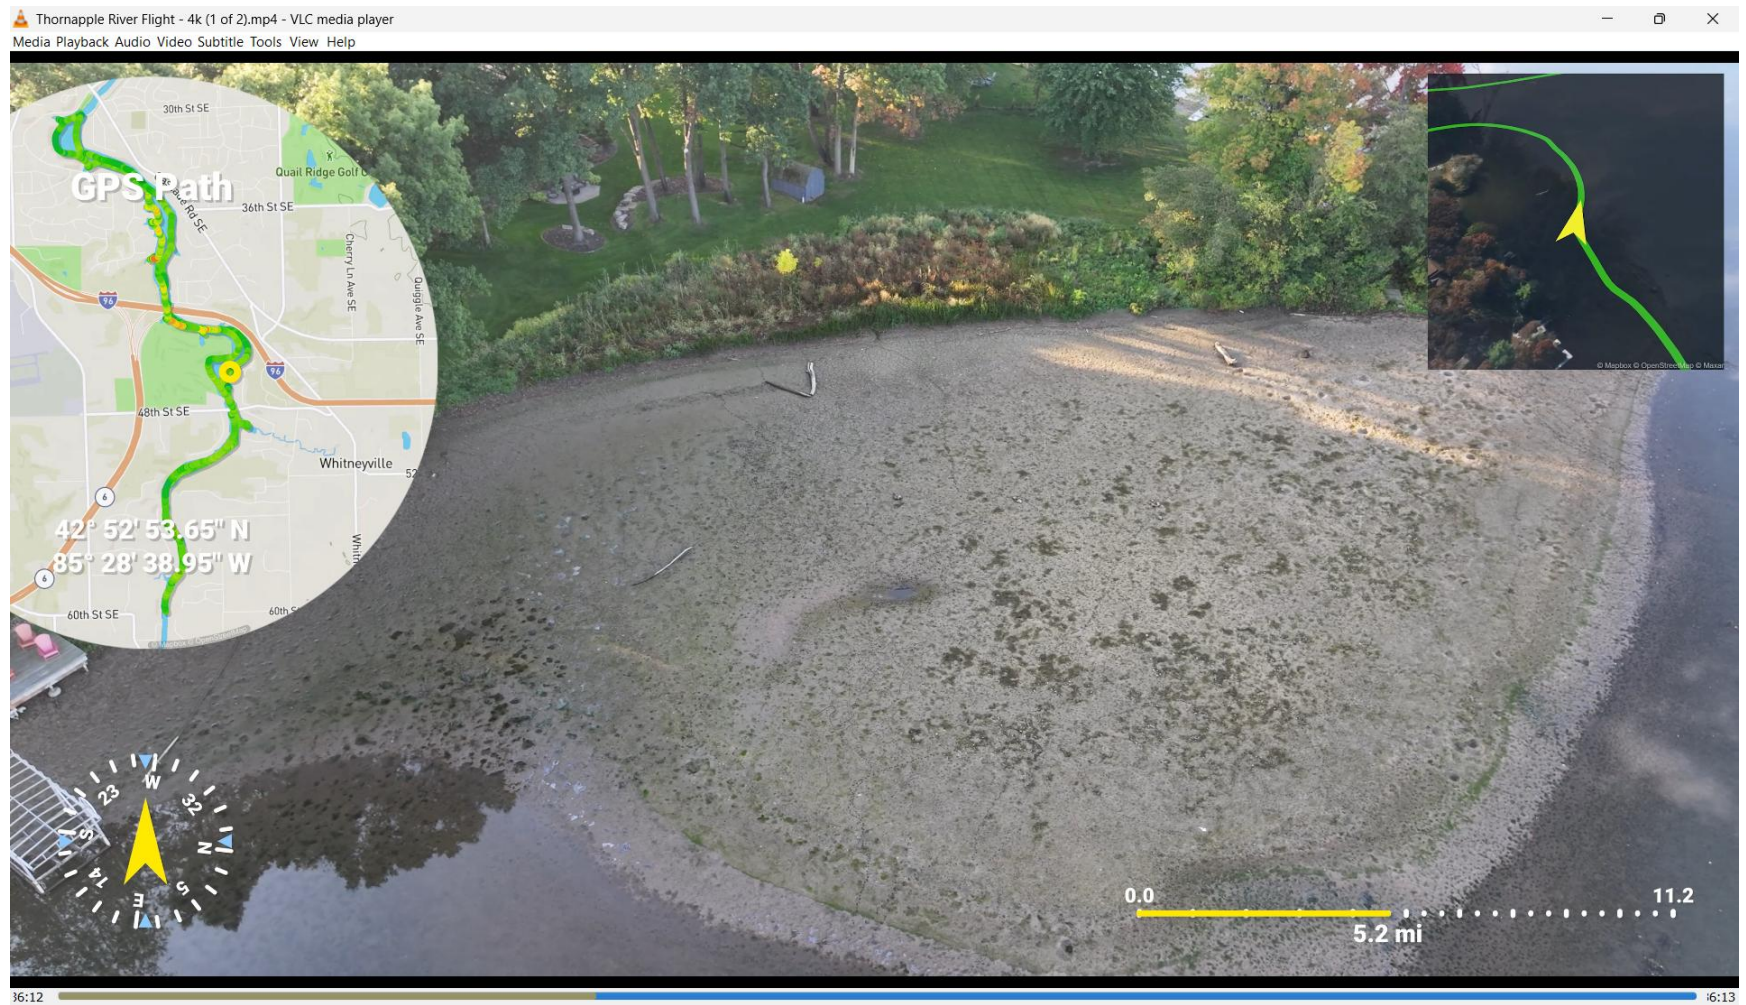
AREA 13: Local deposition at 4607 Little Harbor Drive. Deposition due to inside bend and slow water area .

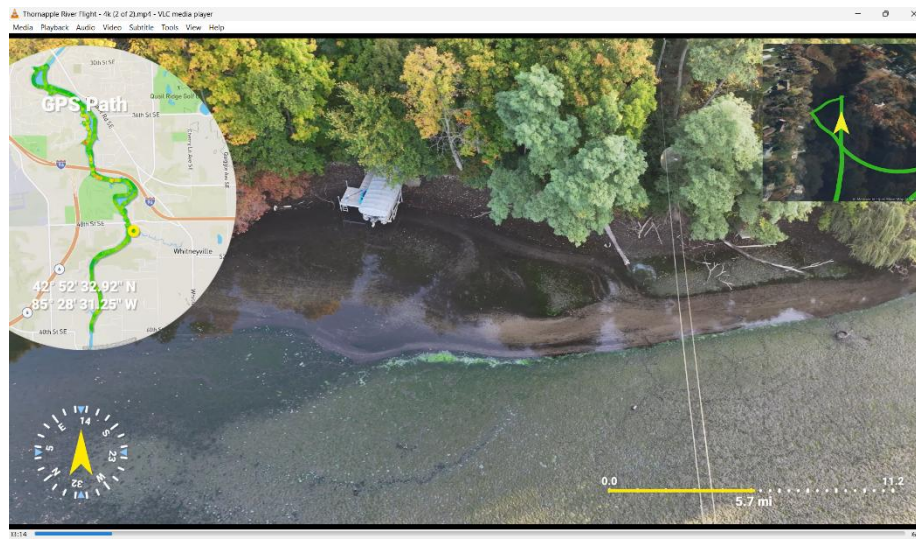
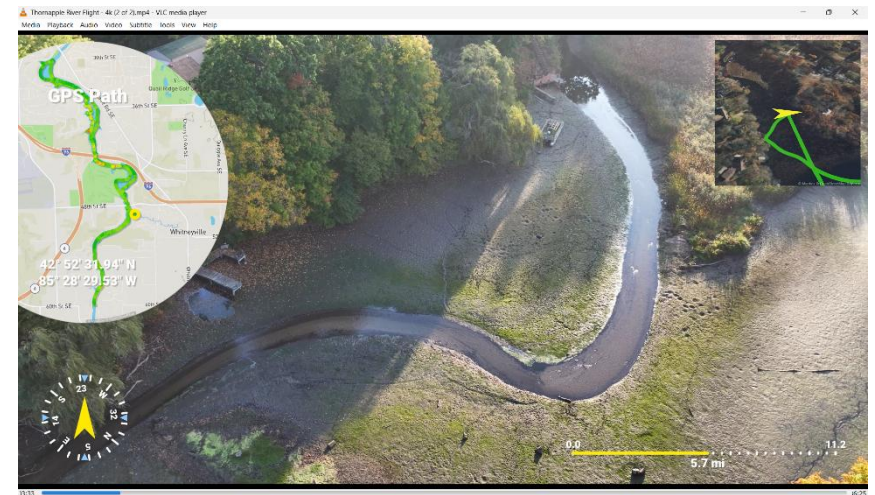
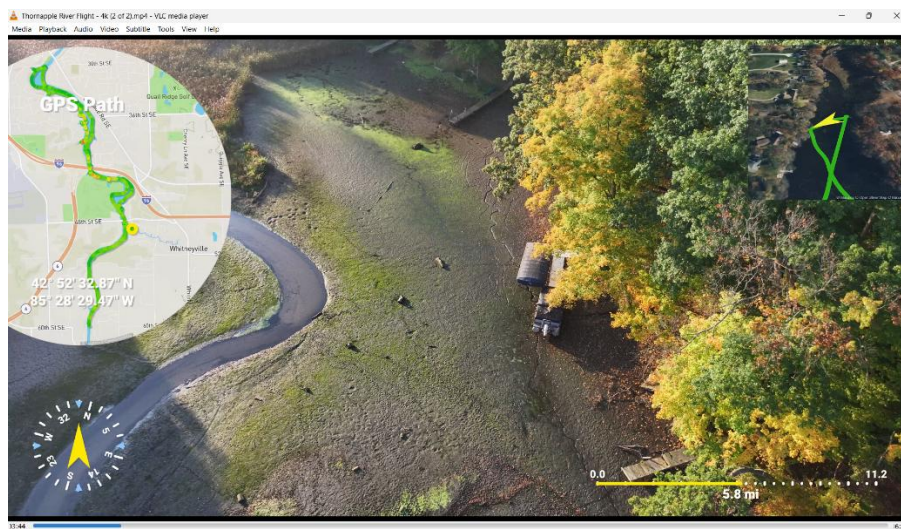
AREA 14: Significant sediment deposition at mouth of 48th Street Bayou Drain due to upstream erosion.

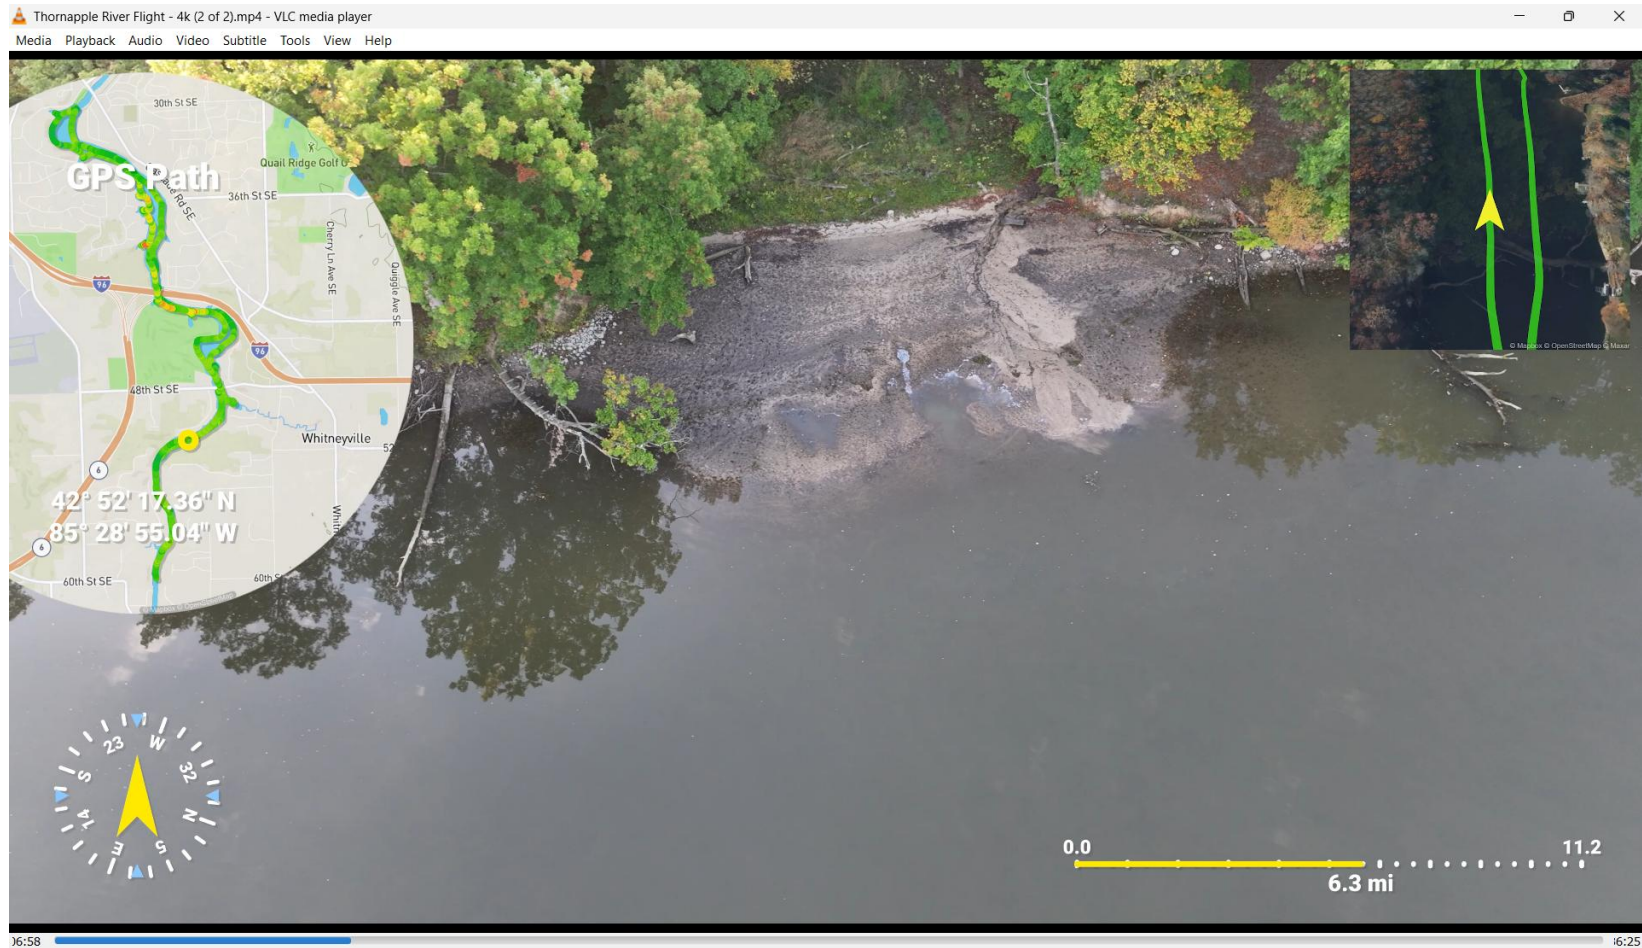
AREA 15: Deposition from localized erosion in small creek originating near Kirkwood Drive.

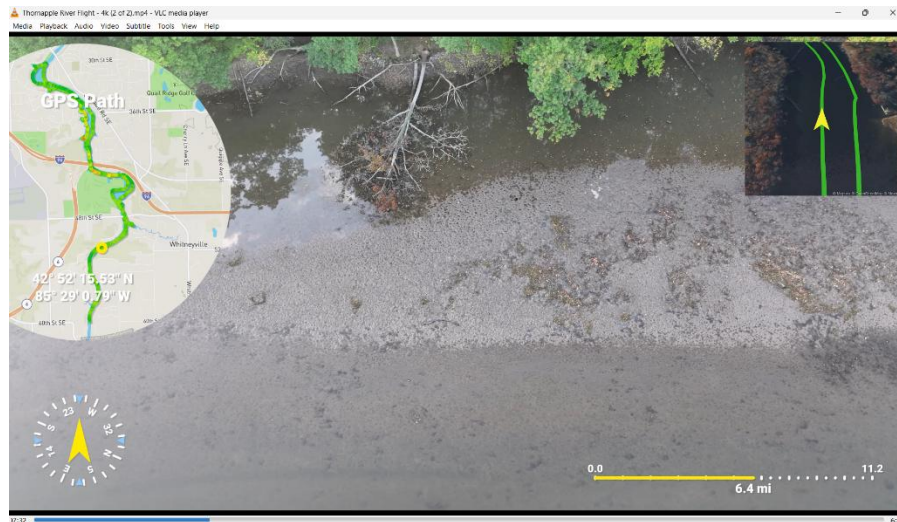
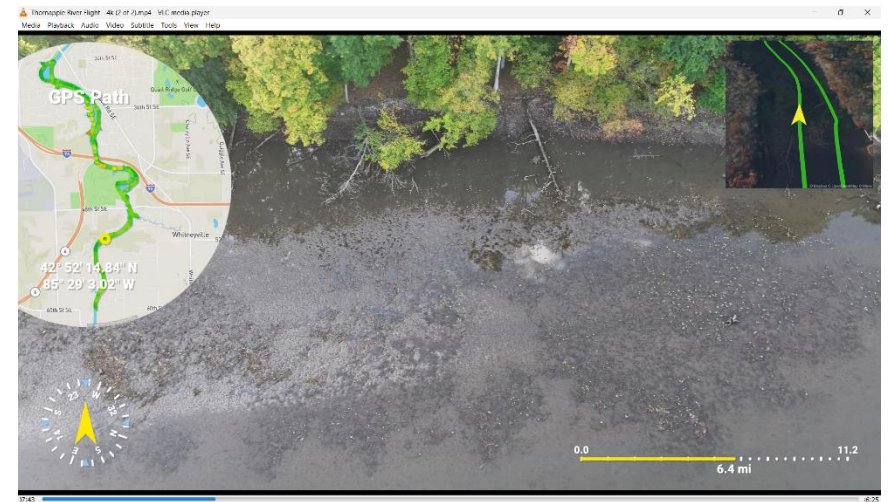
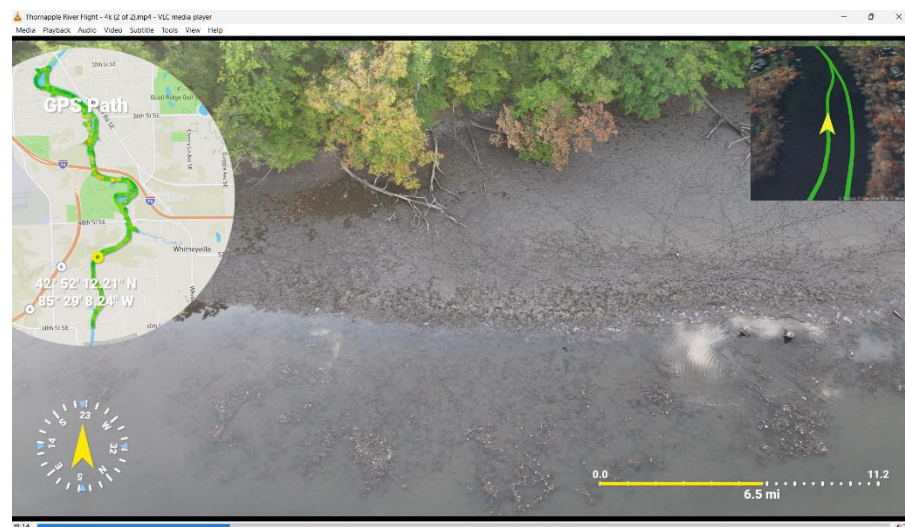
AREA 16: Sediment deposition on east bank north of Kirkwood Drive. Deposition due to slow water area.

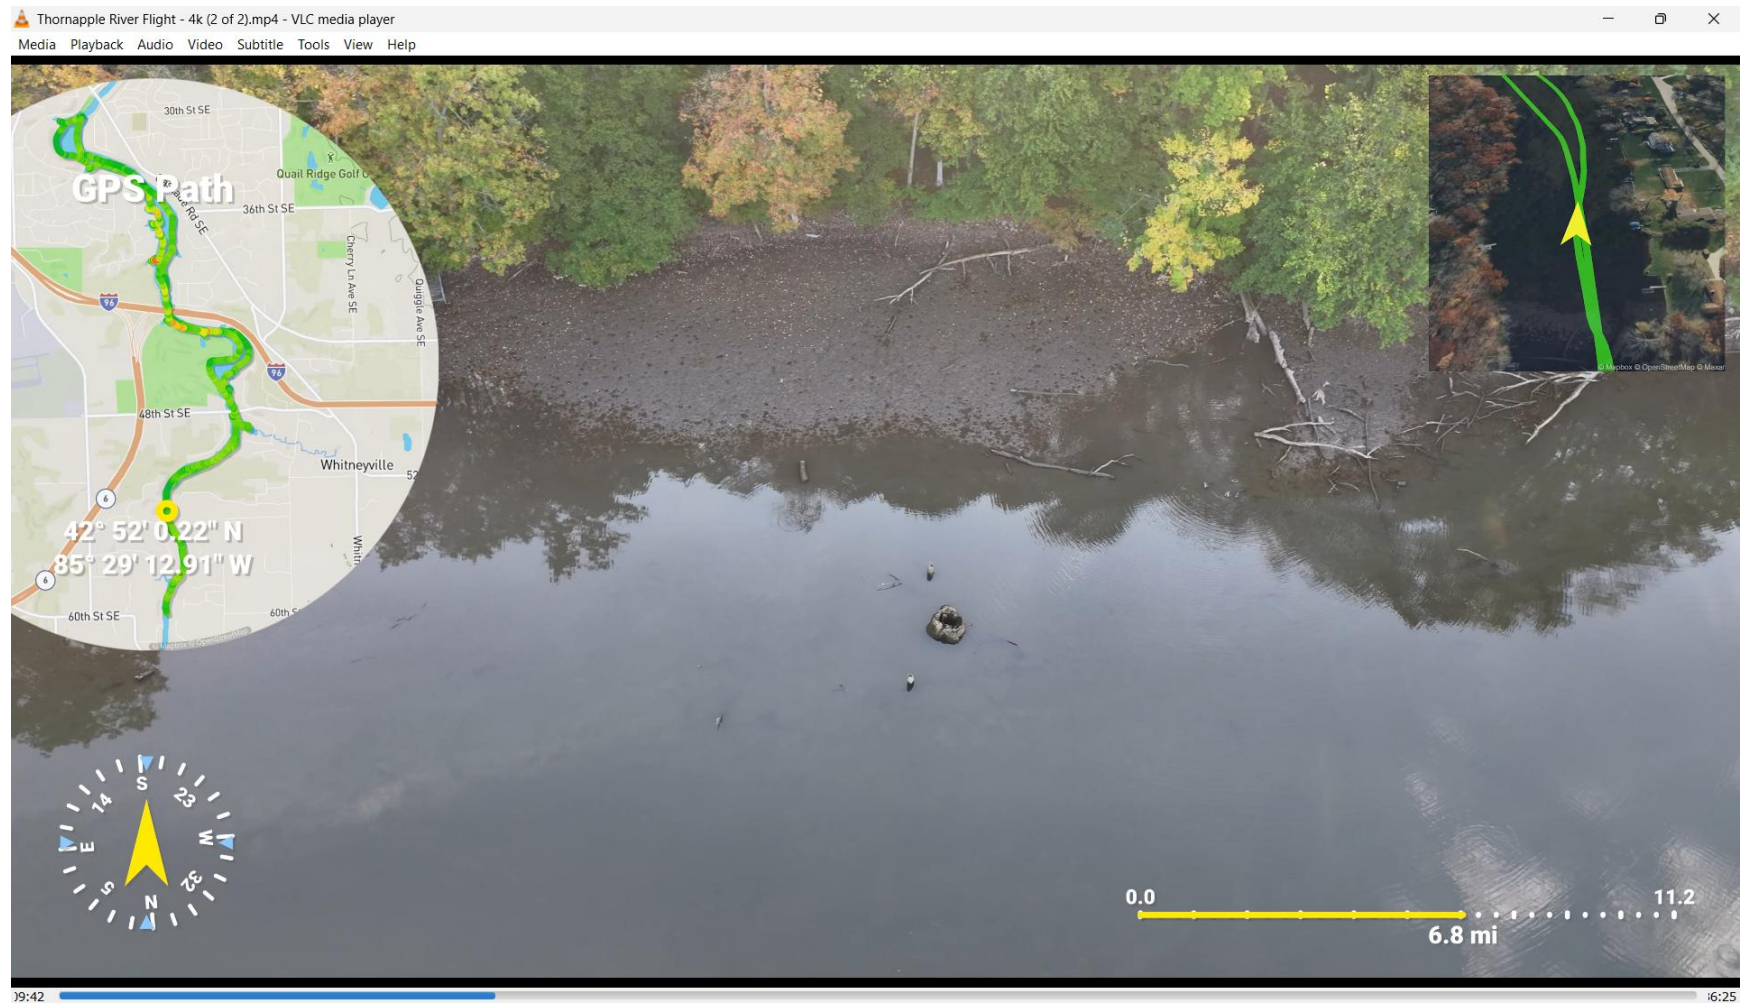
AREA 17: Local deposition at 5407 Buttrick Avenue (end of Peacock Point Pvt.). Deposition due to inside bend and slow water area.

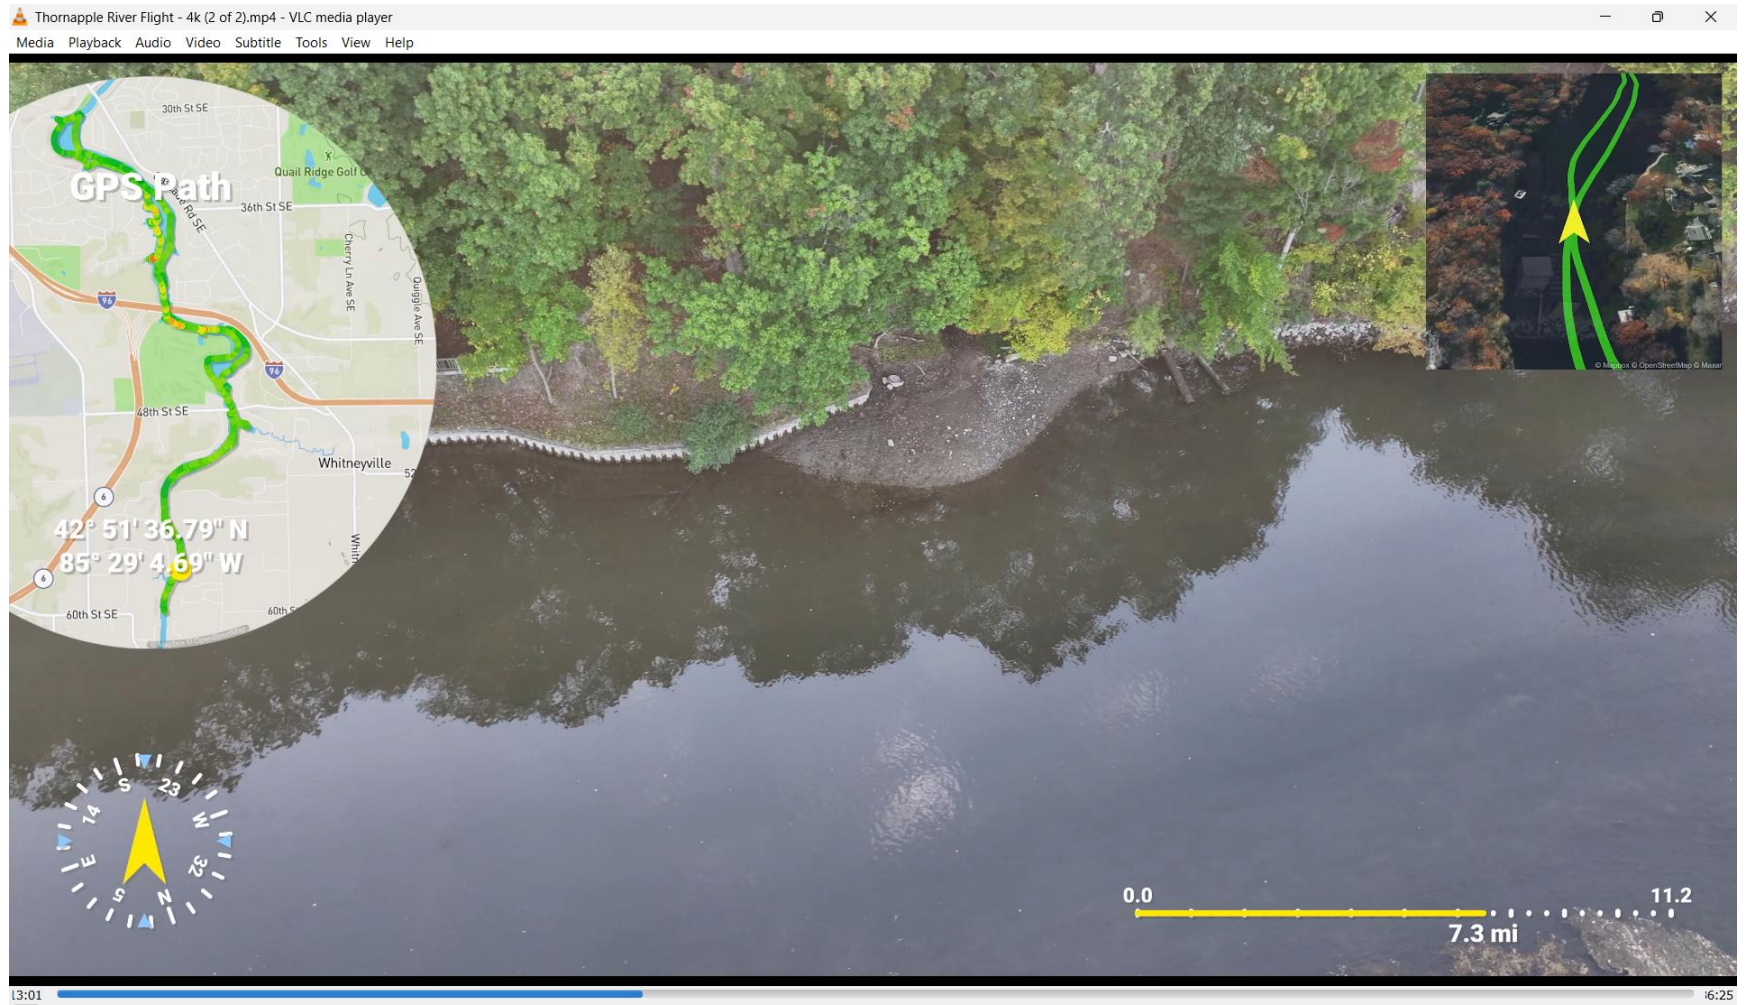
## AREA 18: Moderate deposition at mouth of Glenwood Pond Creek.

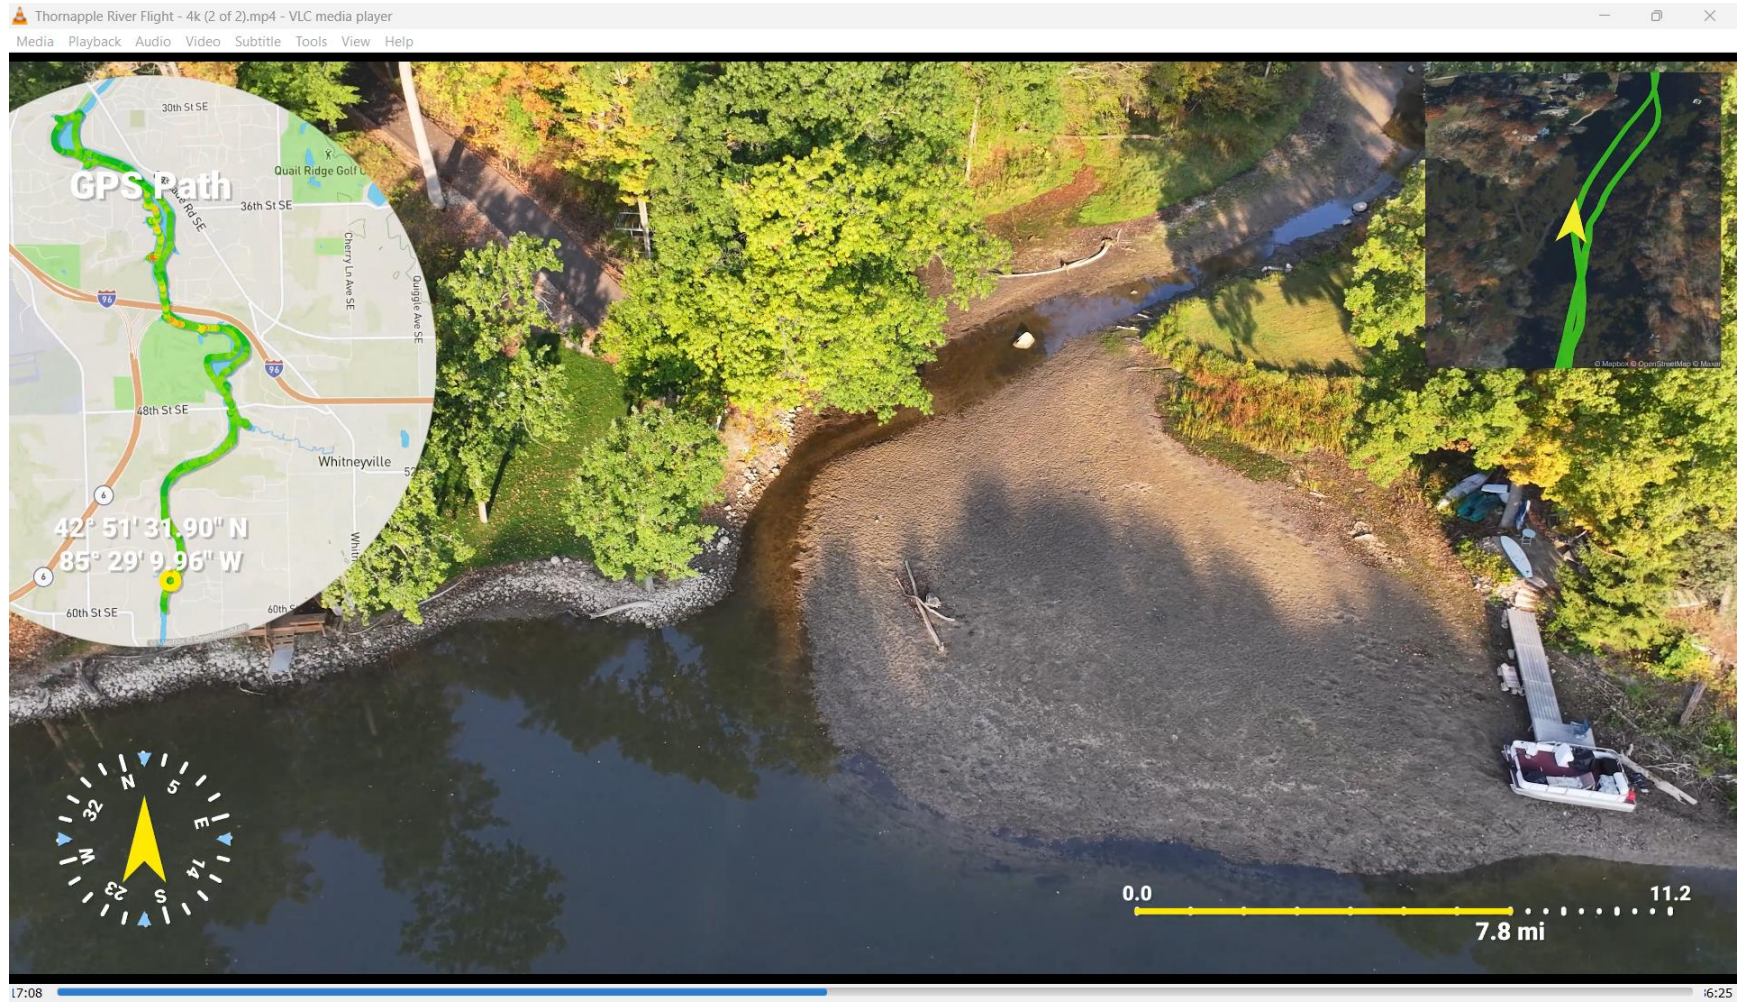
AREA 19: Significant deposition at mouth of South Beltline Creek due to upstream erosion.

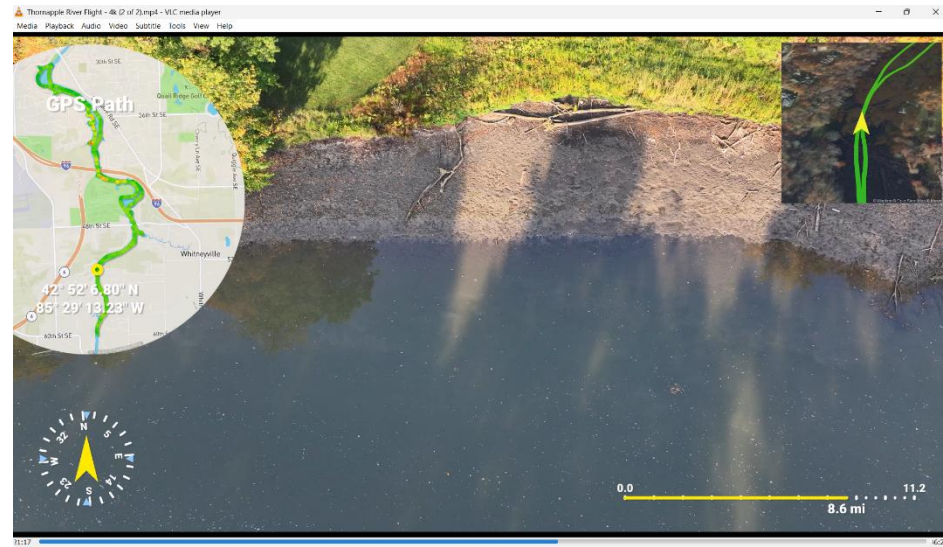
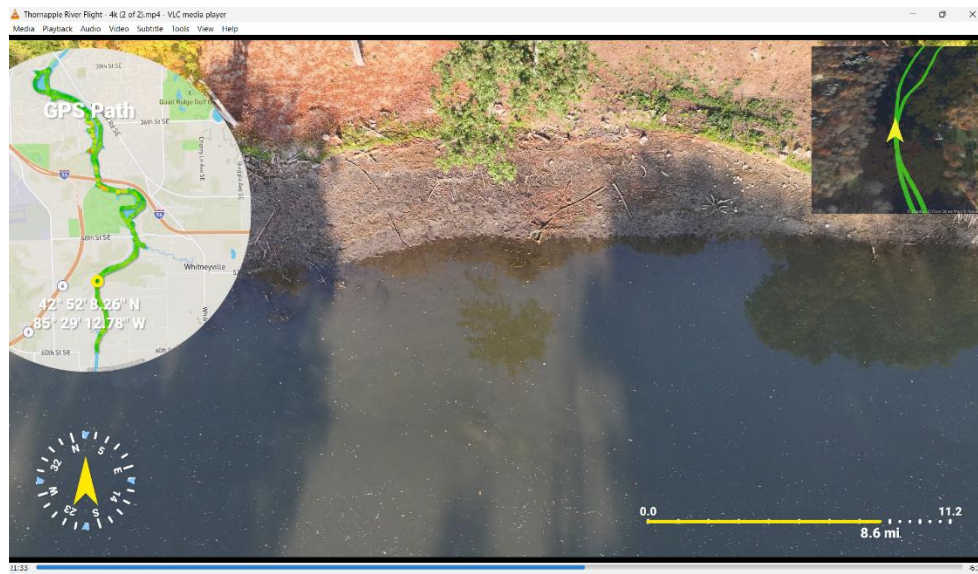
AREA 21: Minor localized bank sedimentation.

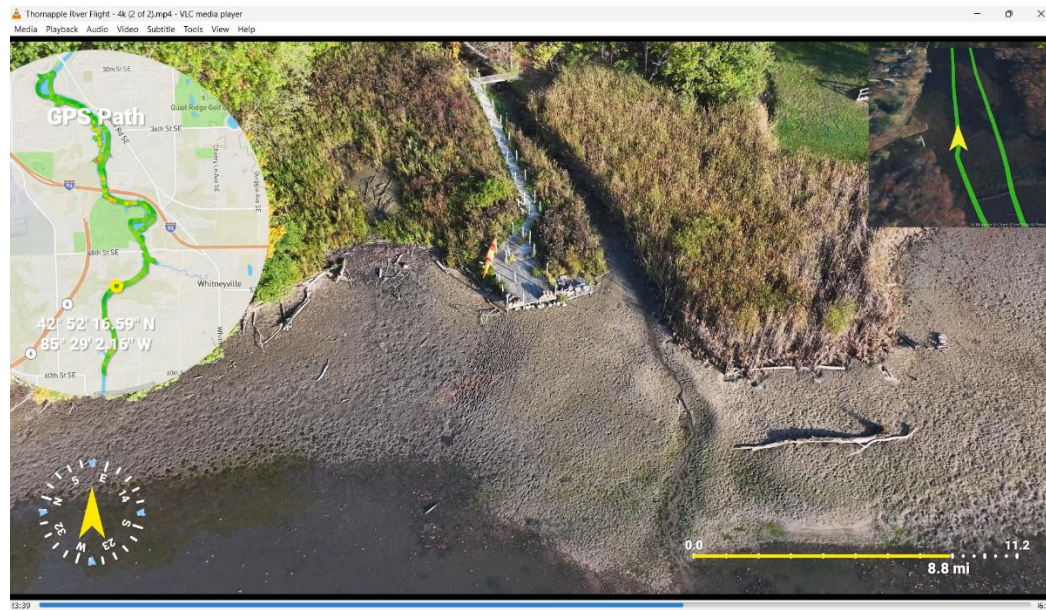
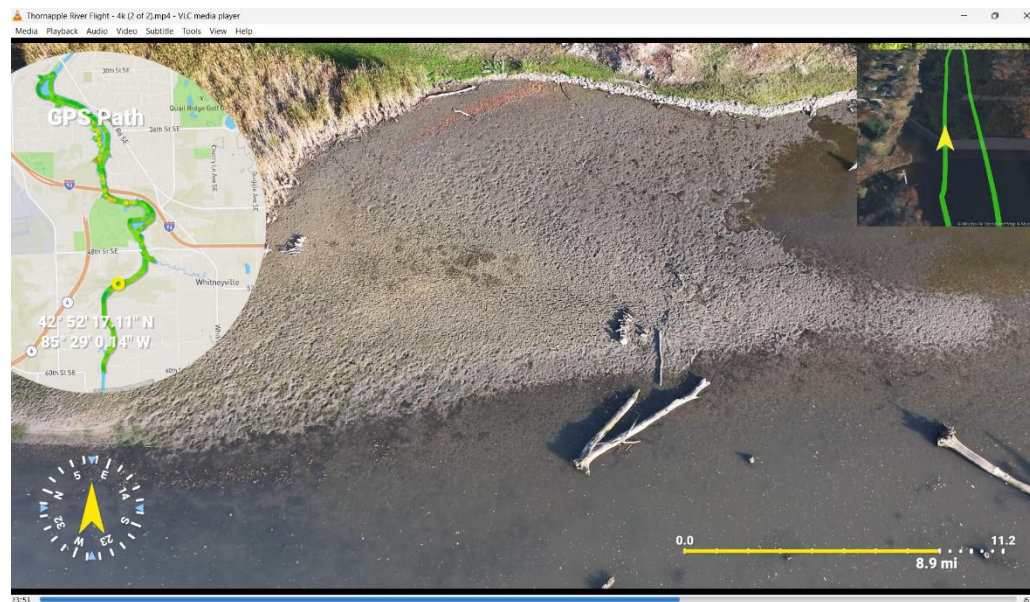
AREA 22: Significant sediment deposition at mouth of Dayenu due to upstream erosion.

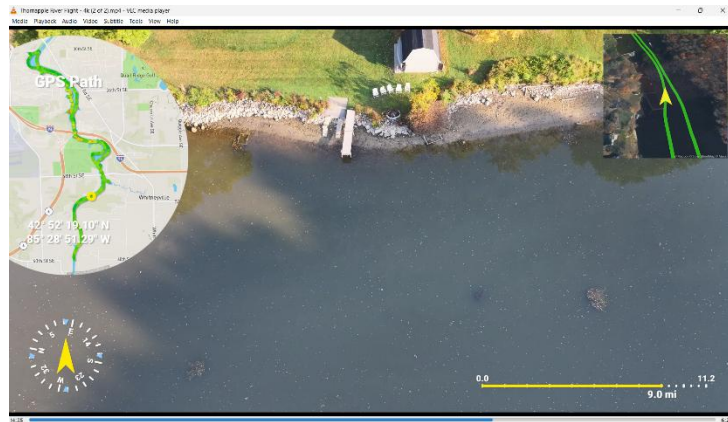
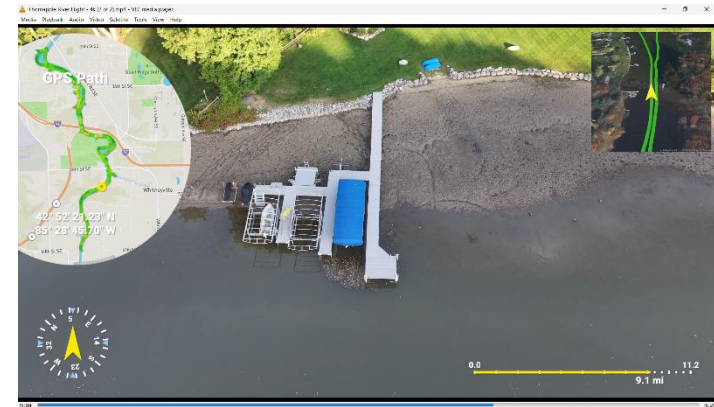
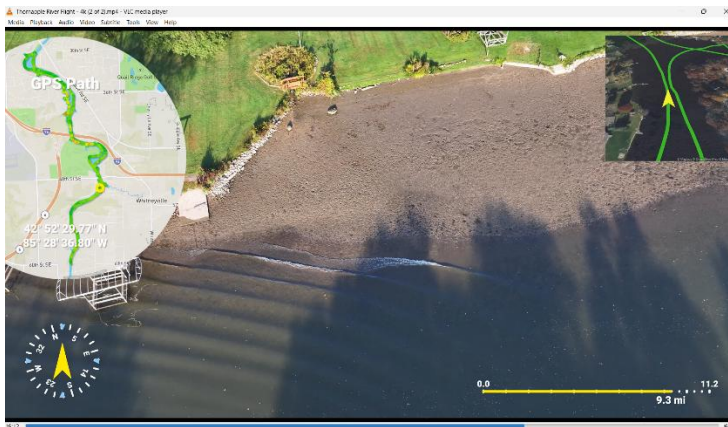
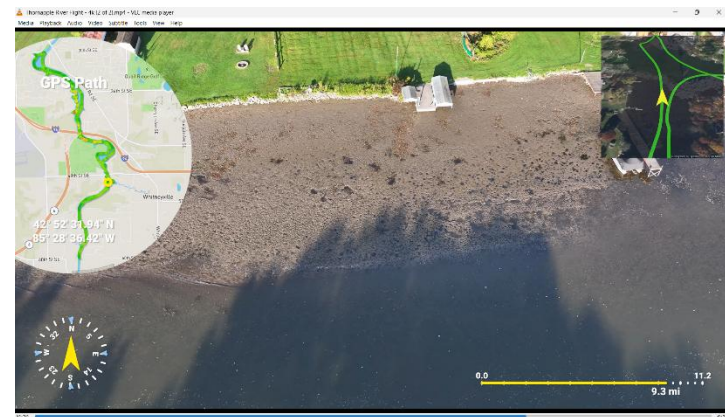
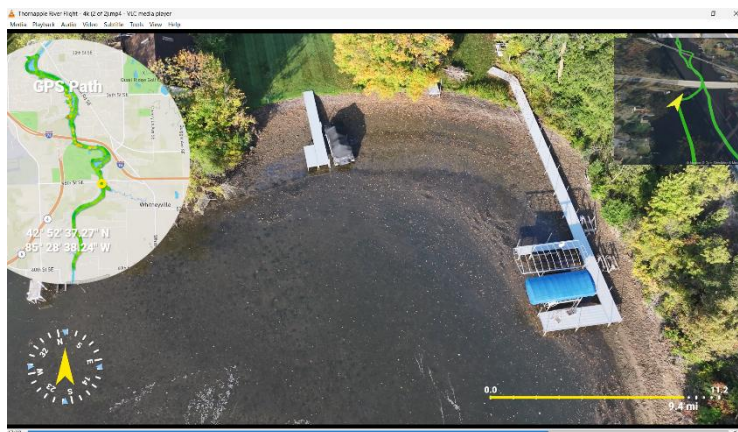
AREA 23: Local deposition along west bank from 5016 Sequoia Drive to 4812 Sequoia Drive. Deposition due to inside bend and inset harbor areas which create slow water areas.

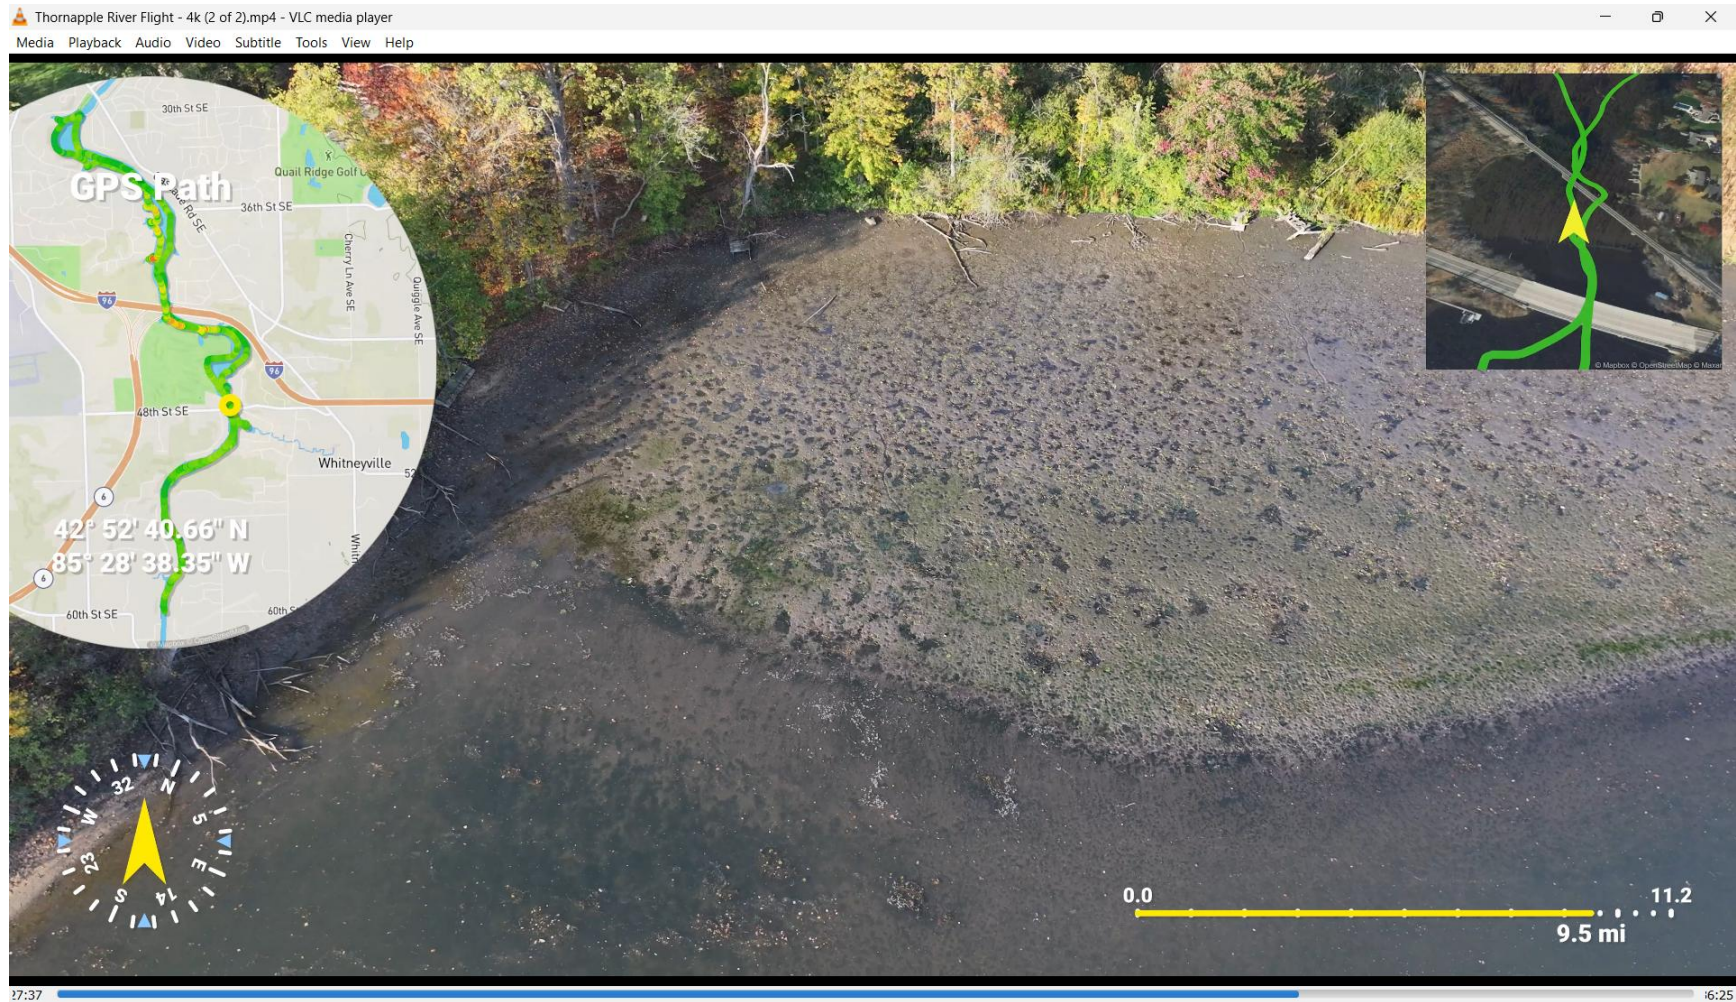
AREA 24: Local deposition along west bank just downstream of 48th Street Bridge. Deposition due to inside bend and inset harbor areas which create slow water areas.

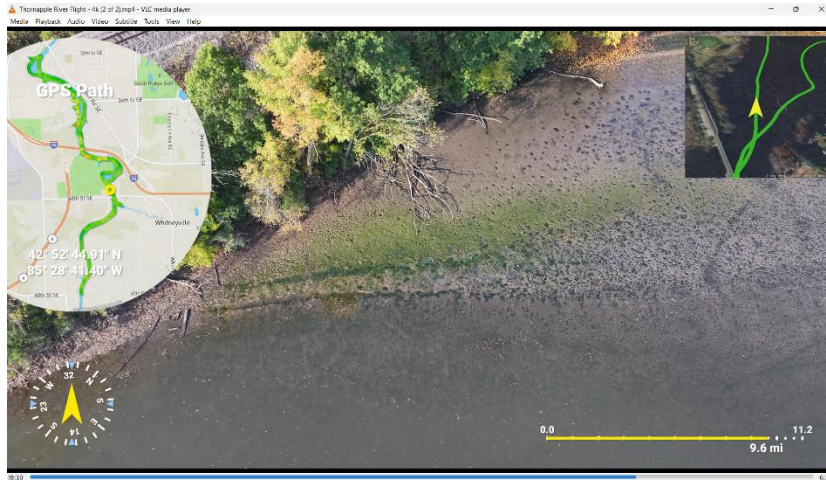
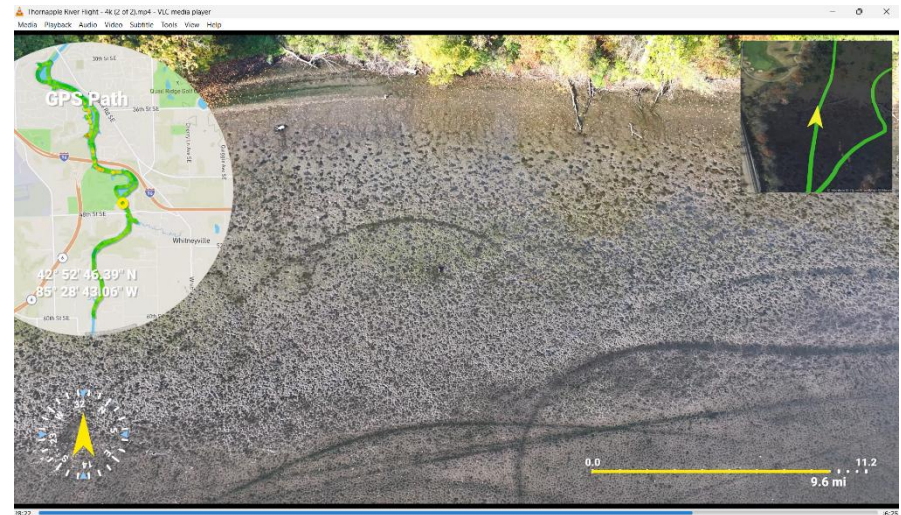
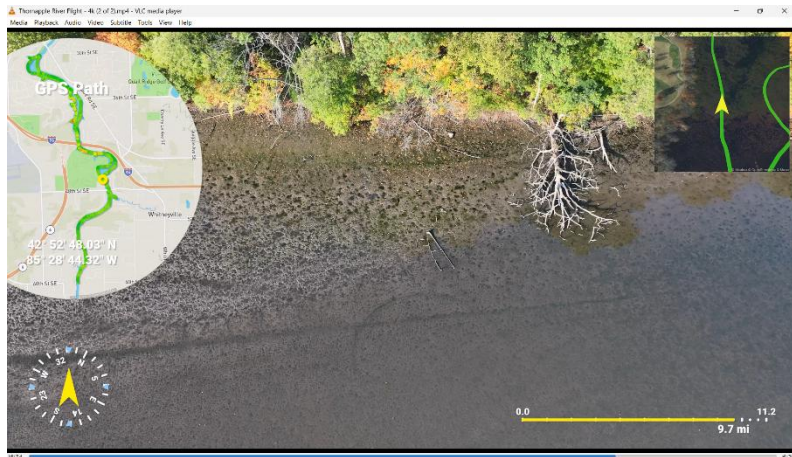
AREA 25: Local deposition along west bank just downstream of 48th Street Railroad Bridge. Deposition due to inside bend and inset harbor areas which create slow water areas.

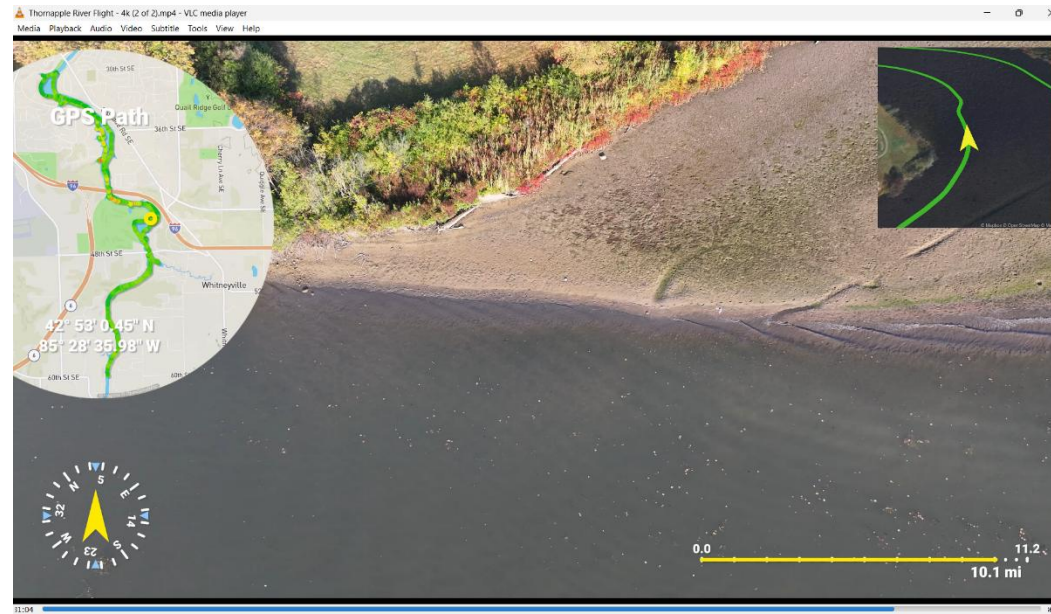
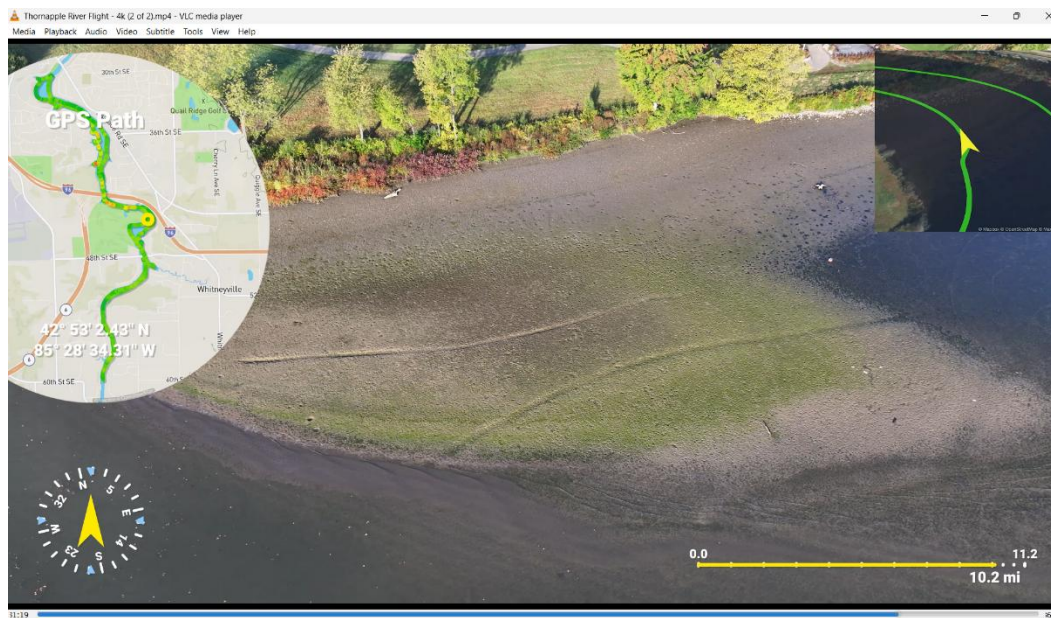
AREA 26: Local deposition along west bank at Thornapple Pointe Golf Club. Deposition due to inside bend which creates slow water area.

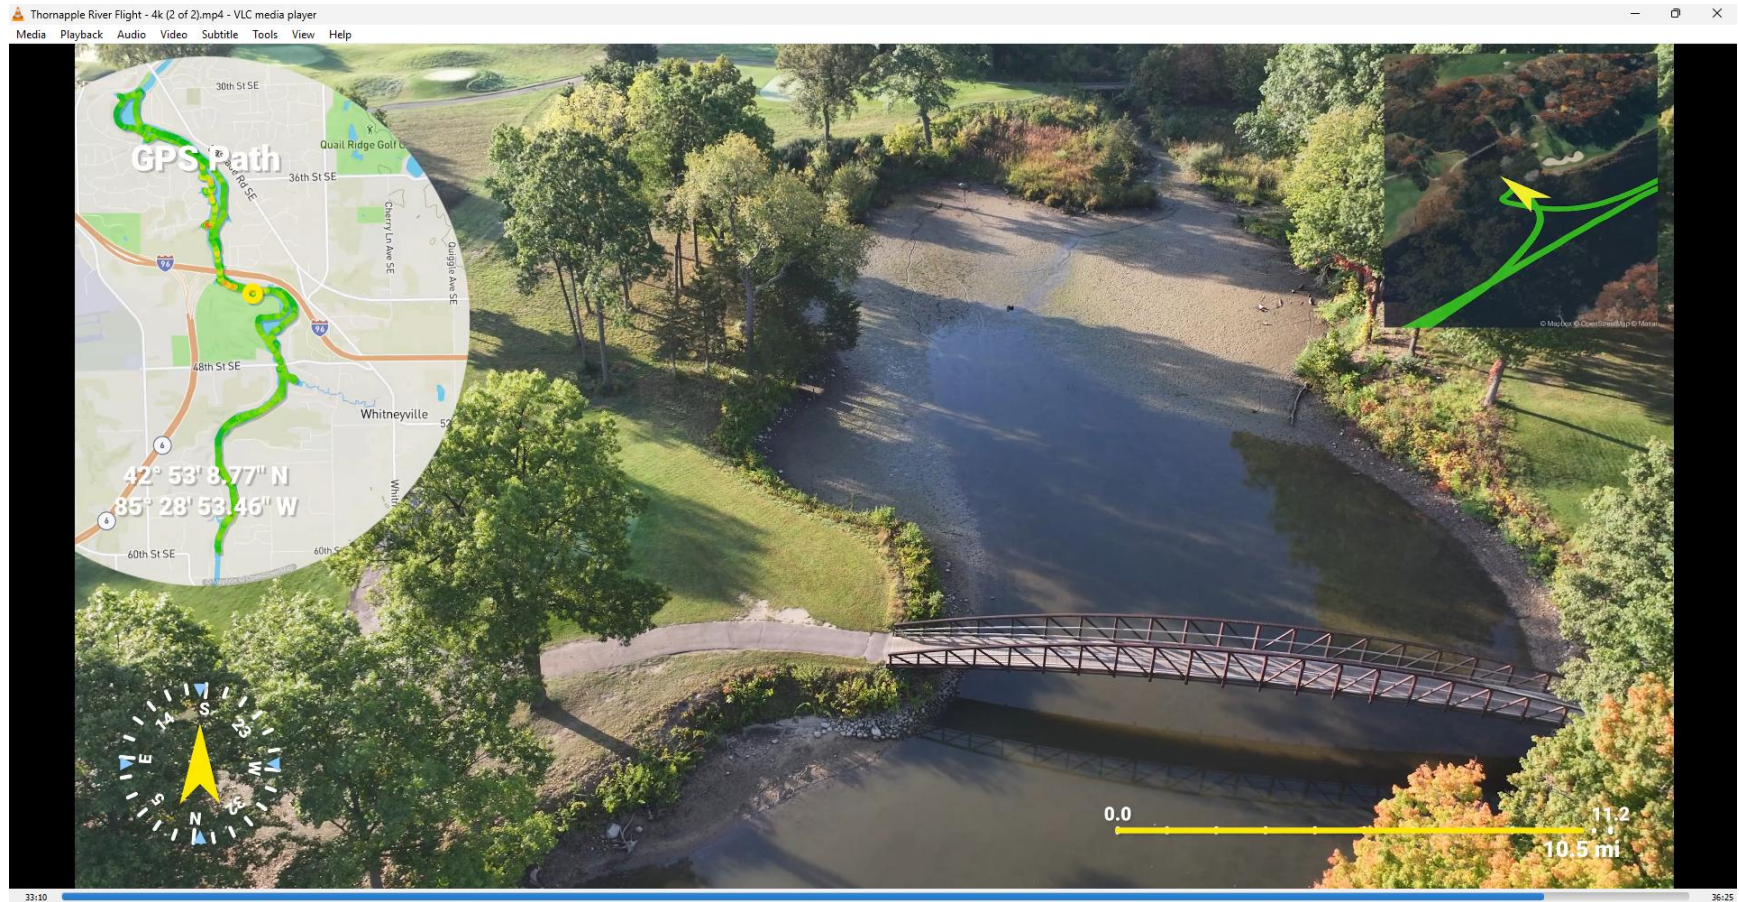
AREA 27: Significant sediment deposition at mouth of Thornapple Pointe Creek from upstream erosion. However, sediment is contained in the local bayou at the golf course and does not extend into main river.
