60th Street District

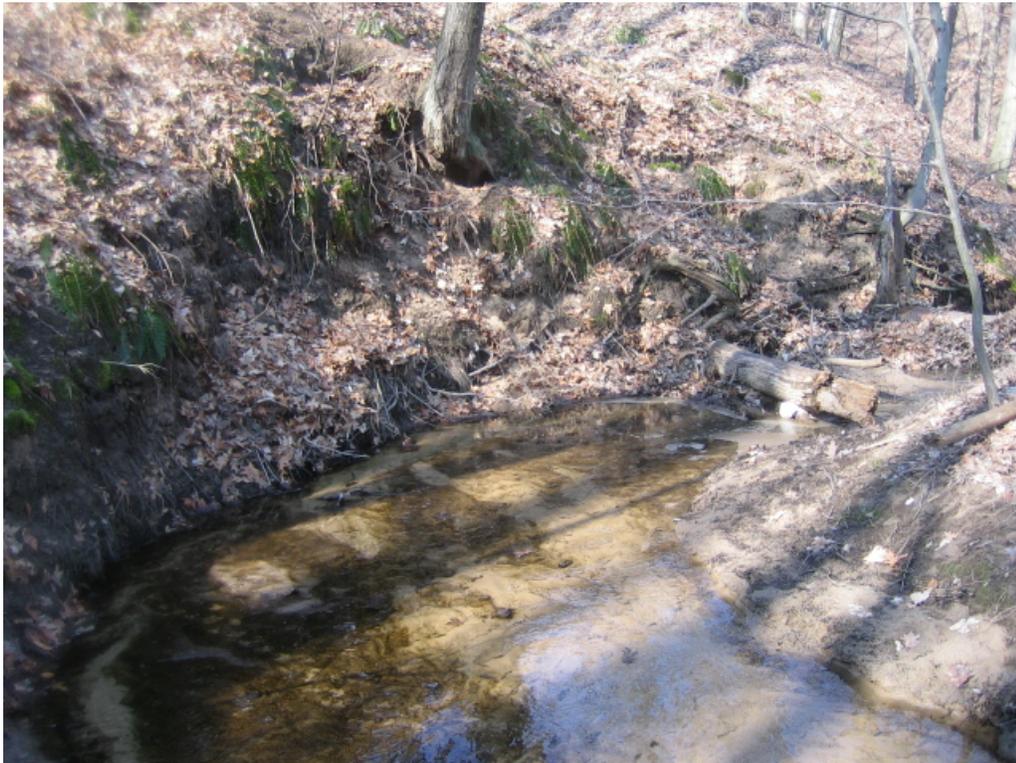
Photograph CD4 (see flag C, Figure CD1)

Downstream of the easternmost Cascade Road crossing severe streambank erosion and failed stabilization efforts are evident (photograph CD3). Lawns parallel the banks before the stream enters a forest. Through the forest, moderate erosion on the outside of meanders is evident. An old farm crossing has collapsed and fallen into the stream approximately halfway between Cascade Road and Cherry Lane. The forest opens to farm land, where the stream narrows and deepens. It then travels through brush until it reaches the Cherry Lane crossing. Downstream of Cherry Lane, both banks of the stream are covered with small brush and slight sedimentation is noticeable. Just upstream of Cascade Road (western crossing for southern branch) the stream is in a mature forest with moderate streambank erosion and sedimentation (photograph CD4). The upstream end of the Cascade Road culvert is clogged with debris causing some flooding to occur (photograph CD5).

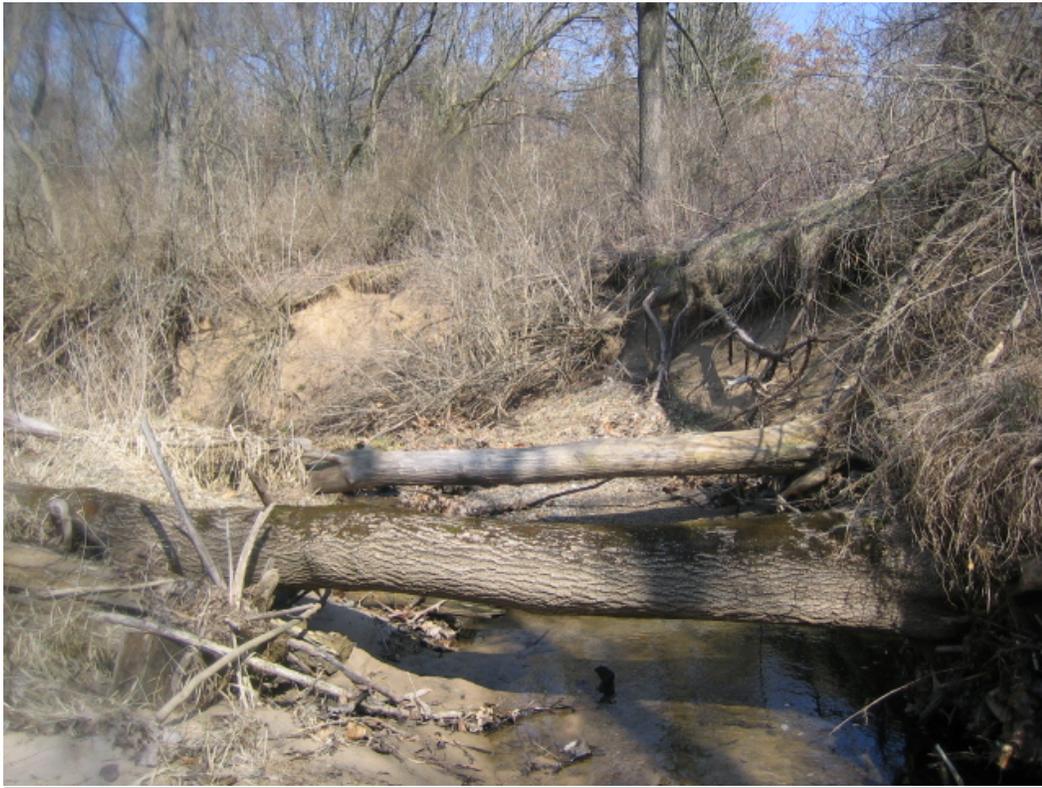
Photograph CD6 (see flag E, Figure CD1)

The confluence of the northern and southern branches occurs between the two eastern Cascade Road crossings. The easternmost Cascade road crossing carries flows from both branches. Sedimentation is evident from this crossing all the way to the discharge point at the Thornapple River. Downstream of Whitneyville Avenue streambank erosion is moderate (photograph CD6). Just upstream of I-96, sedimentation is severe resulting in a culvert over half clogged with sediment (photograph CD7).

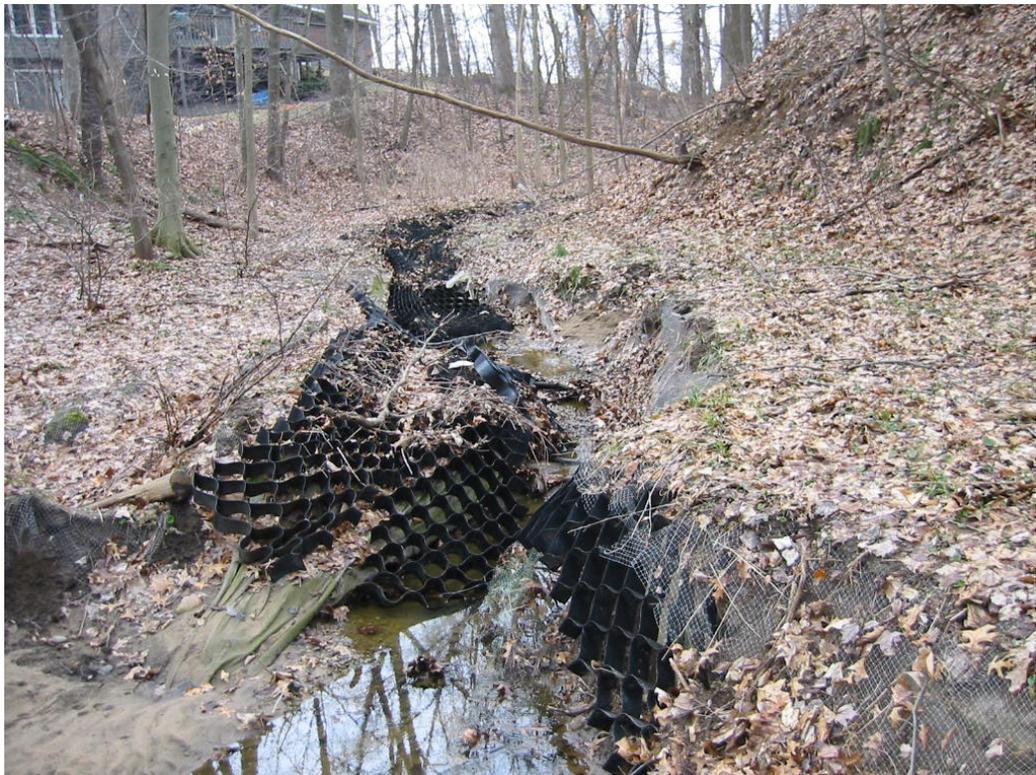
Photograph B1-3 (flag B, Figure B1-1)

The Burger 1 District is shown in Figure B1-1. The stream that drains this district has its headwaters in Cascade Township Park. This stream discharges into a Thornapple River bayou. Flows in the bayou reach the Thornapple River after flowing through the culvert under Burger Drive. Between Burger Drive and Woodbrook Drive there is severe erosion of the streambanks (photograph B1-2). Many meanders exist and there is evidence that new meanders are being created. This gives evidence that the stream is unstable. Between Woodbrook Drive and Forest Valley Drive an attempt was made to stabilize the streambank using GEOWEB Cellular Confinement System to line the channel. The GEOWEB has failed and streambank erosion is still occurring (photograph B1-3). Upstream of Forest Valley Drive the stream becomes a swale through the Cascade Charter Township Park.

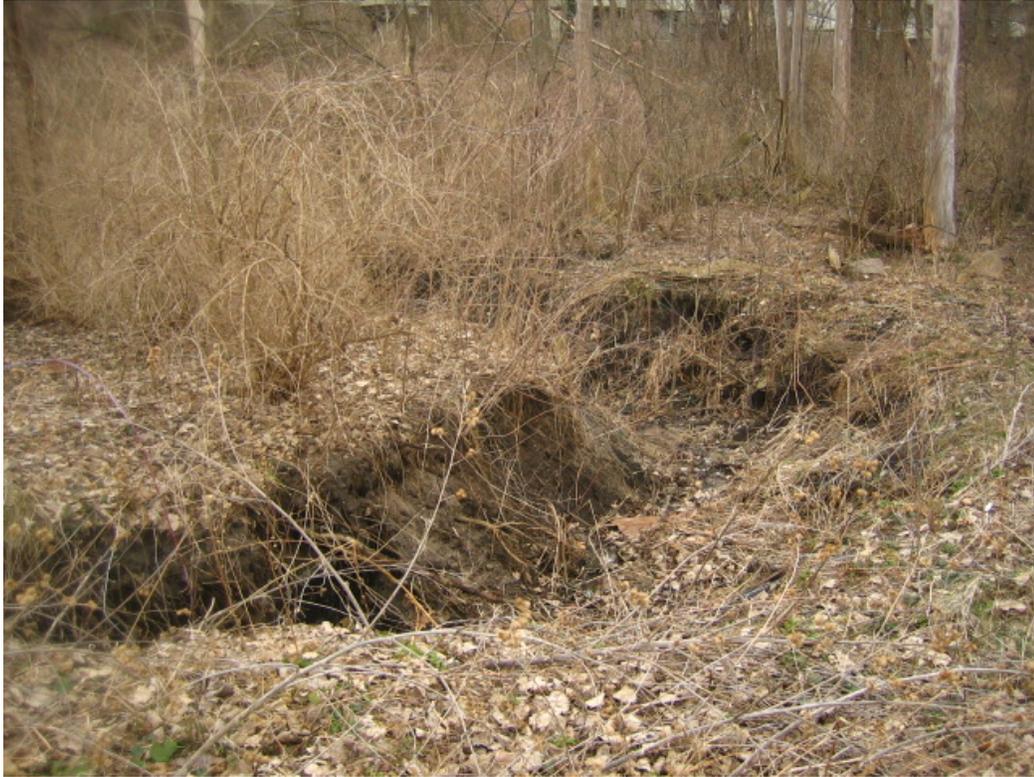
Photograph SP2 (flag A, Figure SP1)

The Sentinel Point District is shown in Figure SP1. The stream that drains this district has two branches both with headwaters in Sentinel Country Club. The northern branch is designated as the Thornapple Hills Kent County Drain. Streambank erosion was noted along the northern branch, upstream of Thornhills Avenue. In this area the overflow of a detention basin caused severe incising upstream of Thornhills Avenue (photograph SP2). Downstream of Thornhills Avenue a large scour pool exists. Further downstream the channel begins to meander with slight to moderate erosion on the banks. Three or four gabion check dams had been installed between Thornhills Avenue and Thornapple River Drive. All seem to be in good shape (photograph SP3). Just upstream of Thornapple River Drive the north and south branches combine. The stream then crosses Thornapple River Drive and a driveway. Downstream of the driveway moderate erosion has occurred and sedimentation is evident on the channel bottom (photograph SP4). The stream then discharges into the Thornapple River.

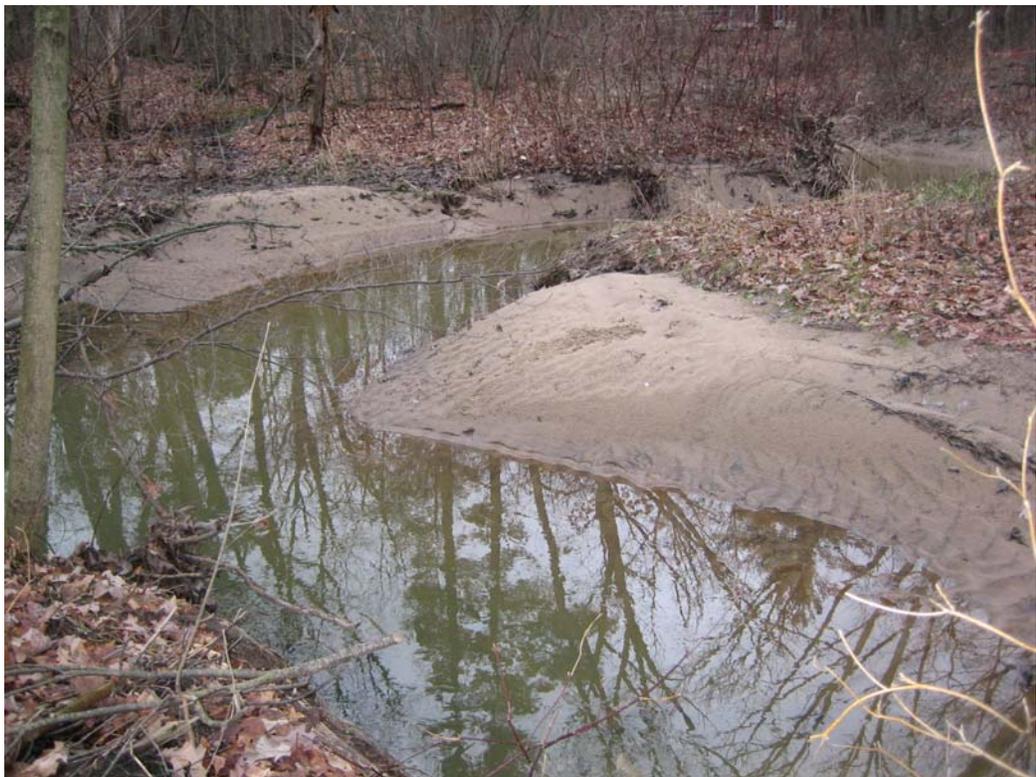
Photograph 3 (see flag B, Figure B2-1)

A construction site with poor soil erosion and sedimentation control is located just upstream of the Kraft Avenue crossing (photograph 2). This site in addition to the new 36th Street extension and interchange could have contributed to the large amount of sediment discovered in the stream. The stream exhibits moderate streambank erosion as it flows through a mature forest upstream of I-96 (photograph 4). Downstream of I-96, the stream flows through a golf course before entering a brushy forest. Downstream of Thornapple River Drive, the surrounding area is mature forest where sedimentation (photograph 3) and streambank erosion are evident. This is consistent up to the bayou at the stream's confluence with the Thornapple River.
