# Thornapple River Sedimentation Control and Mitigation Planning

Prepared for  
**Cascade Charter Township**

June 2026

# Thornapple River Sediment Deposition Areas

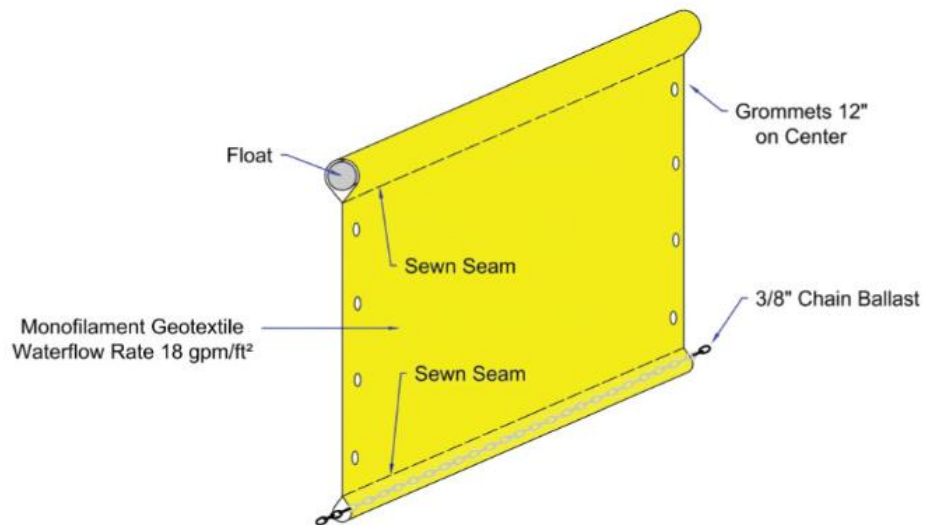
Turbidity curtains are a fabric curtain suspended across a slow water area by floats and secured to the bank. They cannot be traversed by motor boats or anything with a keel/rudder. Because they may present a navigation hazard, regulatory permitting is usually required.

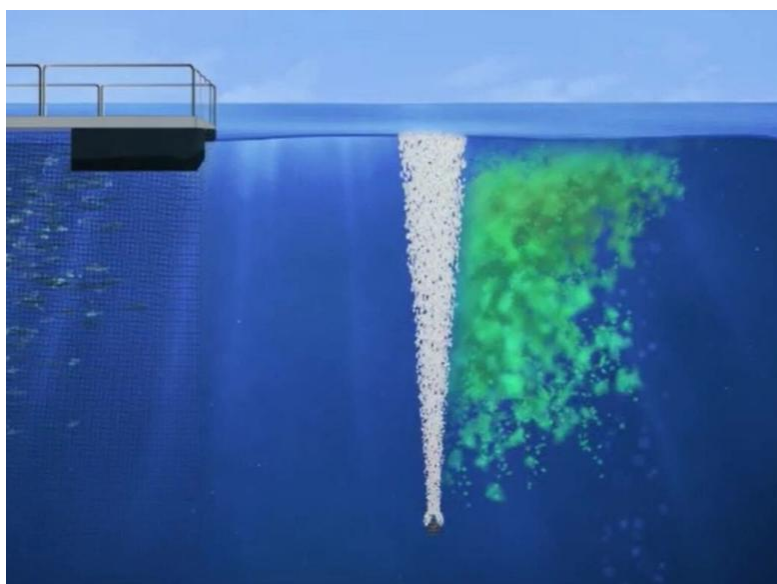
Bubble curtains are created via a submerged air tube and compressor system. They require continuous power for the compressor (and potentially noise attenuators). Their effectiveness is highly dependent on wind/wave/current conditions. Regulatory permitting is usually required for these.

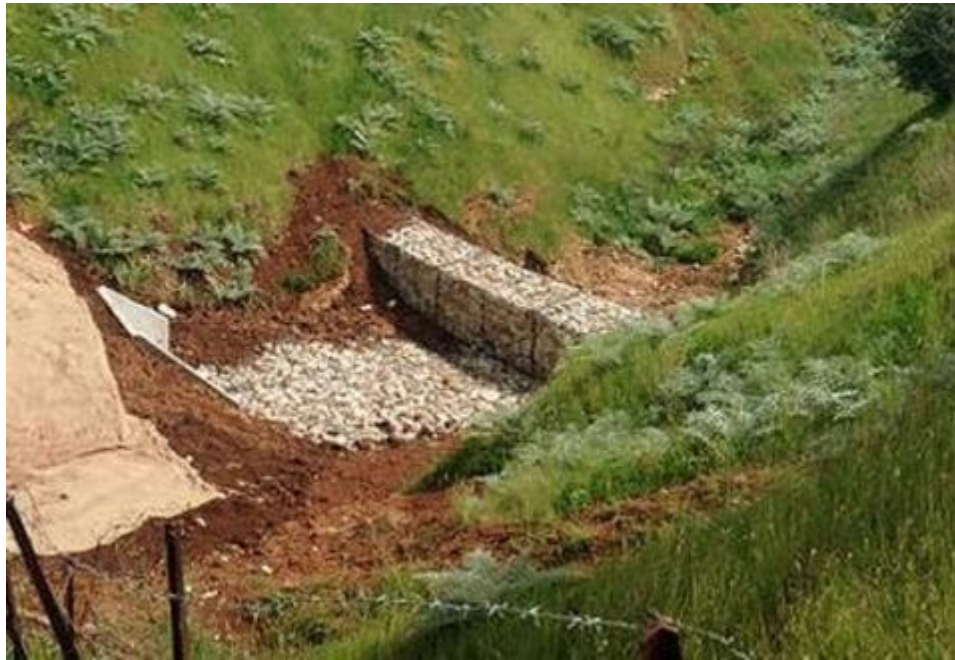
Coarse grained sediment deposition in the river can be removed by periodic dredging or by one-time removal paired with additional management that captures the mobilized sediment upstream of the waterway discharge into the river. Sediment capture is usually achieved with a dam structure of sheeting or rock gabion baskets. The structure is placed across the waterway creating an upstream pool that traps coarse grained sediments which then need to be mechanically removed on a regular basis. The frequency and volume of removal depends on the severity of the upstream erosion and the size of the waterway watershed. There is currently a small gabion basket sediment trap on the Thornapple Hills Drain just upstream of Thornapple River Drive.

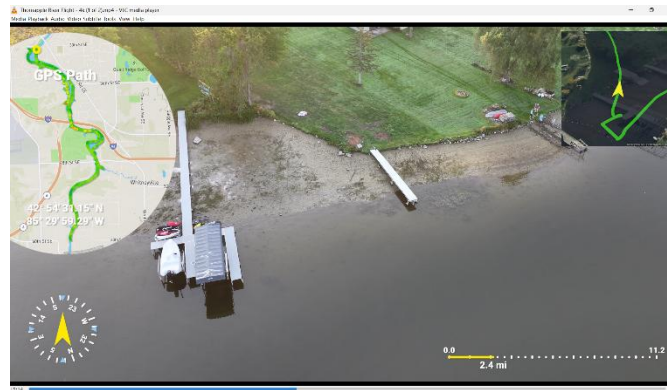
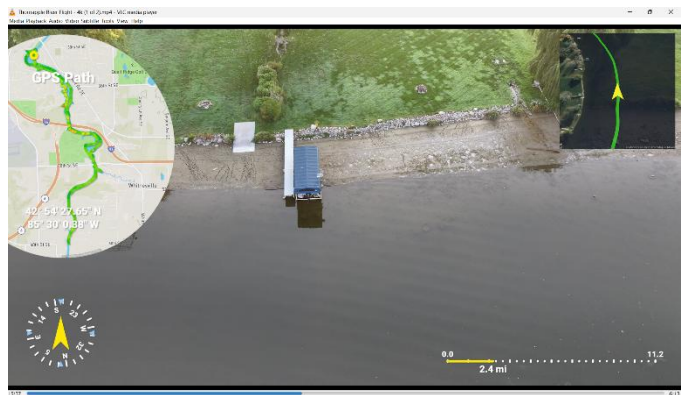
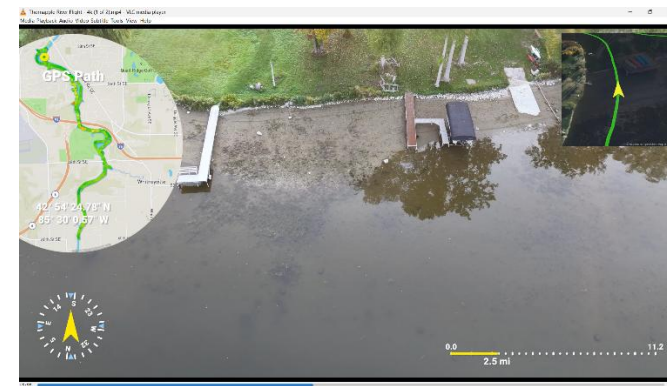
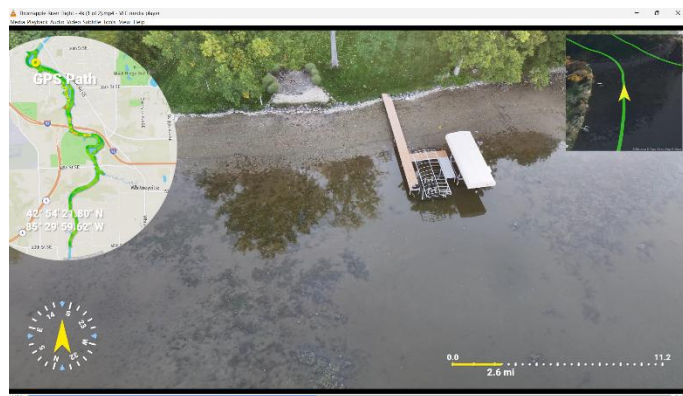
AREA 6: Sedimentation on inside of river bend, east side of river, upstream of the Cascade dam. Related to slow water area on inside of bend but not related to waterway erosion.

Once dredged, slow water areas can be protected with turbidity curtains/bubble curtains, -or they can be re-dredged after enough sediment as re-accumulated.

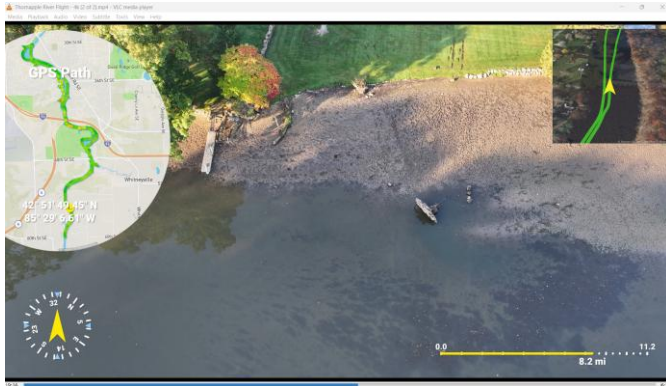
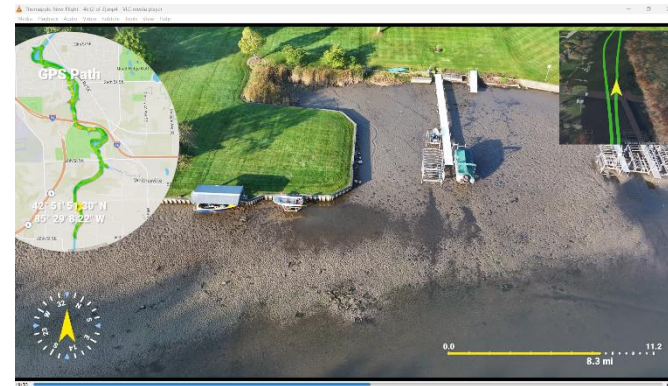
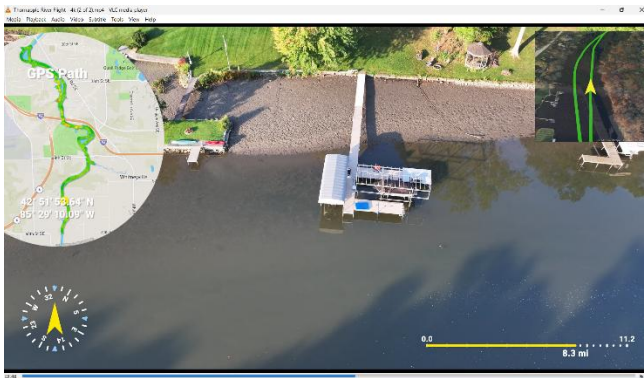
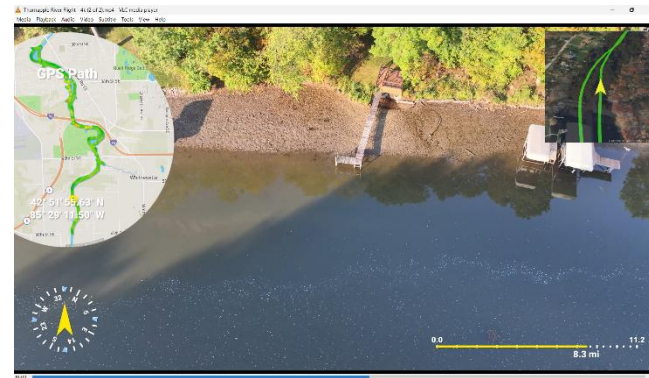
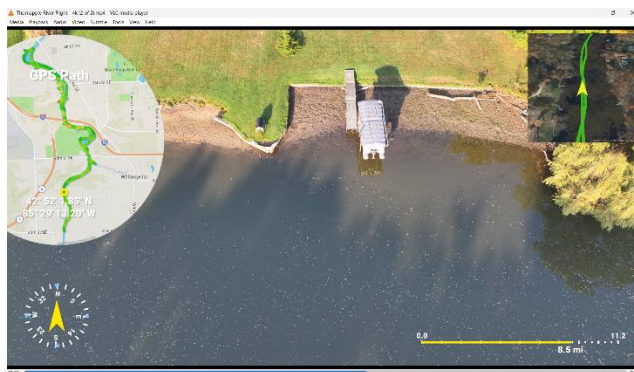
AREA 20: Local deposition along west bank from 7291 Kilmer Drive to 7231 Kilmer Drive. Deposition due to inside bend and inset harbor area which create slow water areas.
