C A S C A D E T O W N S H I P

C E N T E N N I A L P A R K

Final Draft

MARCH 2008

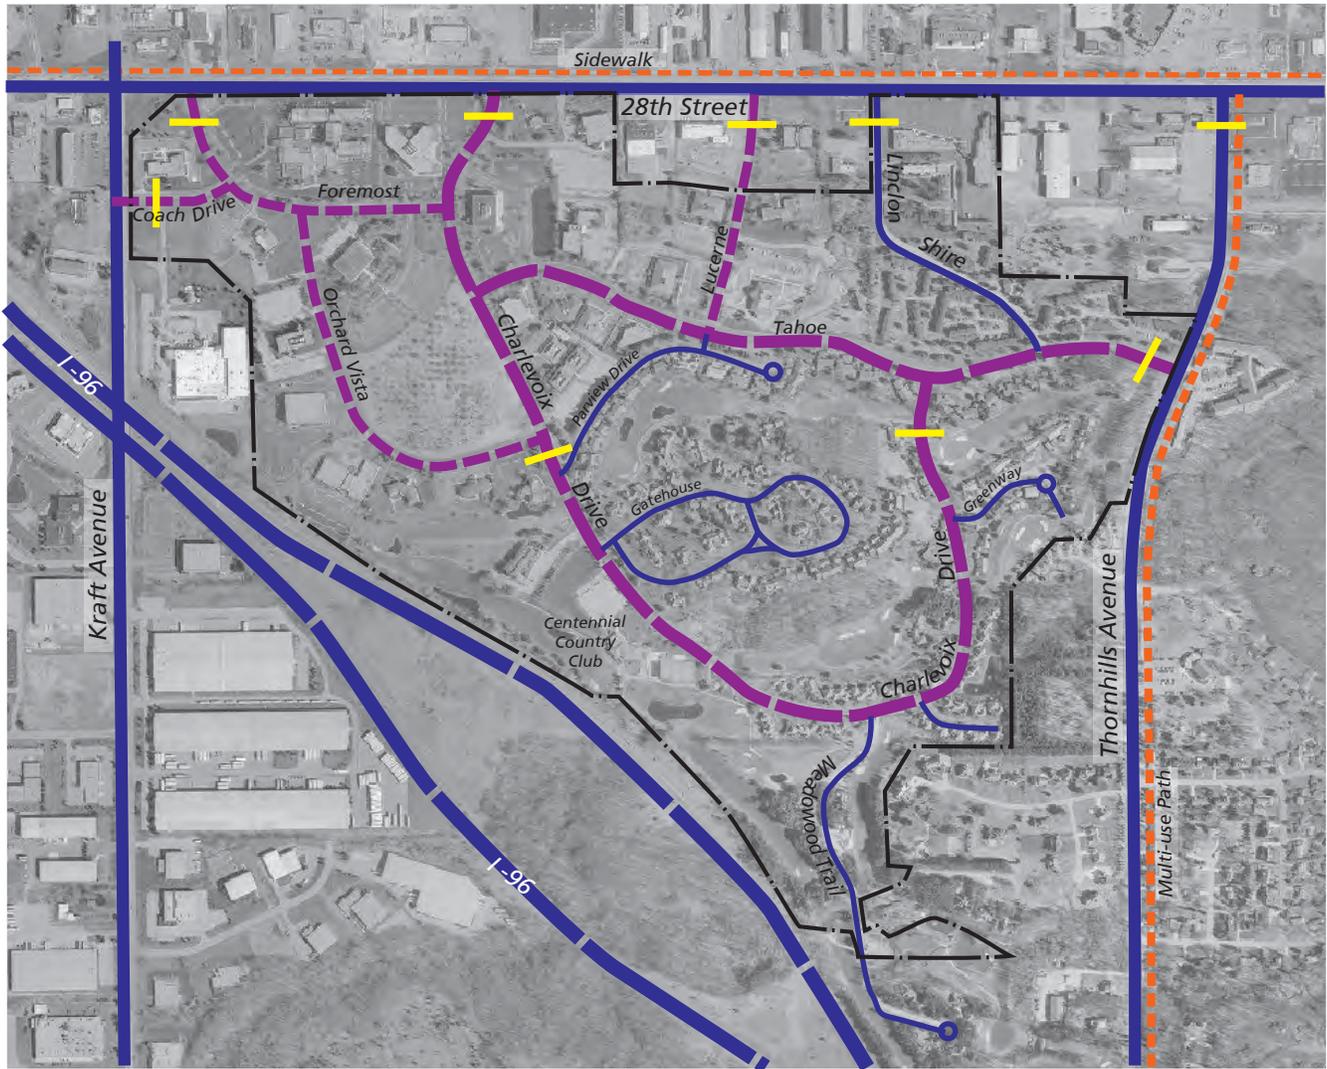
- Internal Road
- External Road
- Sidewalk
- Traffic Count Location

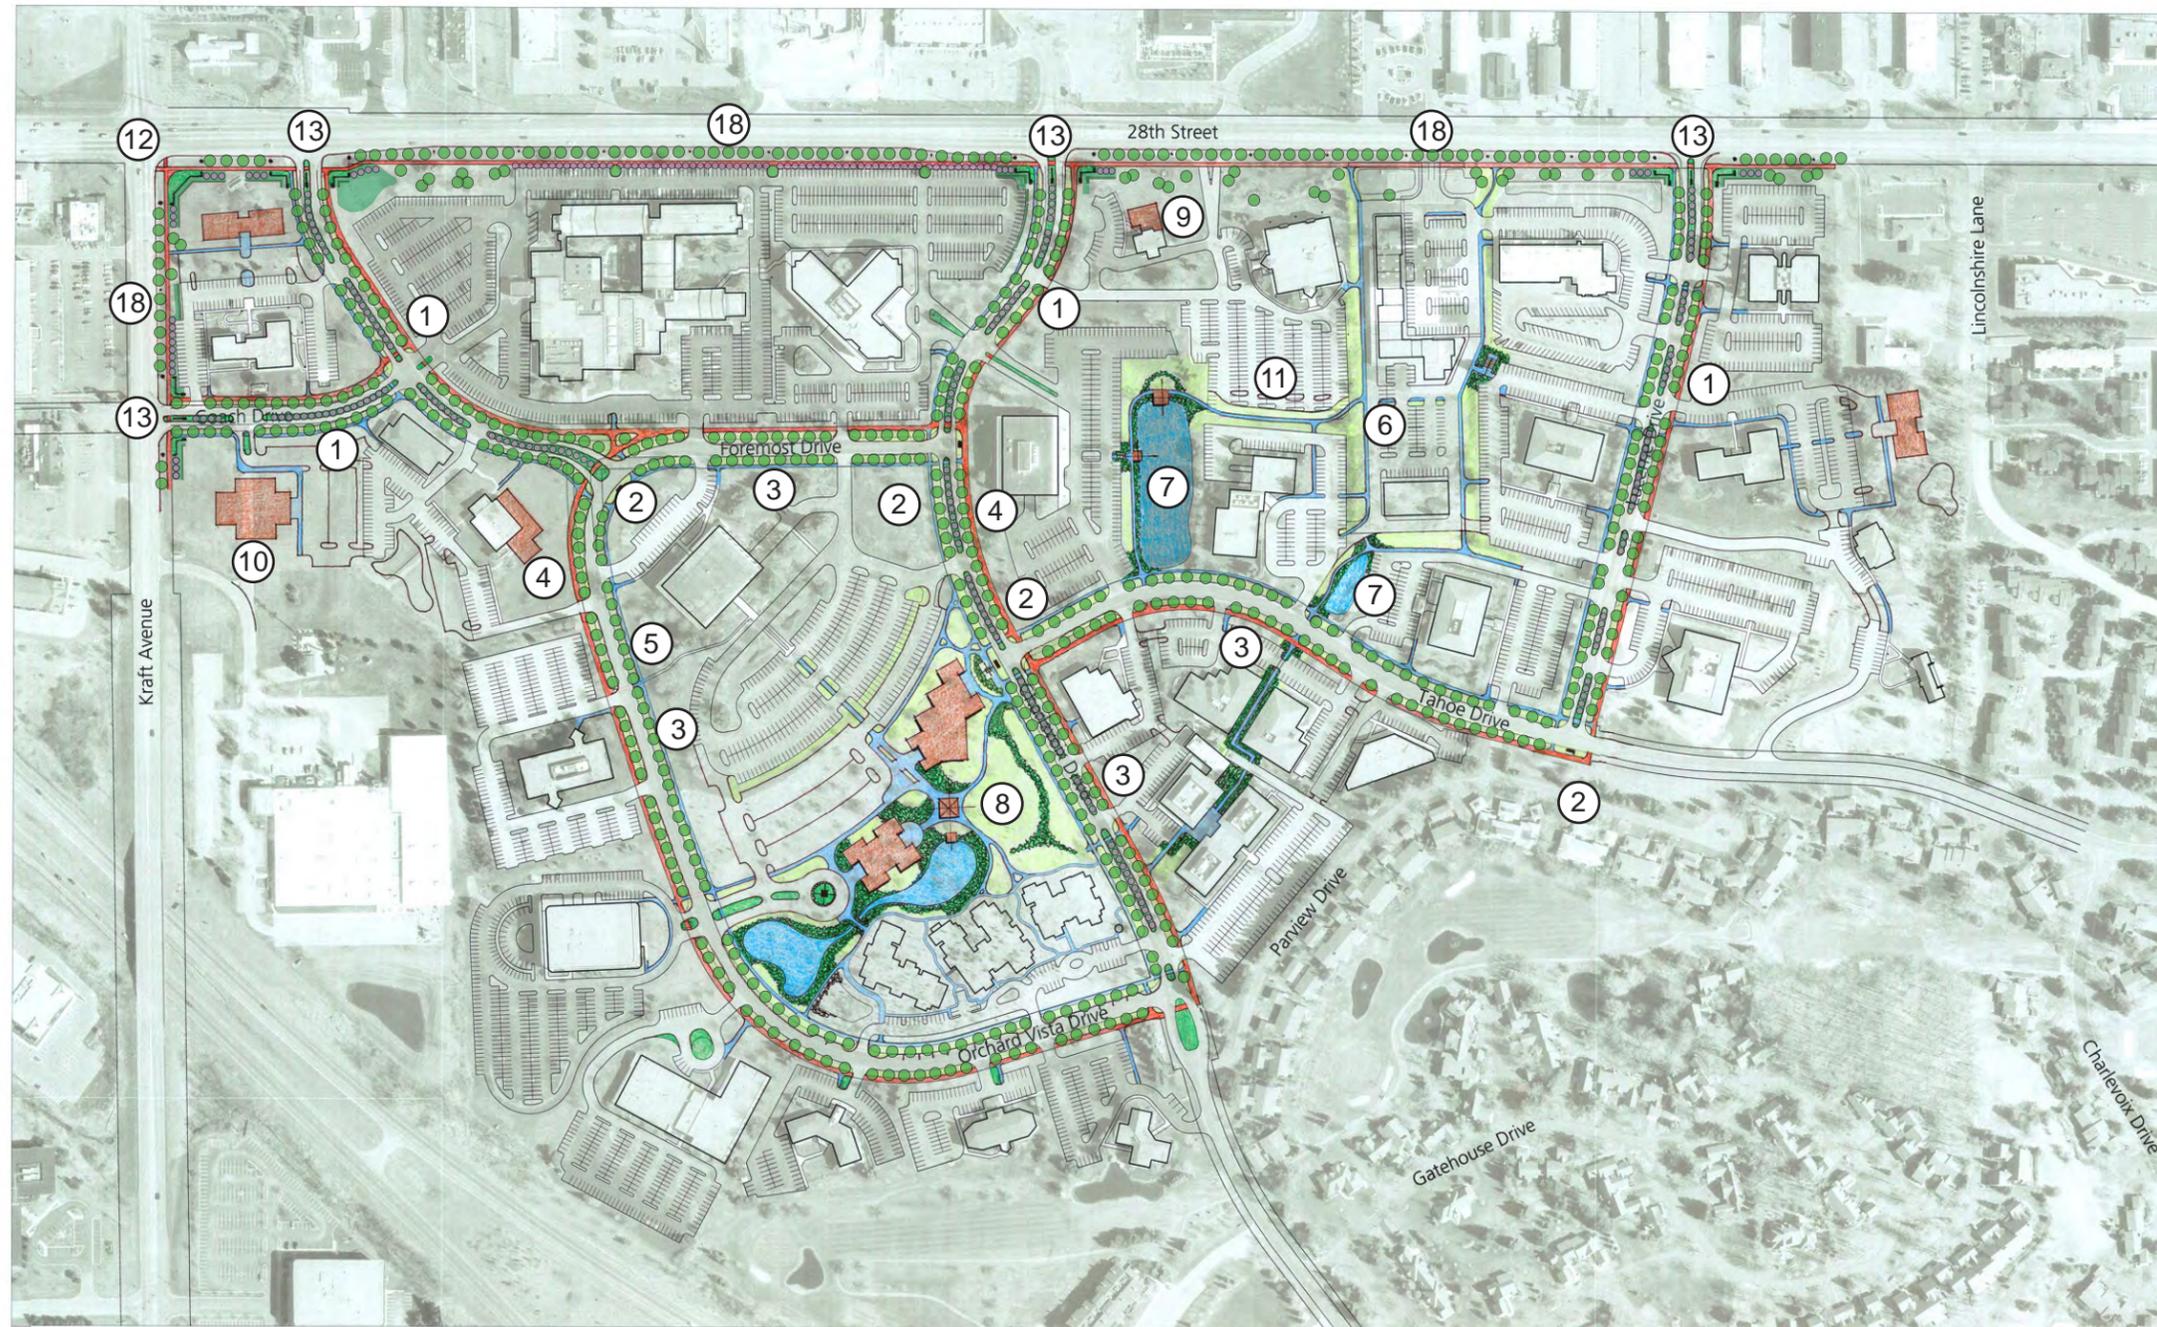
Vehicular and Pedestrian Circulation

- ① Boulevard Streets with Landscape Treatment
- ② Roundabouts (see alternate plan in Appendix)
- ③ Narrowed Streets
- ④ Multi-use Paths
- ⑤ Sidewalks
- ⑥ Informal Path System

The Master Plan addresses the public and private improvements recommended for Centennial Park. These improvements are targeted to enhance the use, function and image of the property. The recommendations discussed below are keyed to the plan on page 14.

- ① **Boulevard Streets with Landscape Treatment**
Boulevard Streets are recommended at all four entrances from 28th Street and Kraft Street. Boulevards will require cooperation for encroachments onto adjacent properties and approval from the Road Commission. Boulevards provide the following benefits:

- ② **Roundabouts (See Alternate Plan in Appendix)**
Four roundabouts are recommended at key decision points. The roundabouts will require cooperation for encroachments onto adjacent properties and approval from the Road Commission. Roundabouts provide the following benefits:

- Landmark features for way finding
 - Landscape displays of seasonal plantings
 - Facilitate turning at intersections
- ③ **Narrowed Streets**
Narrowing the streets without boulevards is recommended. This will also require approval from the Road Commission. Narrowed streets provide the following benefits:

- Narrowed streets slow traffic
 - Narrowed streets provide additional ROW allowing for pedestrian amenities
 - Narrowed streets allow for street trees
- ④ **Multi-use Paths**
Ten-foot wide multi-use paths are recommended on one side of the street (indicated in red on the plan). This will also require approval from the Road Commission. Multi-use paths provide the following benefits:

- A place for bike riding
 - A place for joggers and walkers
 - A place for rollerblading
 - Pedestrian connections between businesses
- ⑤ **Sidewalks**
Seven-foot wide sidewalks are recommended on the alternate side of the street (indicated in blue on the plan). This will also require approval from the Road Commission. Sidewalks provide the following benefits:

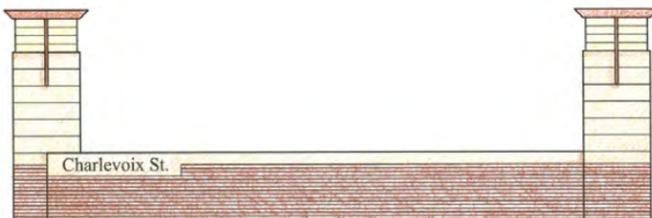
SIDE WALL AND STREET SIGN

NORTH ELEVATION

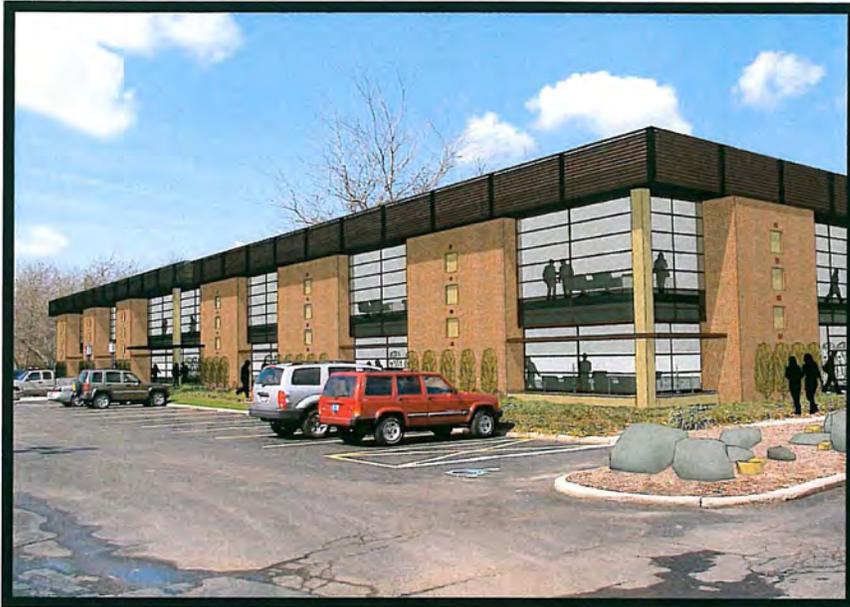
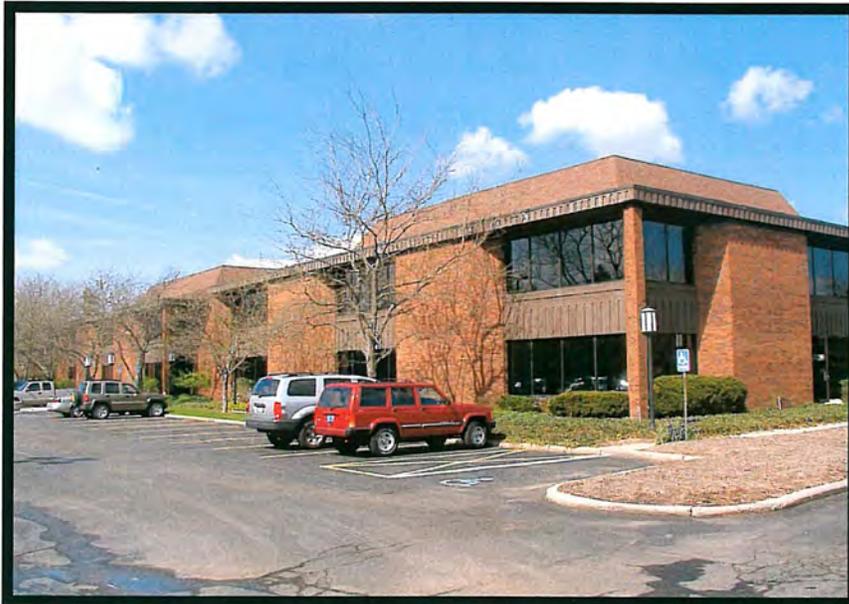
ENHANCED CONCEPT

EXISTING BUILDING

- Map ID No. 1 - 5630 28th Street, The Image Building
- Map ID No. 14 - 2905 Lucerne, Champlain Building
- Map ID No. 22 - 3040 Charlevoix, office building
- Map ID No. 23 - 3030 Charlevoix, Charlevoix Fitness Center
- Map ID No. 31 - 3075 Orchard Vista, Metron Building
- Map ID No. 34 - 5740 Foremost Dr., former Exchange Financial

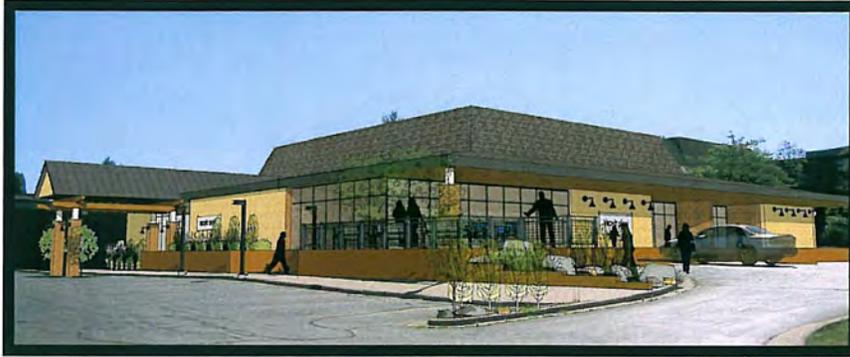
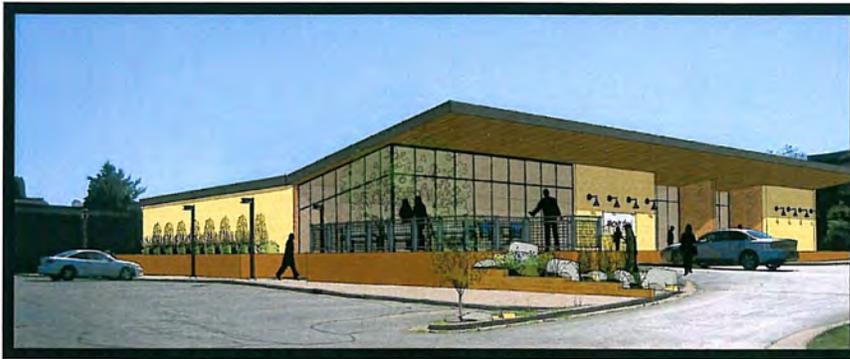
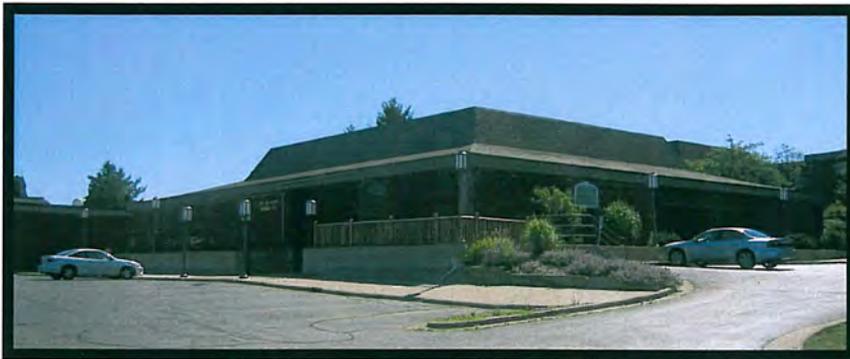
ENHANCED CONCEPT 1

ENHANCED CONCEPT 2

EXISTING BUILDING

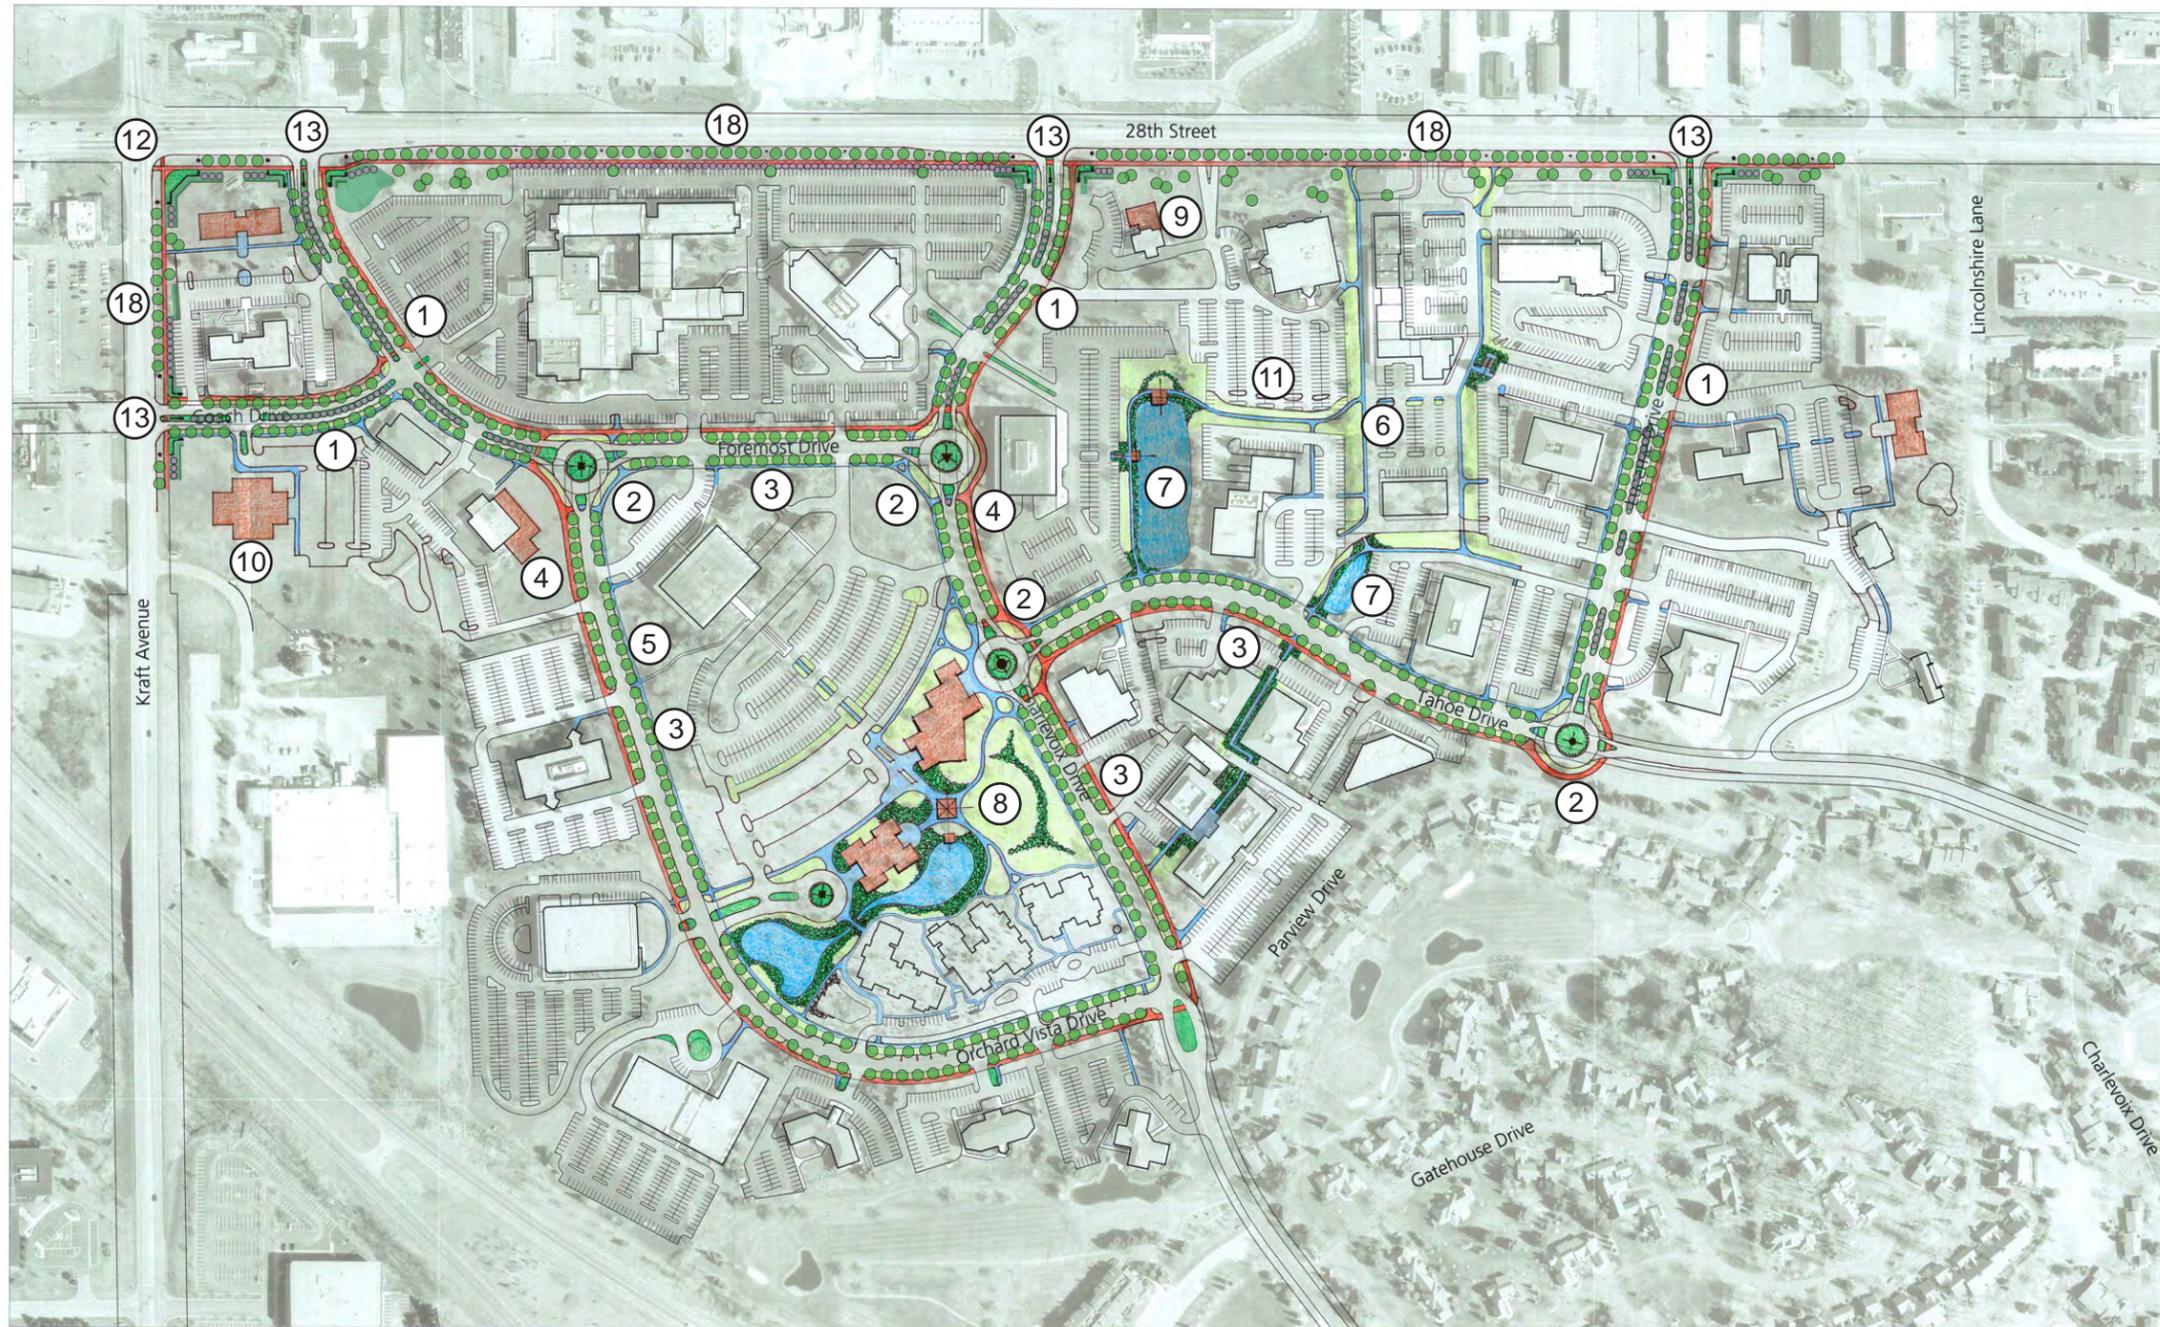
Vehicular and Pedestrian Circulation

- ① Boulevard Streets with Landscape Treatment
- ② Roundabouts
- ③ Narrowed Streets
- ④ Multi-use Paths
- ⑤ Sidewalks
- ⑥ Informal Path System

As an alternative to the selected circulation plan, the BRI Team studied and presented the circulation plan shown on page 58 that includes roundabouts.

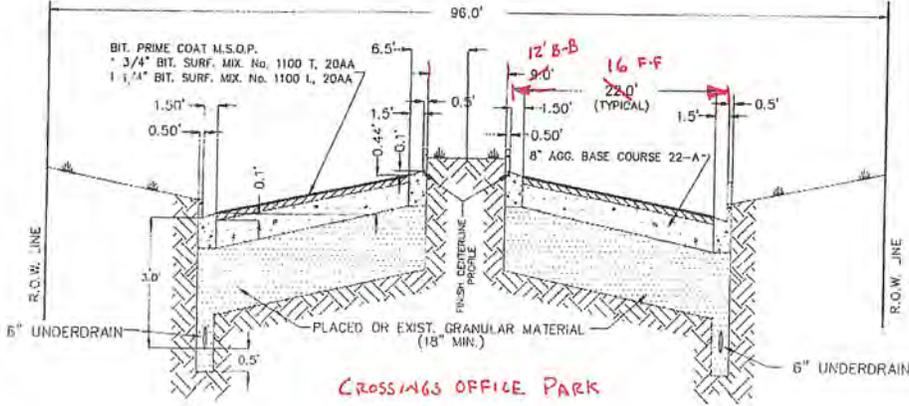
An acceptable median design is shown below. It would be a 16-foot (face to face) wide travel lane on each side and a 12-foot (back to back). The 16-foot width is needed to allow for passing a stopped or stalled vehicle. This would also allow for the development of a left turn lane at driveways and internal intersections leaving a 4-foot median. This design is a modification of an existing design used in the Crossings Office Park in Gaines Township. The median will not be allowed at intersections with major roadways (28th Street and Kraft Ave).

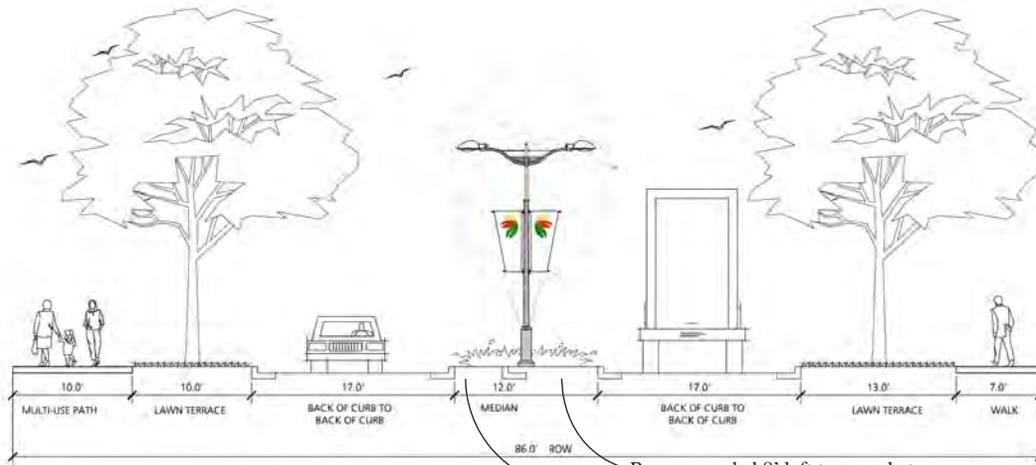
86' ROW BOULEVARD

Recommended 8' left turn pocket
 Remaining 4' concrete island (see plan).
 Trees and lights will not be possible within this narrow median.

The KCRC letter requests wider travel lanes, a wider median and left turn pockets. The revised road cross sections follow with comments regarding the implications of the KCRC comments:

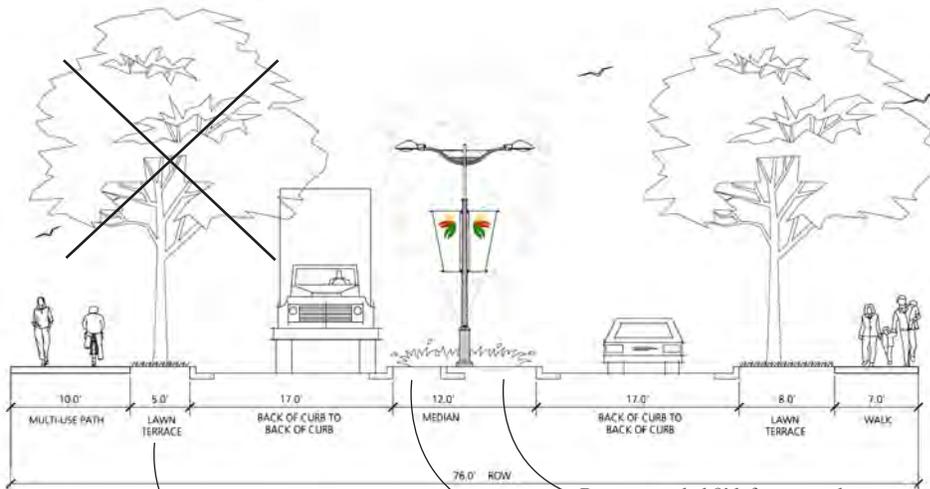
76' ROW BOULEVARD

Tree not possible in 5' lawn terrace, additional ROW would need to be acquired to include street tree

Recommended 8' left turn pocket
 Remaining 4' concrete island (see plan).
 Trees and lights will not be possible within this narrow median.

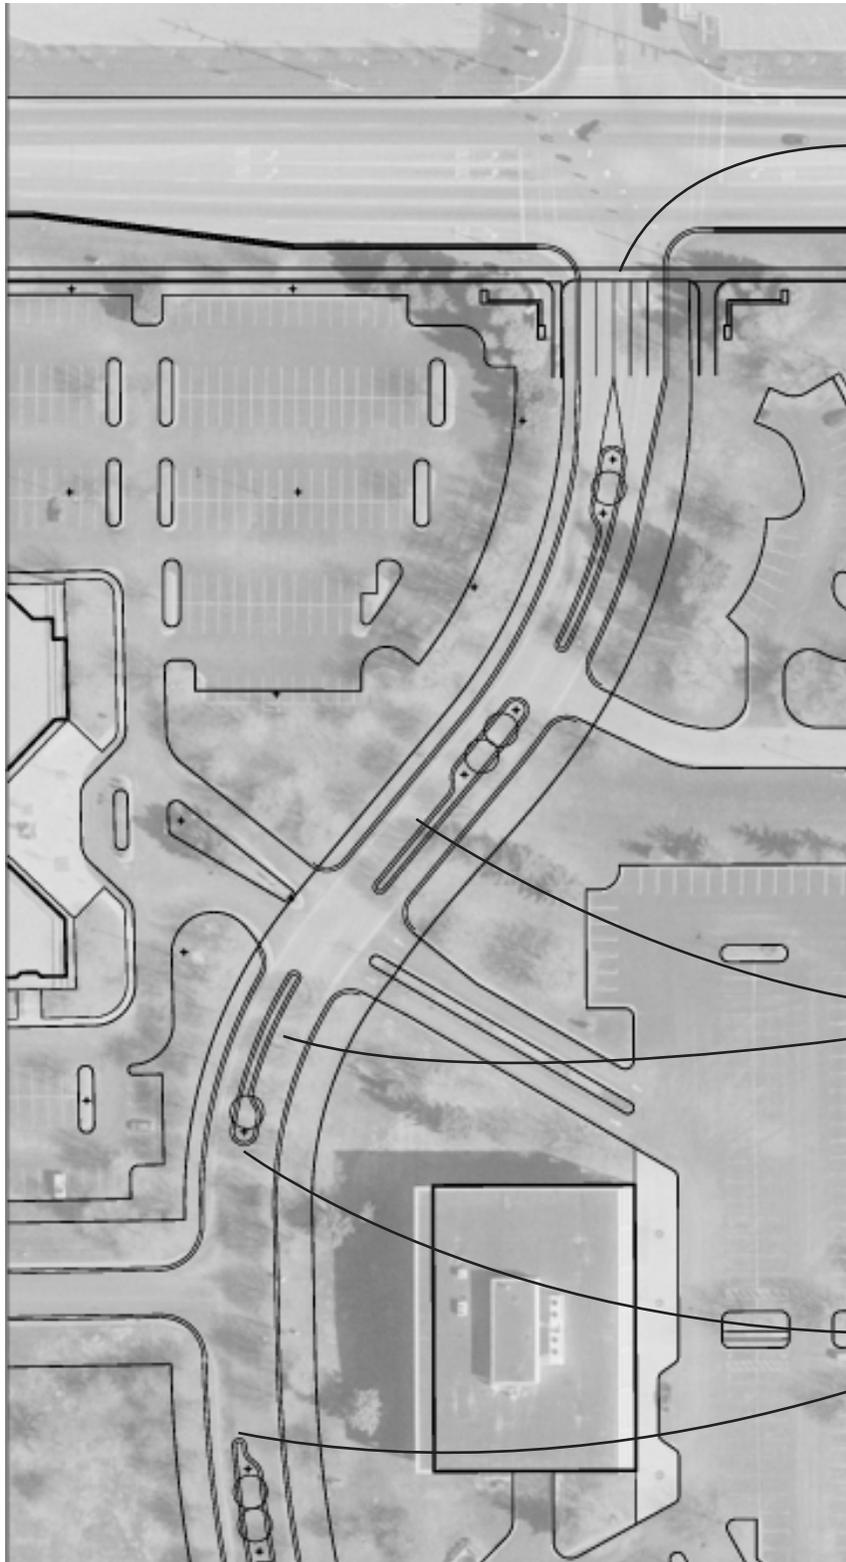
BOULEVARD HELD BACK 100' FROM 28TH STREET ROW

Nose of island held back 100' from 28th Street ROW.
Pedestrian safety compromised. No refuge island or visual barrier.
Boulevard Entry Sign eliminated.

75' long, 8' wide left turn pockets

In conversation with the KCRC, they would like to see the boulevards pulled back from the intersection a minimum of 100'. The following plan demonstrates the impact of this.

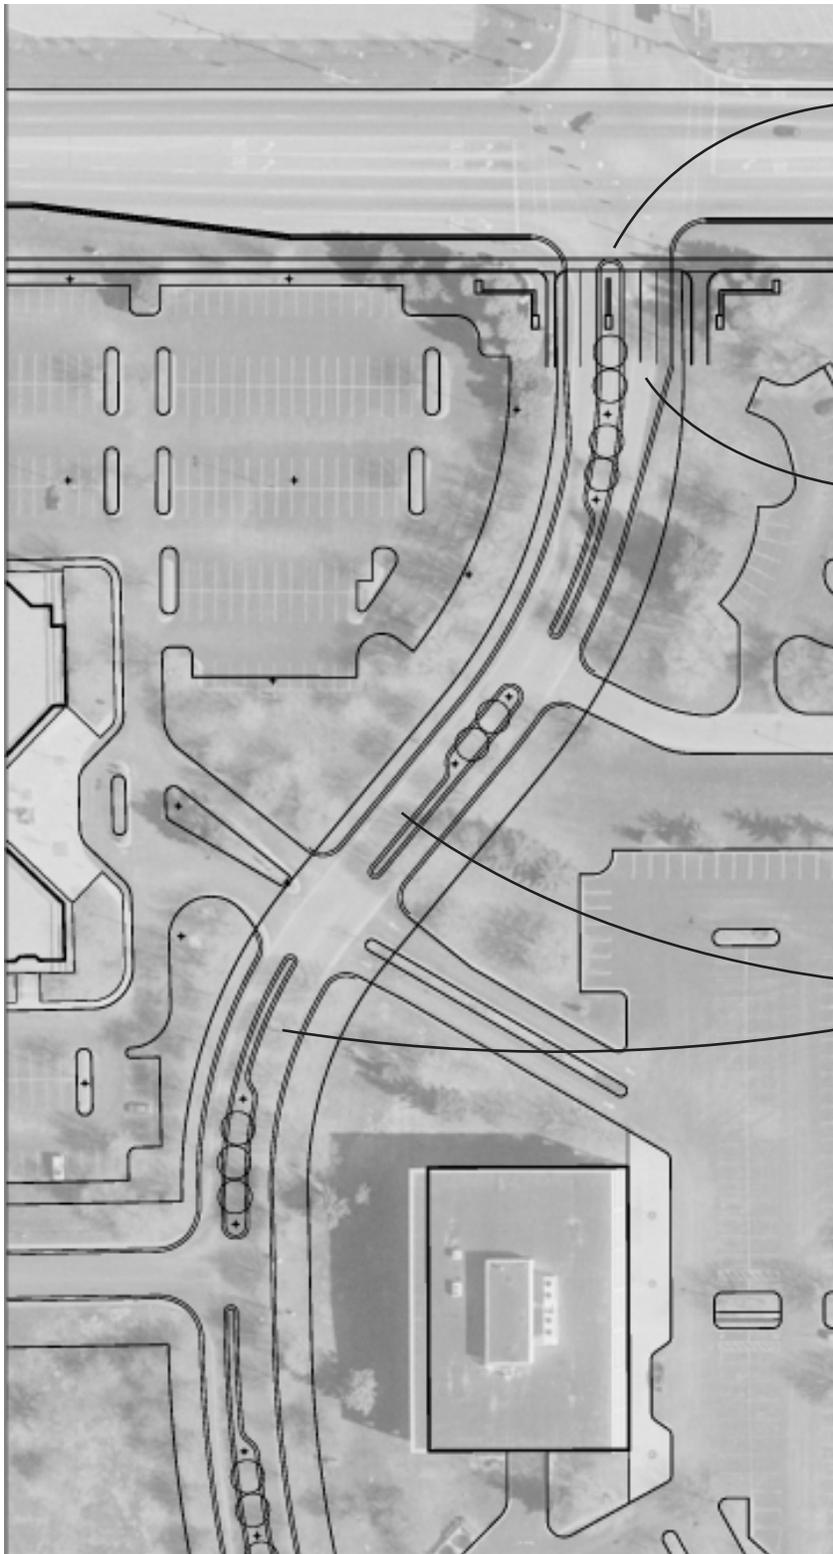
BOULEVARD EXTENDS TO 28TH STREET ROW

Nose of island extends to the crosswalk and is flush with the road surface within the crosswalk. This enhances pedestrian safety by providing a safe haven in the island and enhancing motorists of their surroundings. Provides a location for the Boulevard Entry Sign.

Lanes intended to align with those across 28th Street.

Extending the boulevard to the sidewalk enhances the image of the park, improves pedestrian safety and facilitates wayfinding.

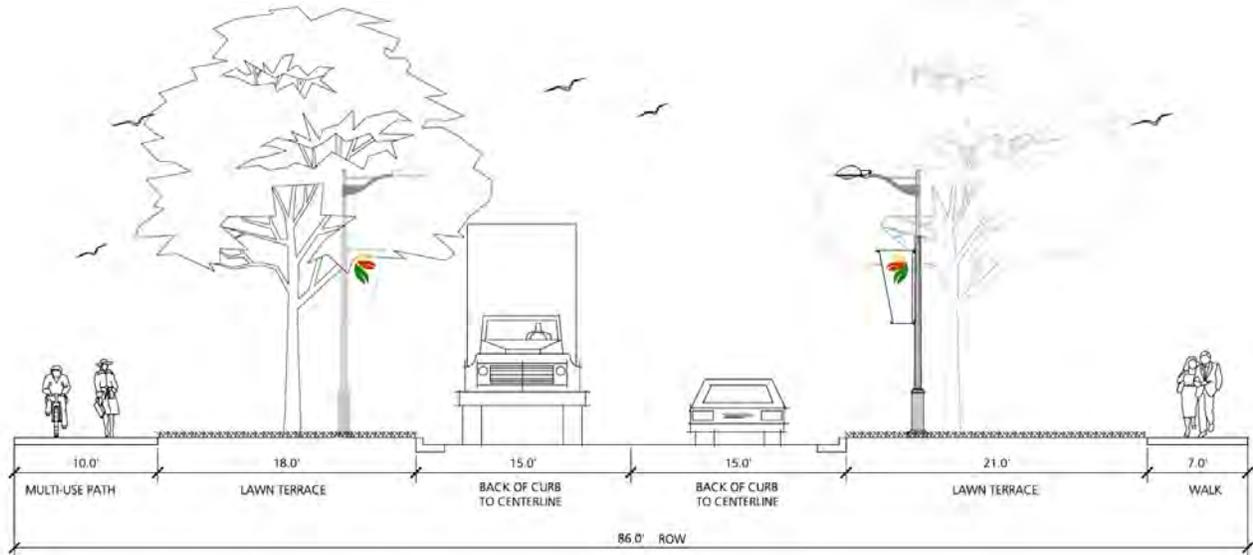
86' ROW NARROWED ROAD

KCRC recommends a thirty foot wide roadway and relocating both curbs to narrow the street symetrically. This would add to the project costs, both in terms of additional curb replacement and additional bituminous. A cross section of the suggested road width is below.

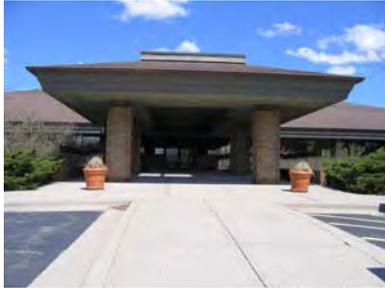
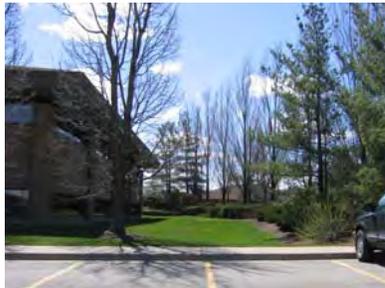
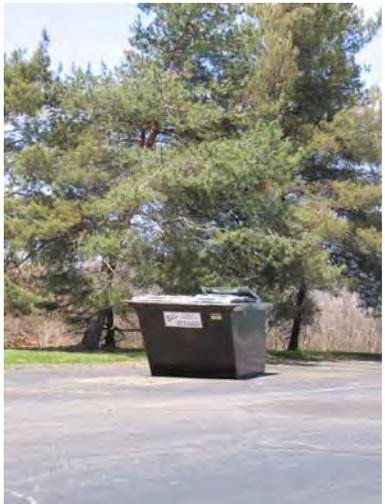
Topography: The overall slope of the site is down from south to north. There is a ridge in the middle of the entrance.

Paving: Asphalt, in fair condition.

Lighting: Adequate, shoebox fixture, some fixtures are missing.

Flatwork: Concrete sidewalks in fair condition.

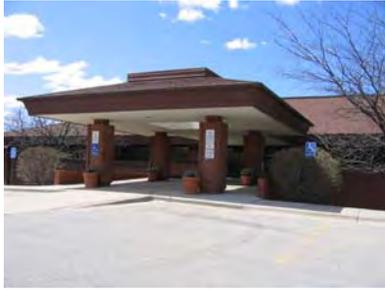
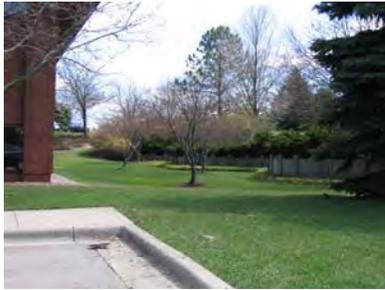
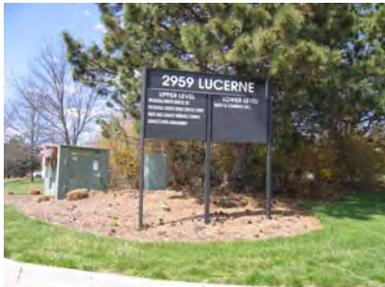
Topography: Sloping down from east to west and from the south to the northwest.

Paving: Asphalt, in fair condition. Needs to be restriped, some serious cracks. Parking islands are paved.

Flatwork: Concrete sidewalk in fair condition.

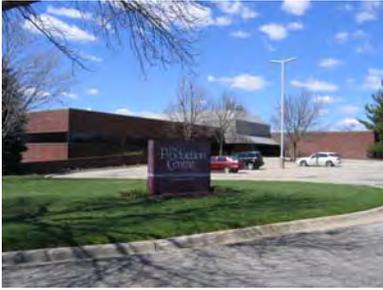
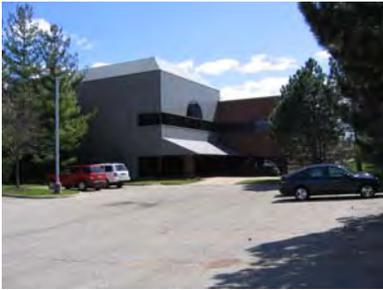
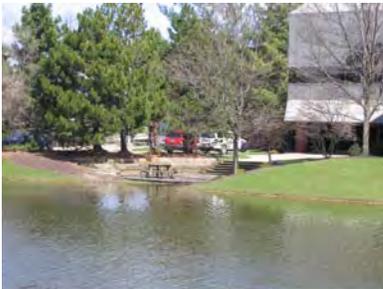
Topography: Slight slopes down from east to west.

Paving: Asphalt, in fair condition. Parking islands are paved.

Flatwork: Concrete sidewalk in good condition.

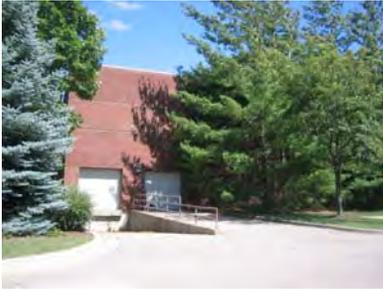
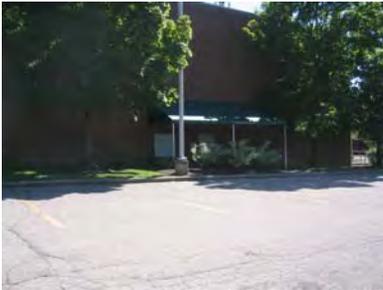
Somewhat damaged concrete sidewalk at both entries (rust stains and some cracks).

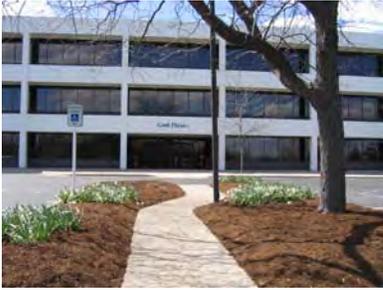
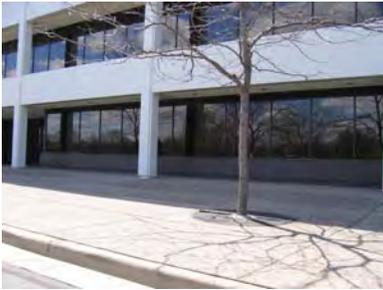
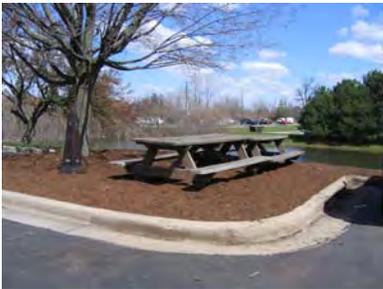
Topography: The site slopes slightly down from west to east.

Paving: Asphalt, in good condition. Parking islands are landscaped.

Flatwork: Concrete sidewalks (with exposed aggregate finish) in good condition.

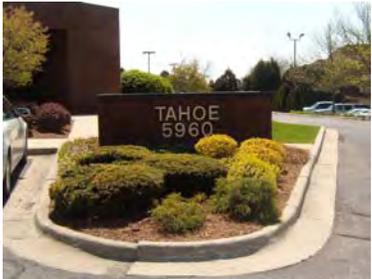
Overall Visual Impact and Street Presence

Direct and clear access from Tahoe.

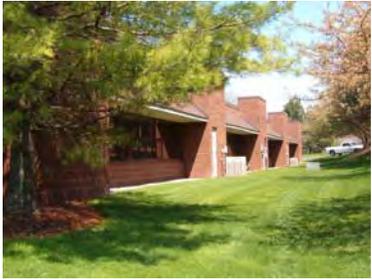
Building Character and Individuality

Structure of the building is concealed, strip windows throughout, curtain wall at entry.

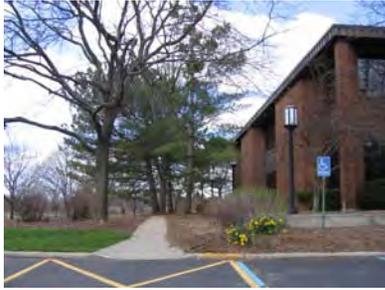
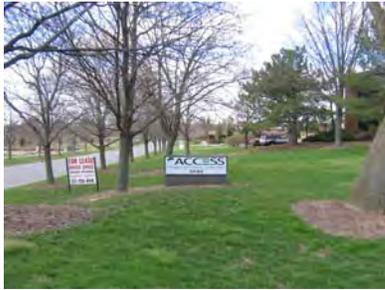
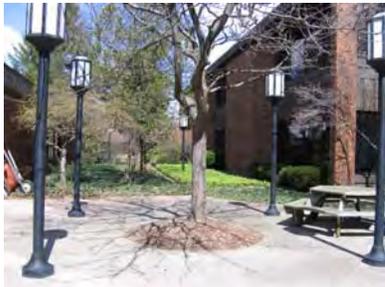
Site Information

Topography: Slight slope down from east to west.

Paving: Asphalt, in fair condition, patched, potholes, subsidence at catch basins.

Flatwork: Concrete sidewalk, in fair condition.

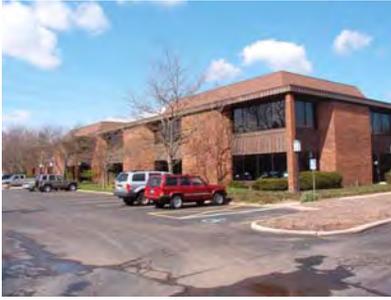
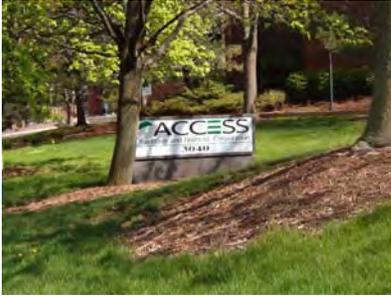
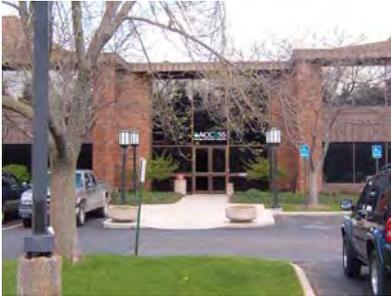
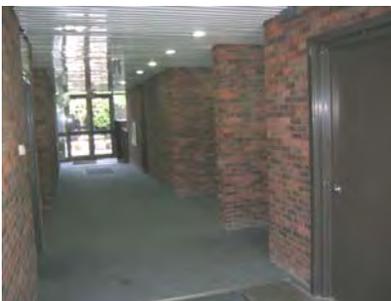
Building Information

Walls: Areas of brick veneer with wood type spandrel panels, wood fascia, wood sill areas - wood is not in good condition. A number of spaces look like there's rot - with paint peeling off.

Restrooms: The restrooms are in good condition but do not comply with current code requirements for barrier free access.

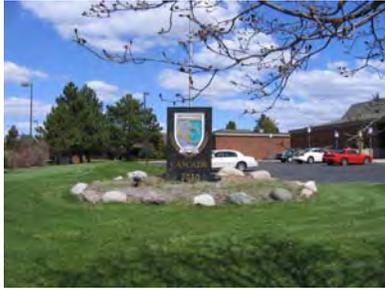
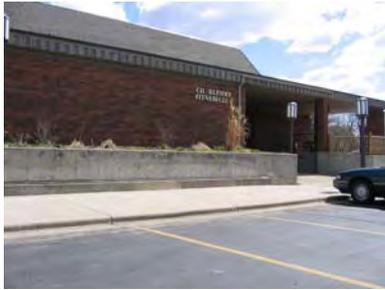
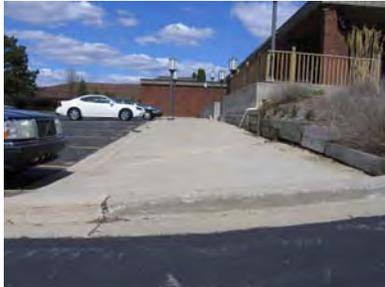
Site Information

Topography: Slight rise to the south.

Paving: Asphalt, in good condition.

Flatwork: Concrete sidewalk, in fair condition.

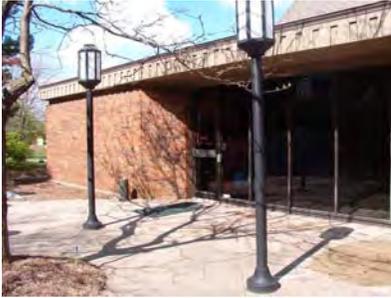
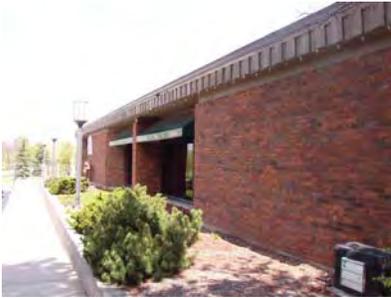
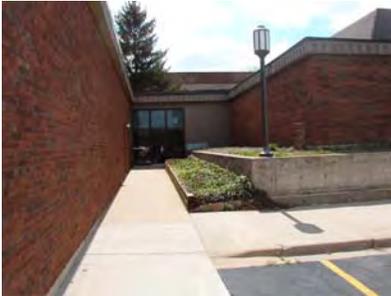
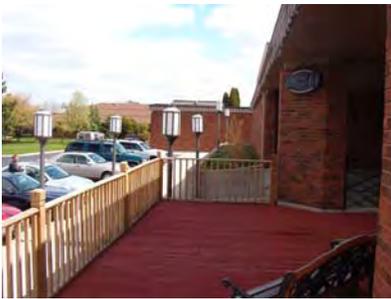
Building Information

Walls: Brick veneer with wood fascia and soffit. wood is in fair condition.

Restrooms: The restrooms do not comply with current code requirements for barrier free access. The restrooms are in fair condition.

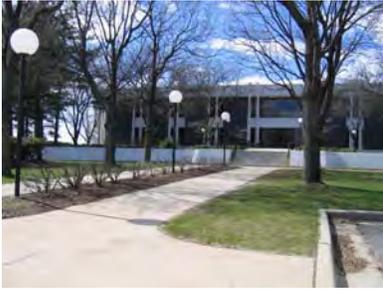
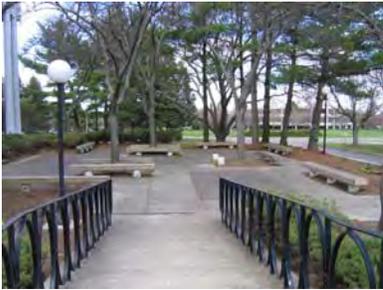
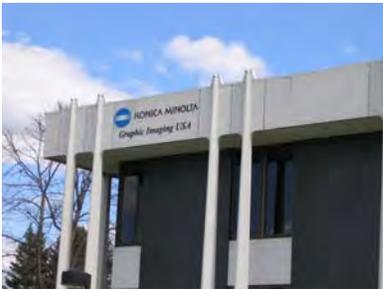
Site Information

Topography: Sloping down from the building in all directions.

Paving: Asphalt, in fair condition.

Flatwork: Concrete sidewalk, in good condition.

Landscape: Good structure, clean, maintained, could use some replacement.

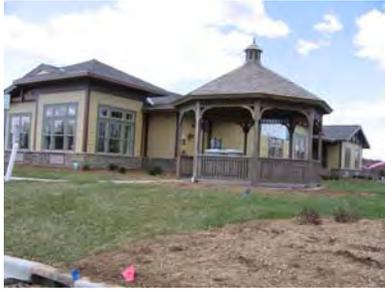
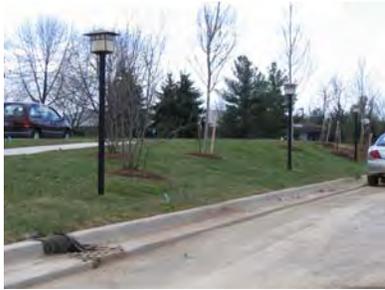
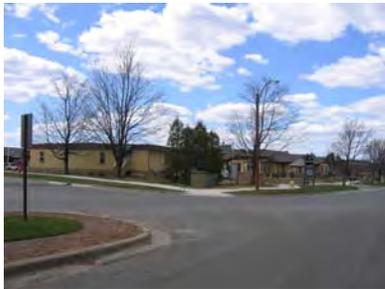
Site Information

Topography: Relatively flat, the western edge slopes down.

Paving: Asphalt, in new condition.

Flatwork: Concrete sidewalks, in new condition.

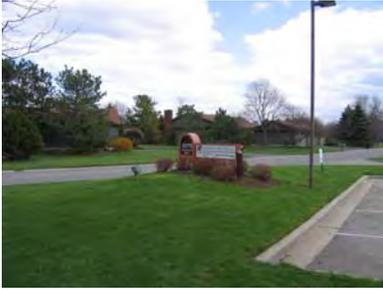
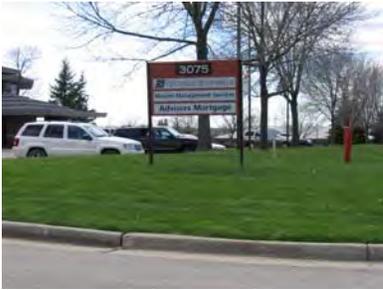
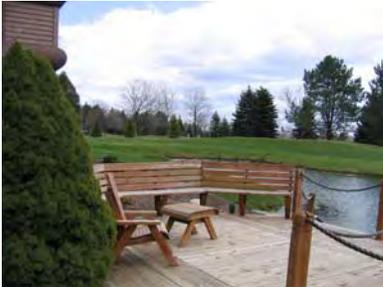
Centennial Park Property / Site / Building Information

Site Information

Topography: Relatively flat, slight fall to the northwest.

Paving: Asphalt, in good condition.

Flatwork: Concrete sidewalk, in fair condition.

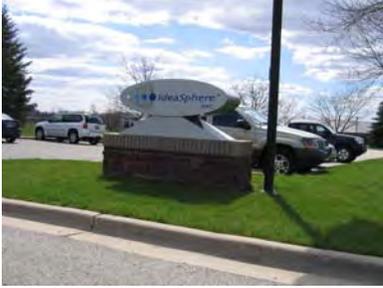
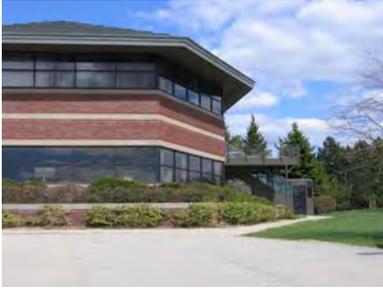
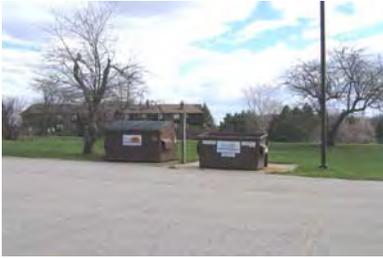
Centennial Park Property / Site / Building Information

Site Information

Topography: Relatively flat, slopes down to the west from the main entry.

Signage: Monument sign at entrance drive. Some of the brick is spalled, evidence of water leakage into the brick base.

Paving: Asphalt, in fair condition.

Flatwork: Concrete sidewalk, in good condition. Exposed aggregate sidewalk at main entry in poor condition.

Landscape: Minimal, some is burned.

Furnishings (Appurtenances): Retaining wall is failing.

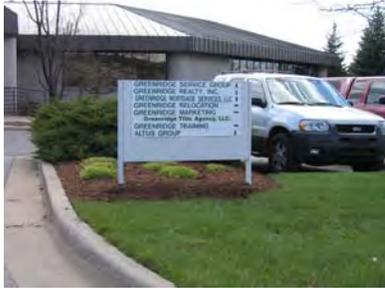
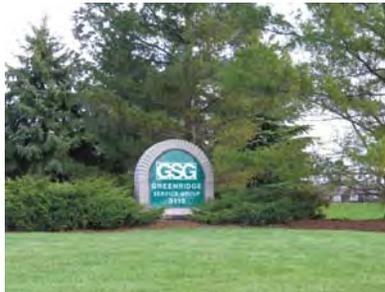
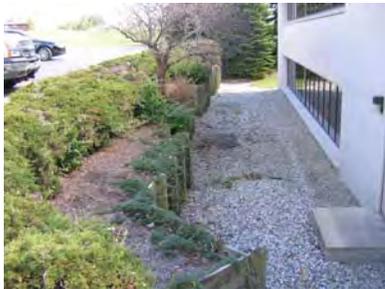
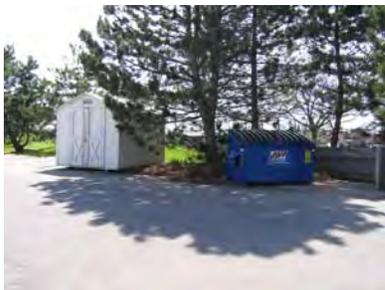
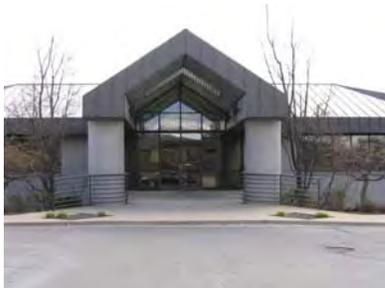
Centennial Park Property / Site / Building Information

Site Information

Topography: Sloping down to south.

Paving: Asphalt, in fair condition.

Flatwork: Concrete sidewalk in fair condition.

Landscape: Retaining walls are failing. Minimal landscape, low maintenance.

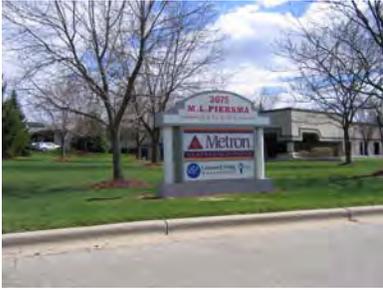
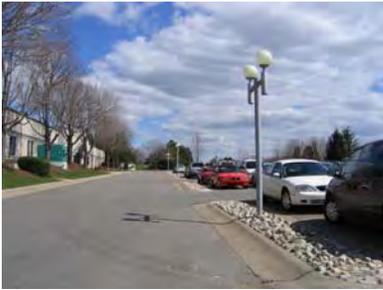
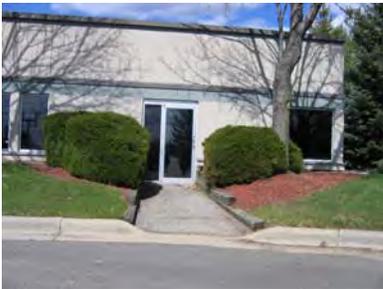
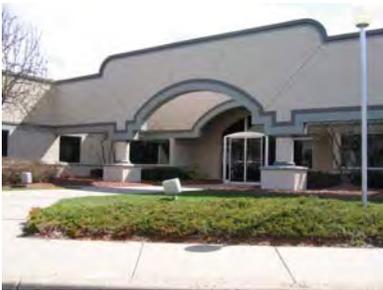
Centennial Park Property / Site / Building Information

Site Information

Topography: Slopes down to the southwest.

Paving: Asphalt, in fair to poor condition on the east side. Several potholes.
Asphalt on the west side, in good condition.

Flatwork: Concrete sidewalk, in fair condition. Some cracking by main entrance.

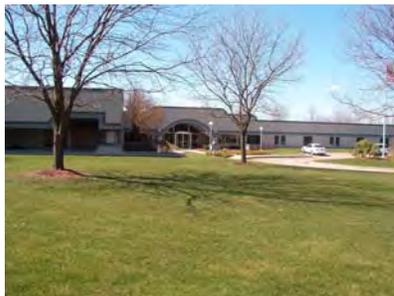
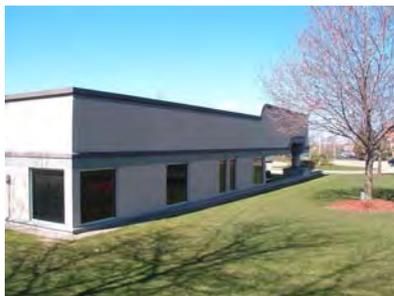
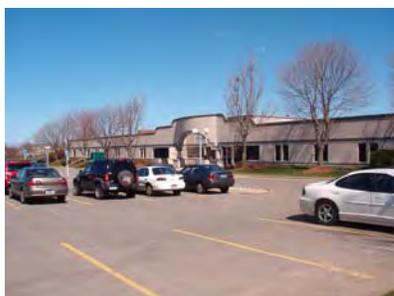
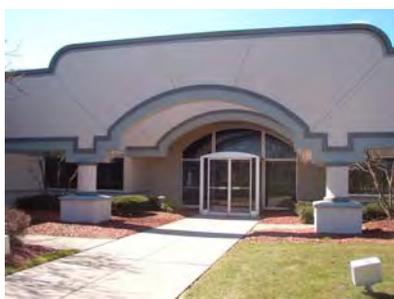
Centennial Park Property / Site / Building Information

Building Information

Walls: The exterior walls are EIFS. The EIFS on the exterior of the building appears to be in fairly good condition, other than at the chipped pillars at the main entrance.

Restrooms: Good condition but do not comply with the current code requirements for barrier free access.

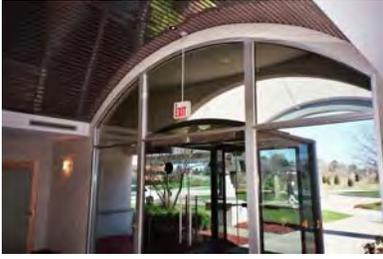
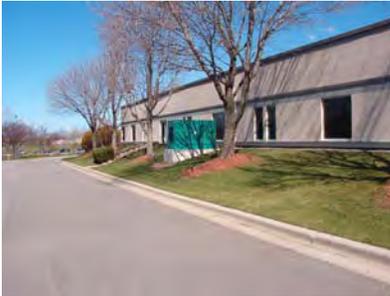
Centennial Park Property / Site / Building Information

Exterior Features and Detractors

"B" Category - Adequate condition with room for improvement.

- Looks like building has recently been refinished.
- Parking has areas that need work.
- Sidewalk has some weeds, cracks.
- Brighten lobby with new light fixtures.
- Parking is in fair to poor condition.
- Landscaping is in good condition.
- Limited signage, but there is a monument sign~ Consider interior upgrades.
- Assess existing technology infrastructure for improvement opportunities.
- Incorporate "green" building standards as appropriate.
