C A S C A D E T O W N S H I P

C E N T E N N I A L P A R K

Final Draft

MARCH 2008

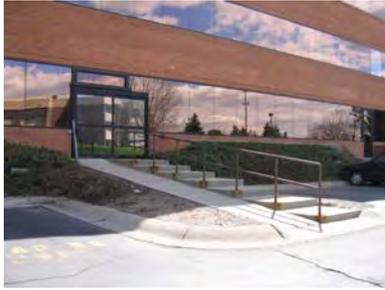
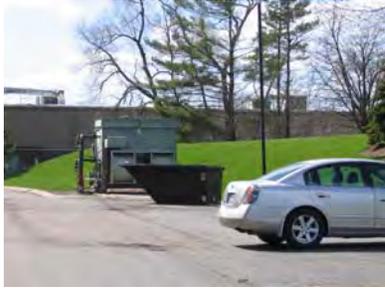
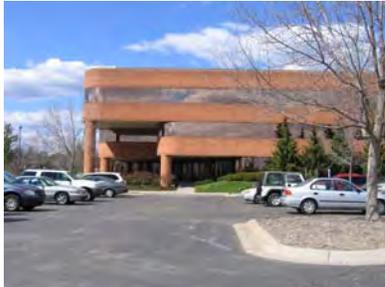
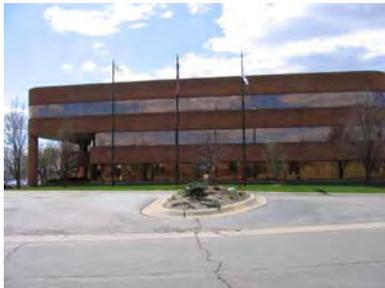
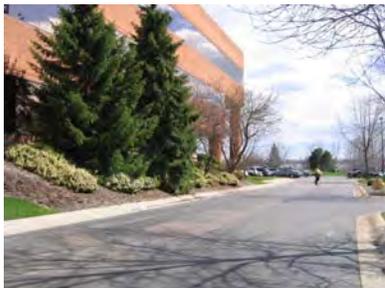
Site Information

Topography: Slopes down to the west.

Paving: Asphalt, in poor condition.

Flatwork: Concrete sidewalk, in good condition.

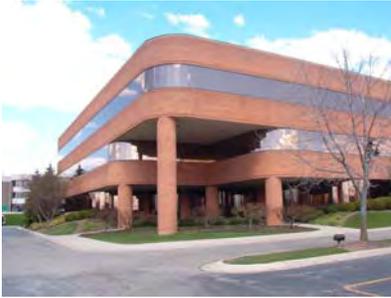
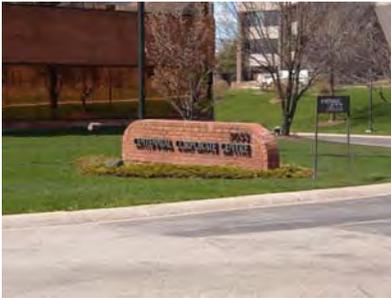
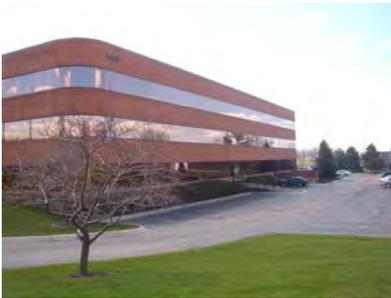
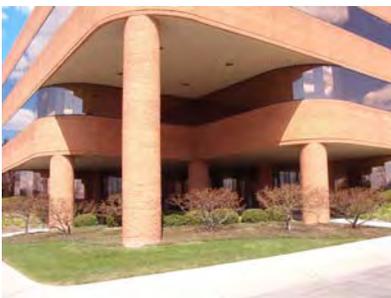
Building Information

Common Areas: corridors are only common areas other than small elevator lobby – good condition.

Restrooms: good condition but do not comply with current code requirements for barrier free access. The BF stalls are 60-inch in width, but they do have the grab bars. The lavatories look like they may be a little high.

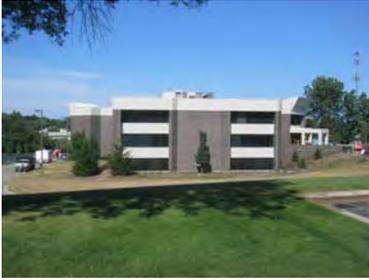
Site Information

Topography: Sloping down to the south.

Paving: Asphalt, in fair condition in the north lot, in poor condition in the south lot.

Flatwork: Concrete sidewalks, in fair condition.

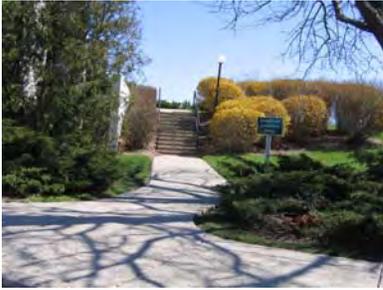
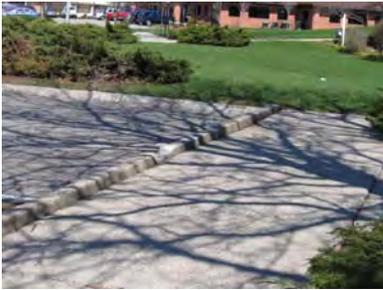
Site Information

Topography: Sloping down to the southwest.

Storm Water Drainage: Underground system, failing storm sewer.

Paving: Asphalt, in poor condition.

Flatwork: Concrete sidewalk, in poor condition. Area adjacent to parking lot is sinking. Stairs on east side are deteriorating.

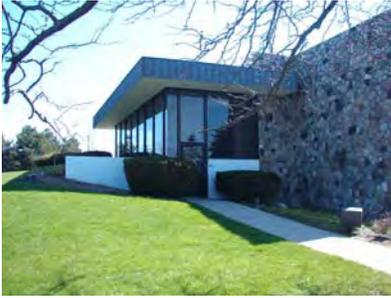
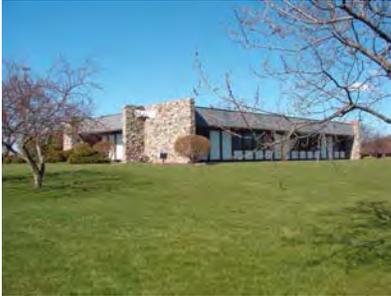
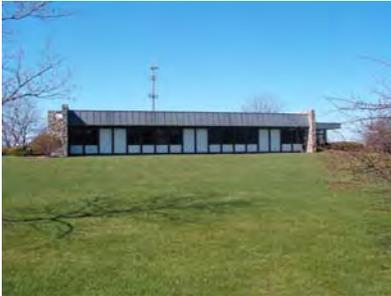
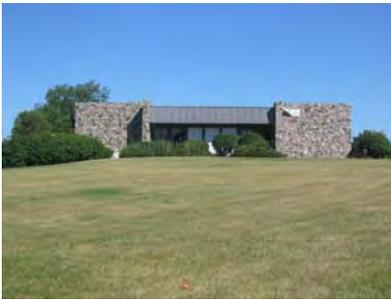
Building Information

Roof: Flat with rusting metal fascia.

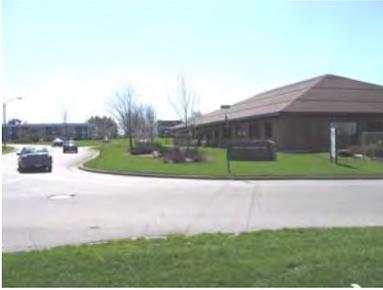
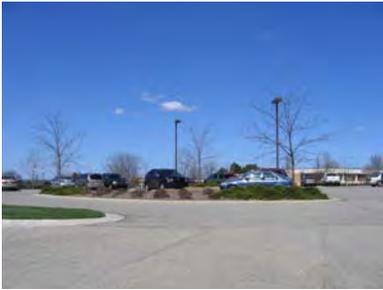
Site Information

Topography: Slopes down to the southwest.

Paving: Asphalt, in fair condition.

Flatwork: Concrete sidewalk, in good condition.
